Facility Condition Assessment

REPORT DATE: September 25, 2023

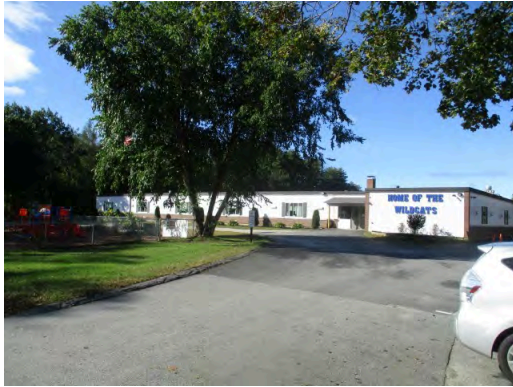
View of property from Elm Street

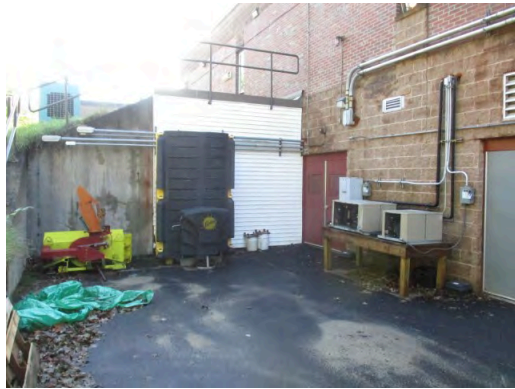
Courtyard at 1982 section boiler room and kitchen entrance showing concrete retaining wall (left)

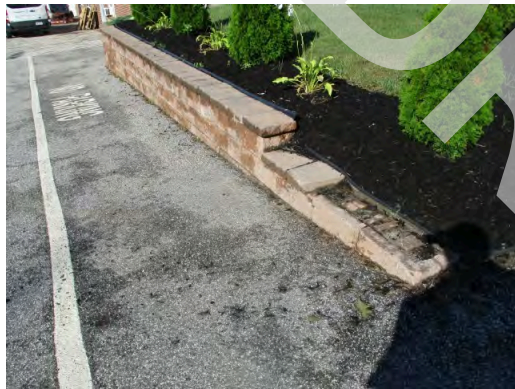
Retaining wall near main entrance showing missing blocks

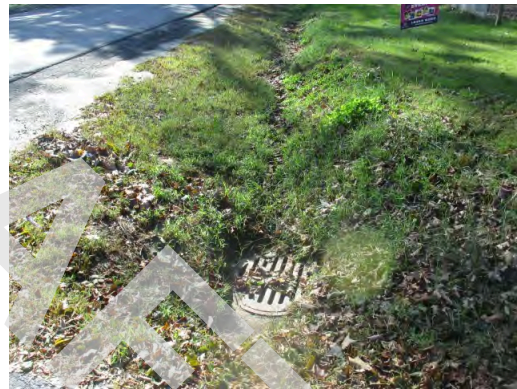
Catchbasin at northeast corner of Property

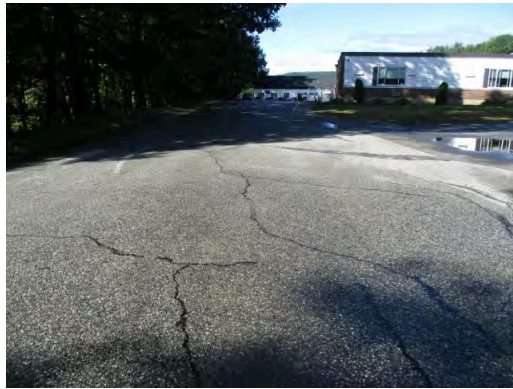
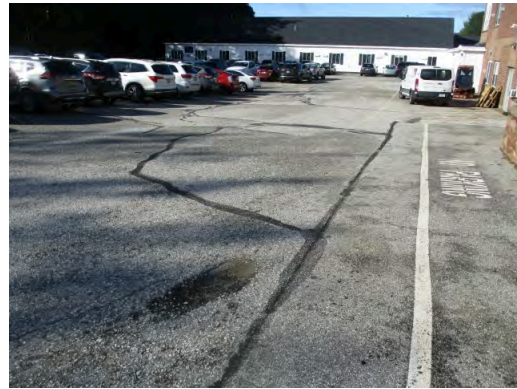
Pavement at south entrance from Elm Street Pavement along south parking area view west

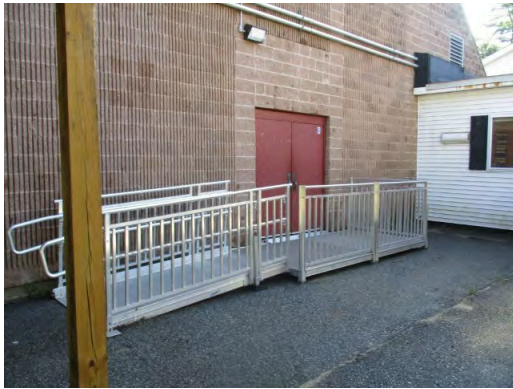
ADA ramp at gymnasium entrance

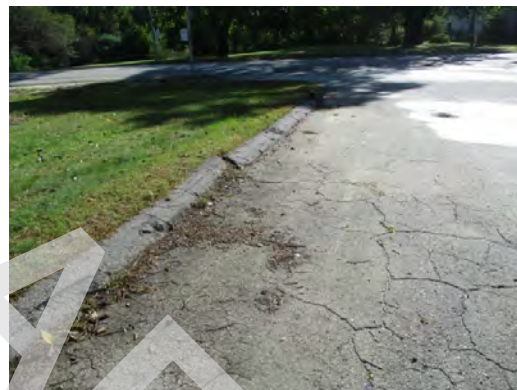
Damaged curbing east of building

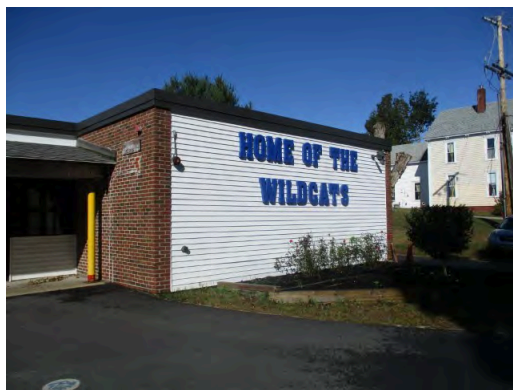
East elevation signage

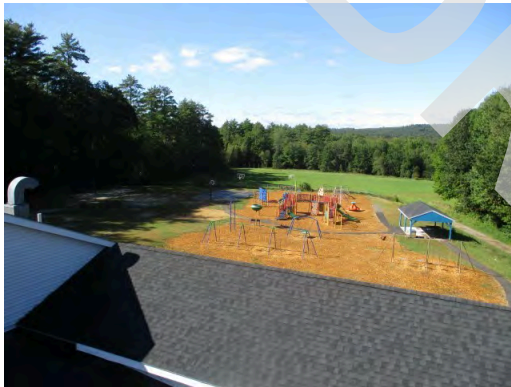
View of playground and athletic field west of building

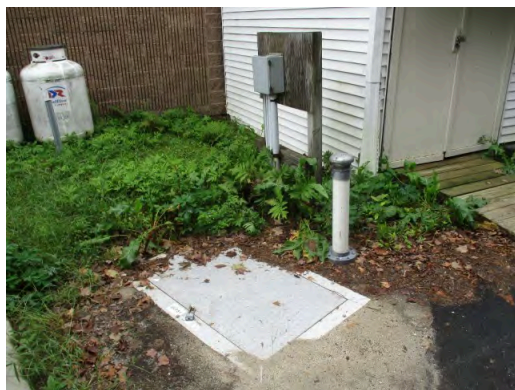
Sewer lift station behind gymnasium

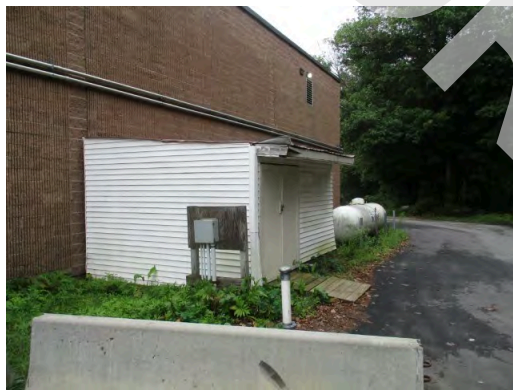
Storage shed behind kitchen

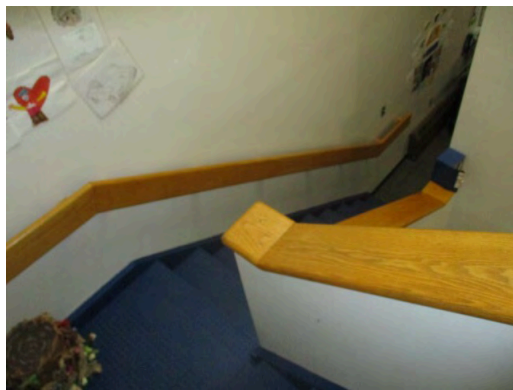
Stairway to office from library

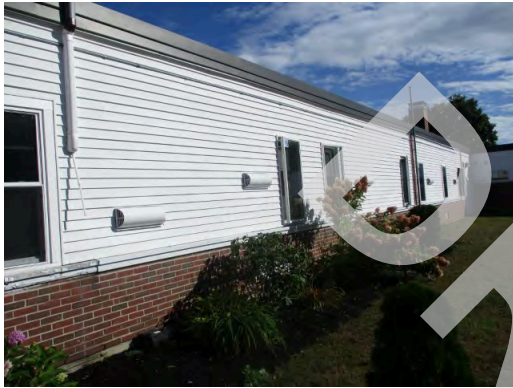
South elevation of 1962 & 1956 sections east of main entrance

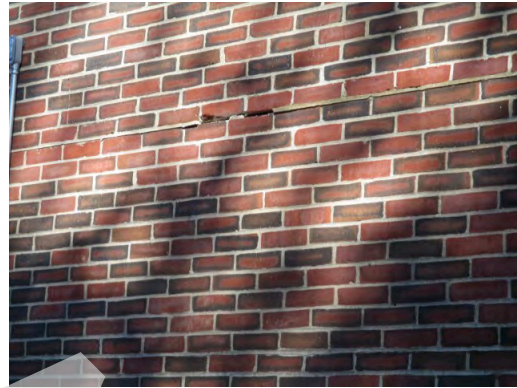
Cracking in brick facade in 1956 section

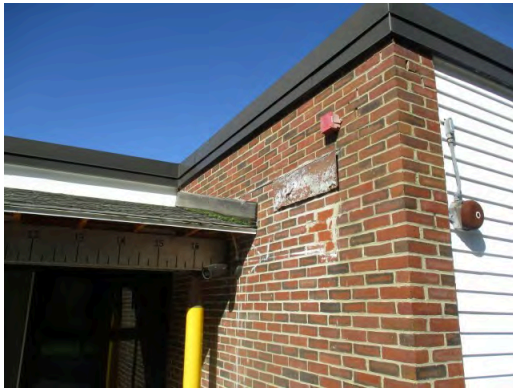
Cracking in facade on north side of east entrance

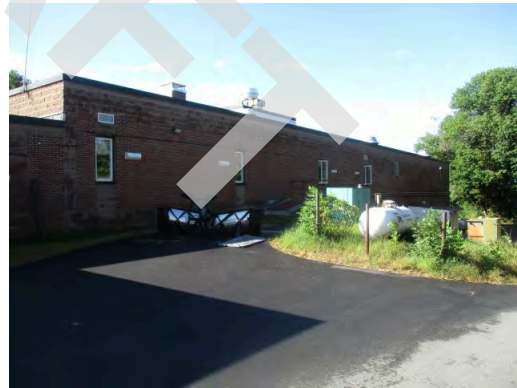
North elevation of 1982 section

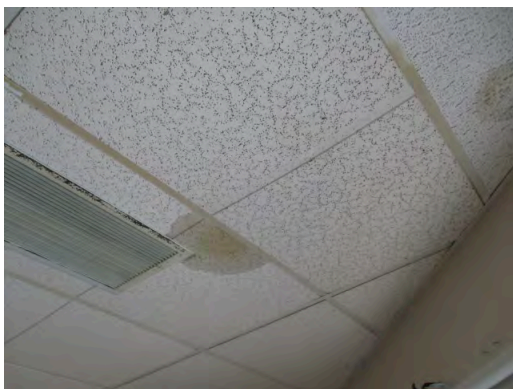
1982 addition classroom 26 ceiling staining

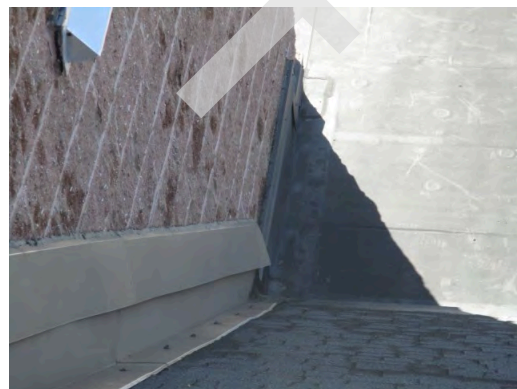
Roof junction over problem area at 1982 section and 2000 connector

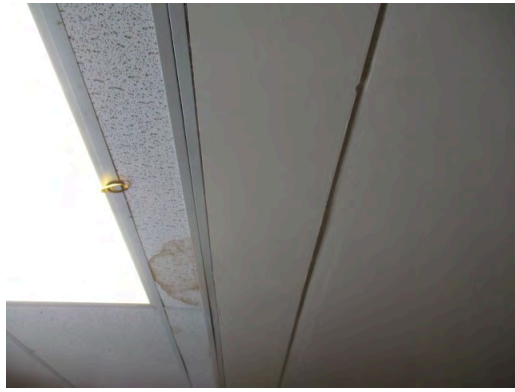
Staining at ceiling junction between 1982 section and 2002 addition

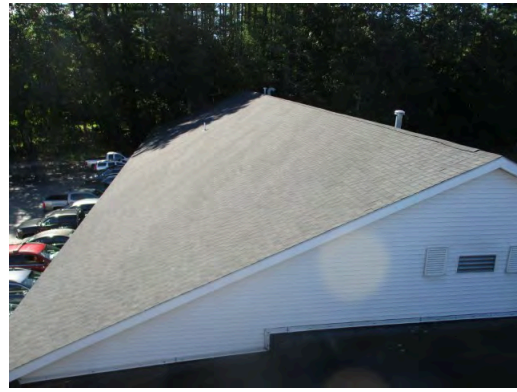
Roof over 2000 section view south

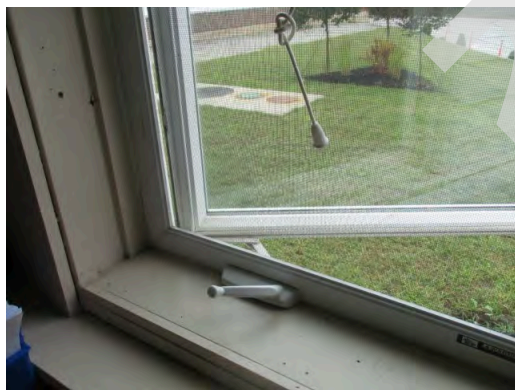
Typical window in classroom 19 in 1962 section

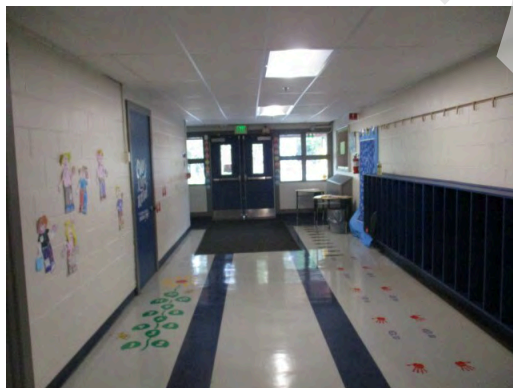
East end of corridor in 1956 section

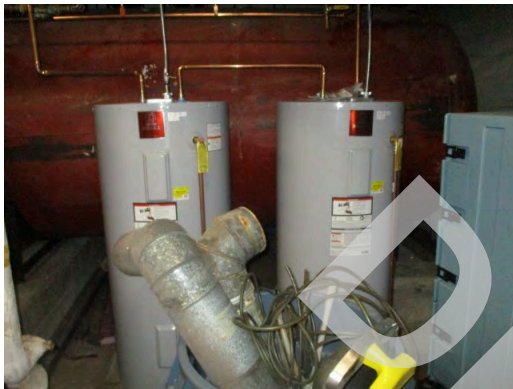
Domestic water heaters in 1982 boiler room

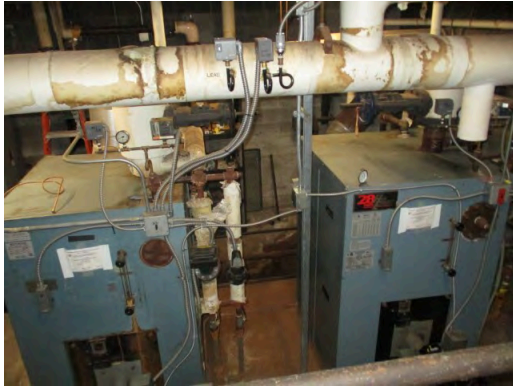
Boiler room in 1956 section

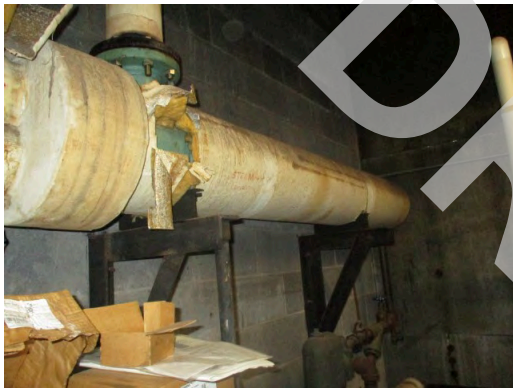
Damaged heat exchanger in 1956 boiler room

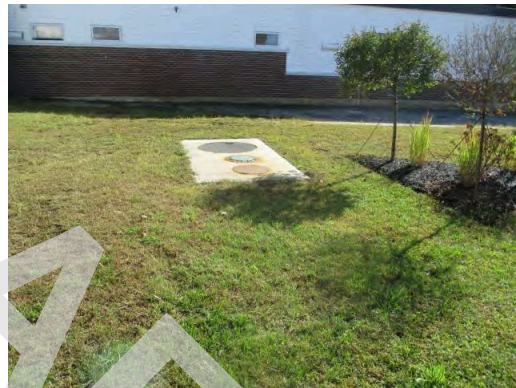
Heating oil UST south of 1956 section

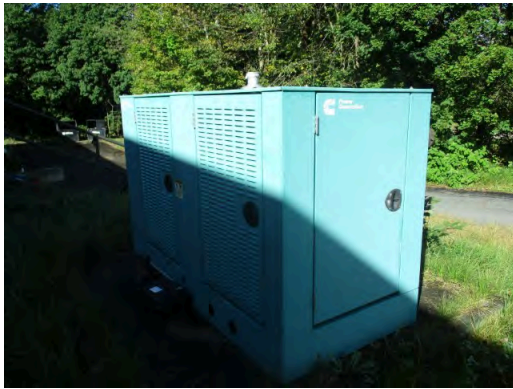
Emergency generator north of 1982 section

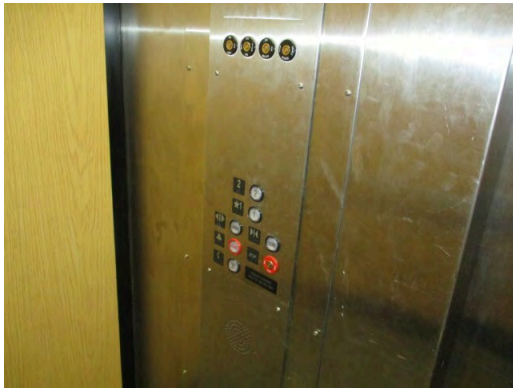
Elevator cab controls

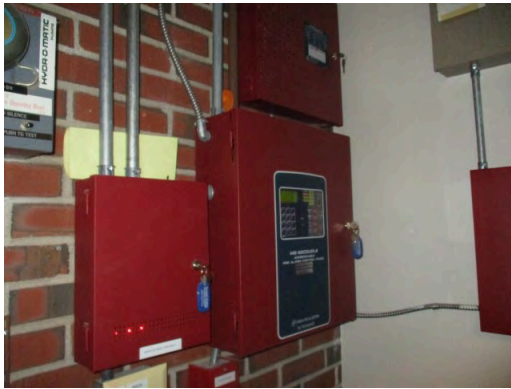
Fire alarm panel in main office

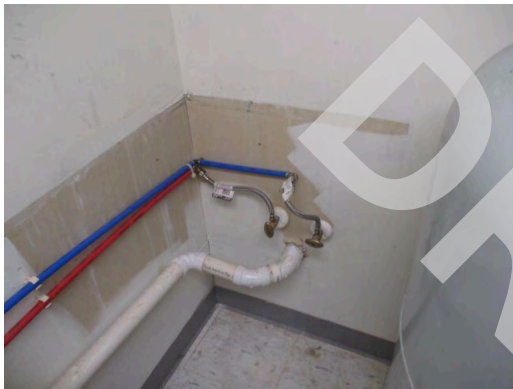
Damaged sheetrock in 2000 addition utility room

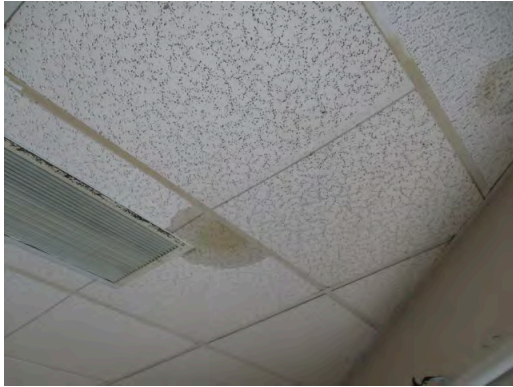
1982 addition classroom 26 ceiling staining

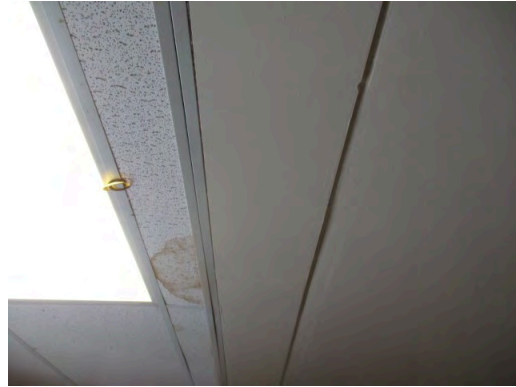
Staining at ceiling junction between 1982 section and 2002 addition

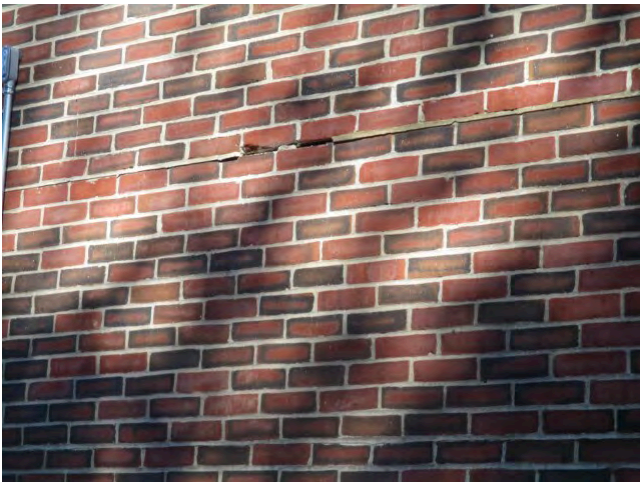
7. Cracking in brick facade in 1956 section

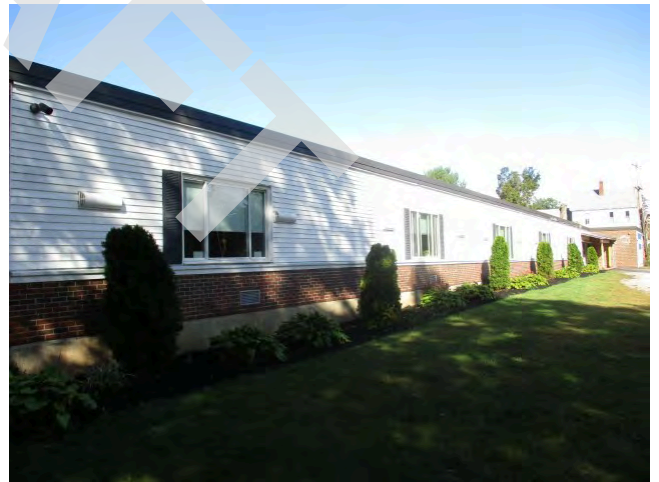
8. East elevation of 1956 section

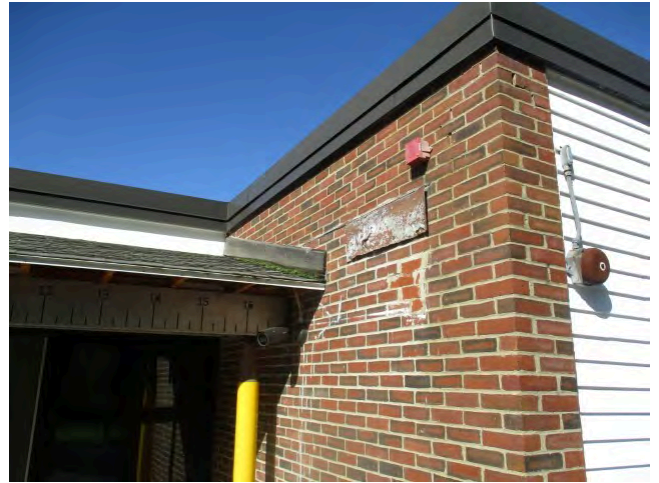
10. Cracking in facade on north side of east entrance

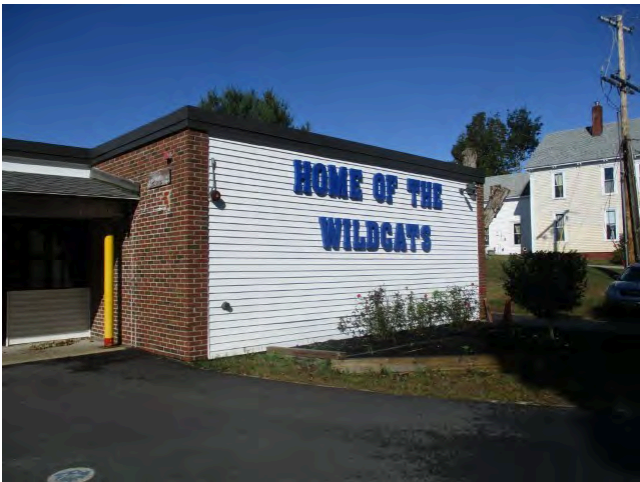
11. East elevation signage

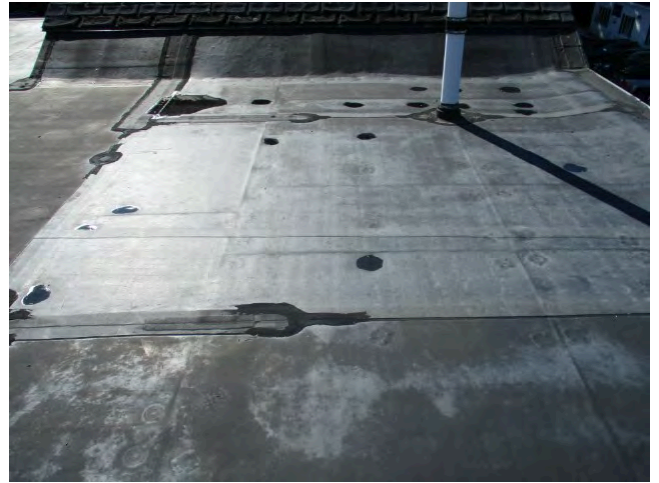
78. Replacement roof section over problem area at 1982 section and 2000 connector

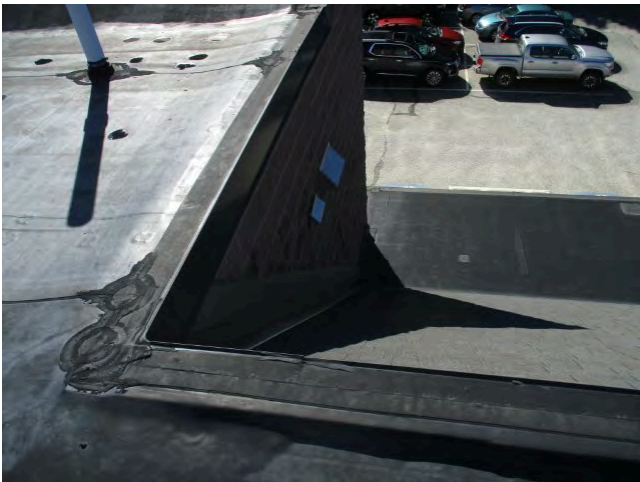
79. Roof section over problem area at 1982 section and 2000 connector

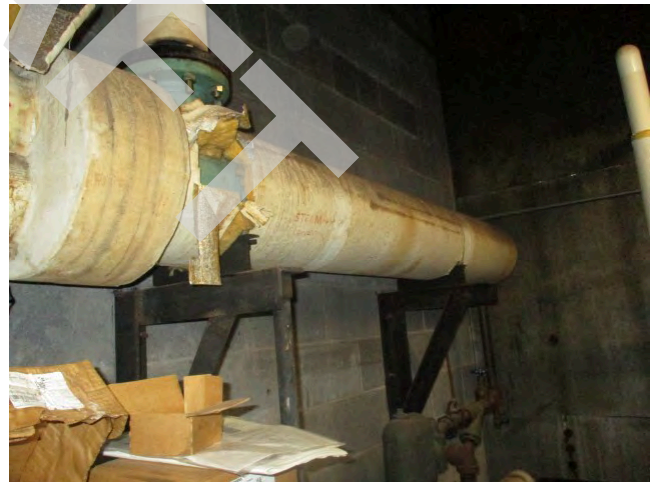
92. Damaged heat exchanger in 1956 boiler room

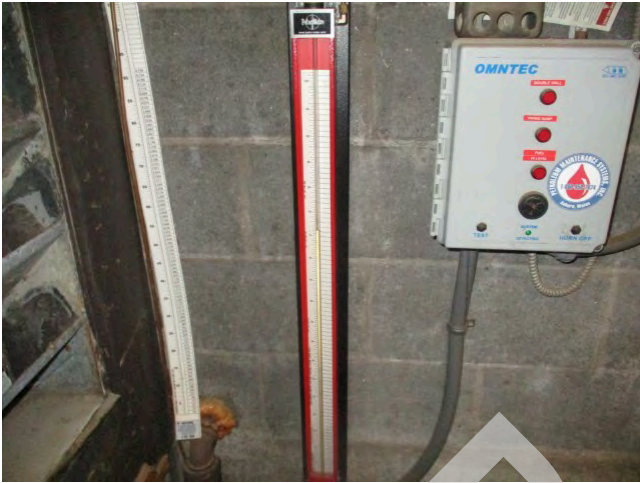
93. Heating oil UST level gauge in 1956 boiler room

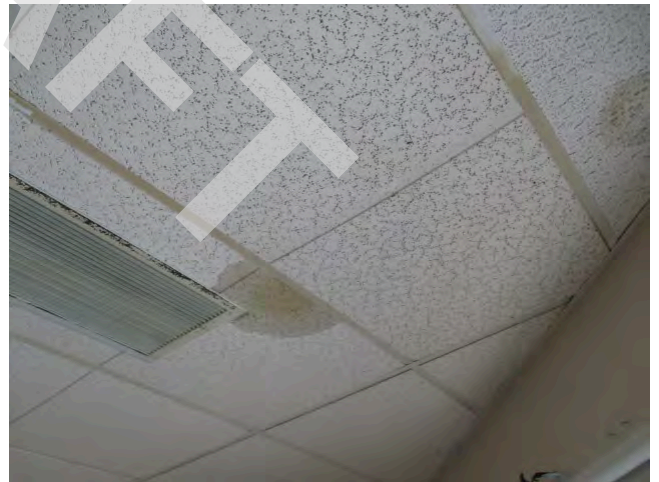
144. 1982 addition classroom 26 ceiling staining

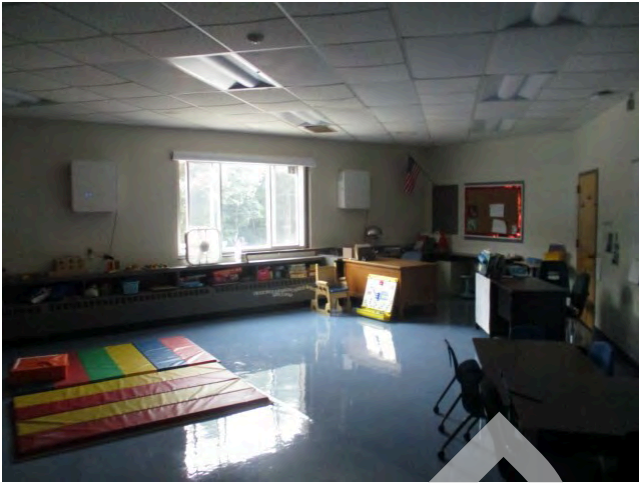
145. 1982 addition classroom 27

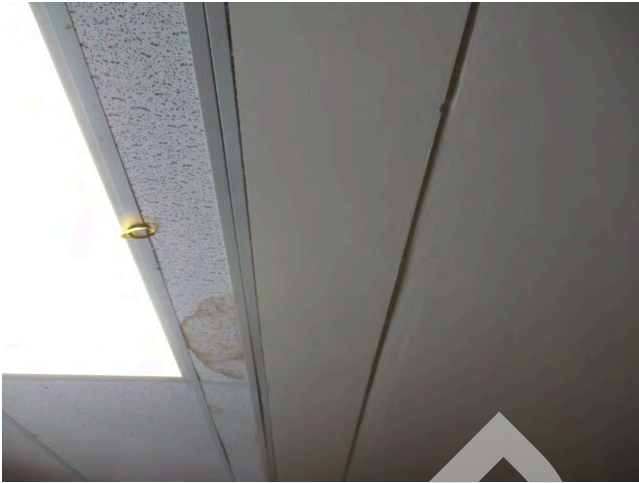
169. Staining at ceiling junction between 1982 section and 2002 addition

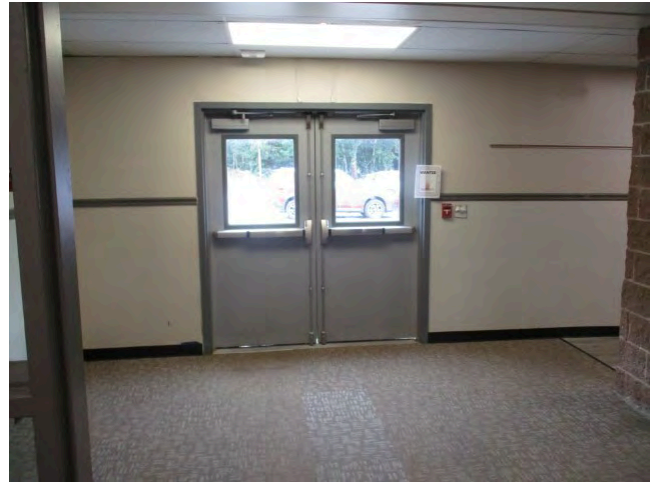
170. Doors on south side of connecting corridor to 2000 addition

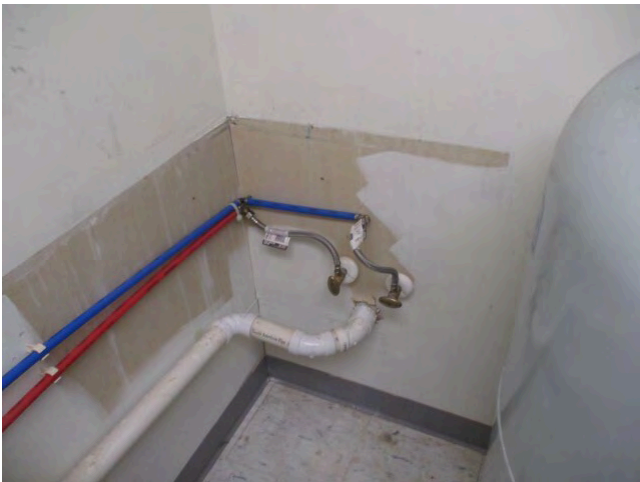
183. Damaged sheetrock in 2000 addition utility room
