Facility Condition Assessment

Poland Community School
1250 Maine Street
Poland, Androscoggin County, Maine 04274

AEI Project No. 482353
Site Assessment Date: September 13, 2023

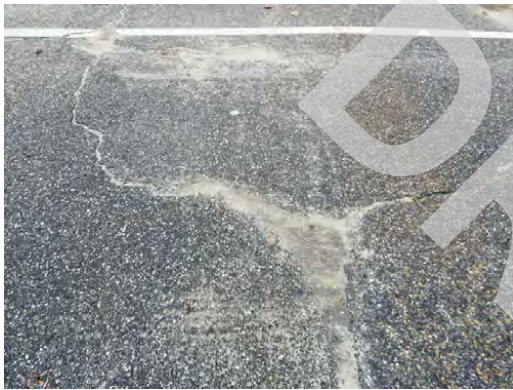
Site - Longitudinal cracking along south parking area

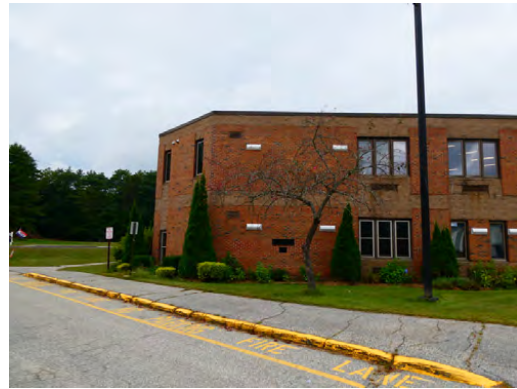
Site - Curb condition along south perimeter

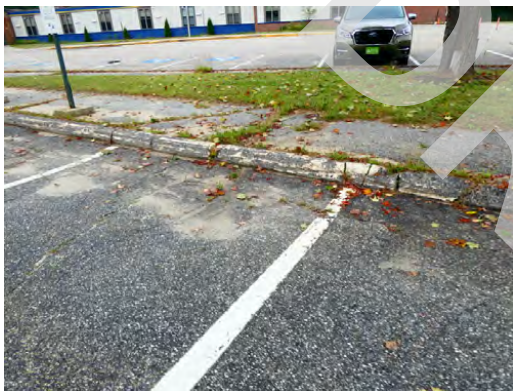
Site - Curb condition along south perimeter

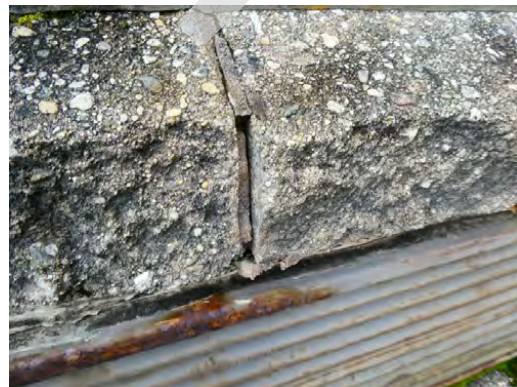
Exterior - Deteriorated mortar joints at CMU along roofline

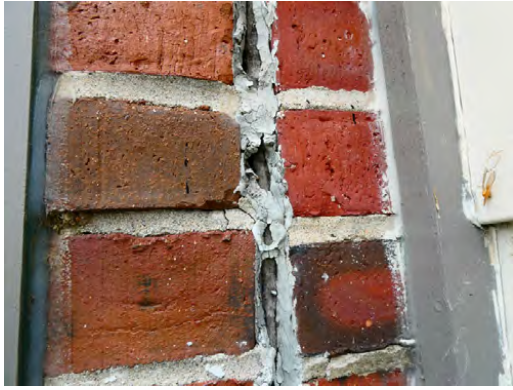
Exterior - Deteriorated vertical sealants along north elevation

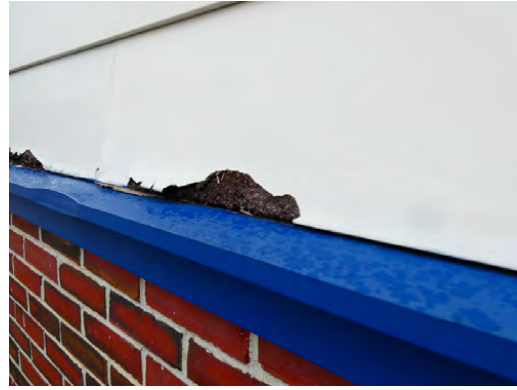
Exterior - Isolated deteriorated wood fiber siding (west elevation)

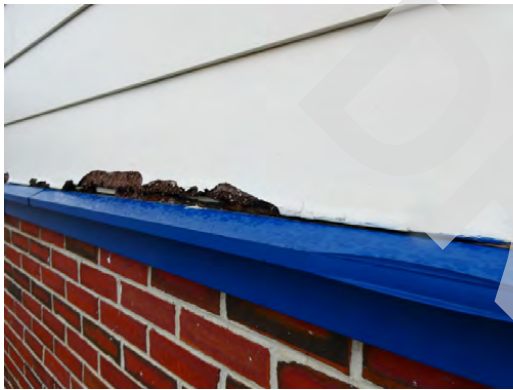
Exterior - Isolated deteriorated wood fiber siding (west elevation)

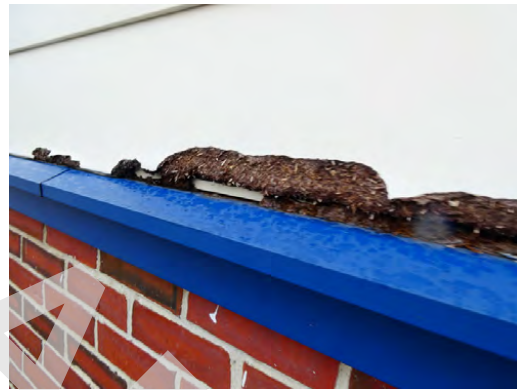
Exterior - Isolated deteriorated wood fiber siding (west elevation)

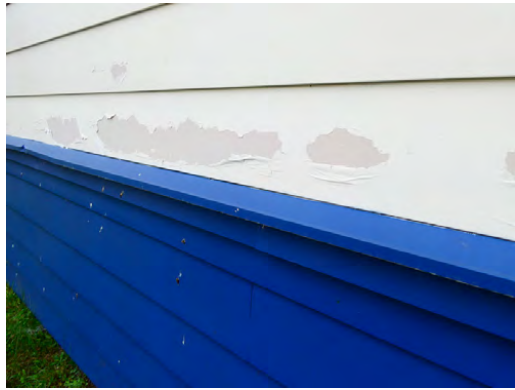
Exterior - Worn paint finish along north elevation

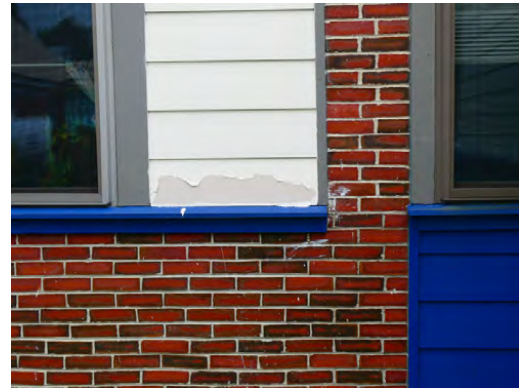
Exterior - Worn paint finish along north elevation

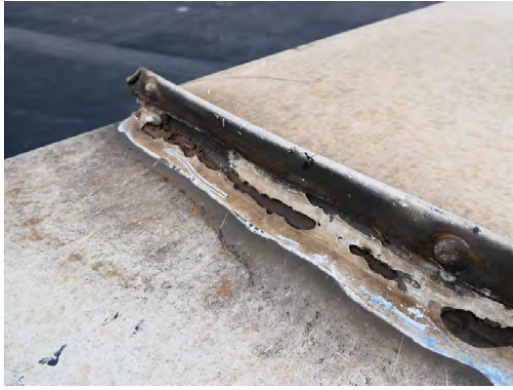
Roof - Deteriorated sealants at parapet wall flashing (central roof)

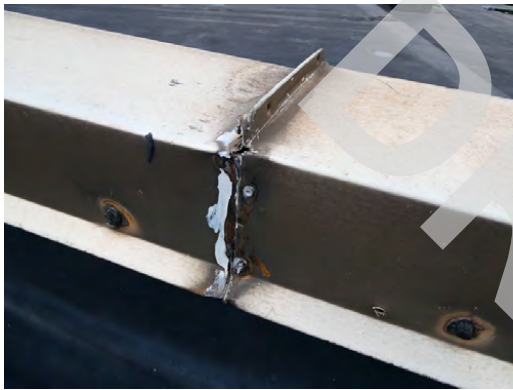
Roof - Deteriorated sealants at parapet wall flashing (central roof)

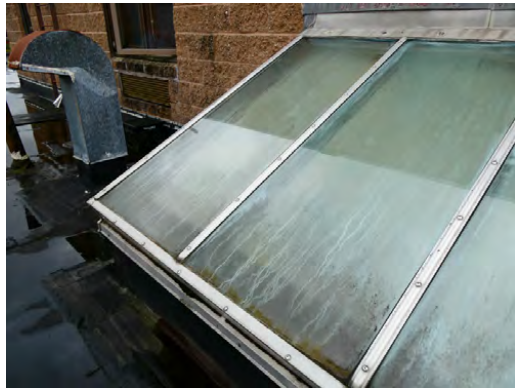
Roof - Skylight glazing with fogging condition

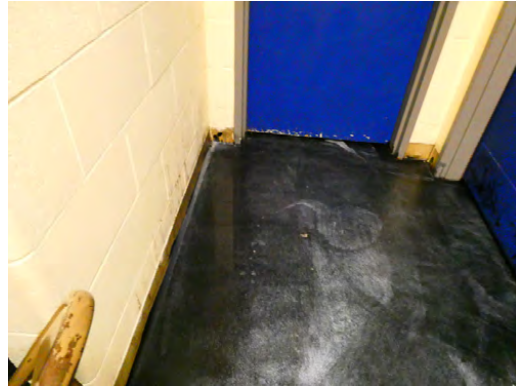
Interiors - Isolated leak at the kitchen bathroom area

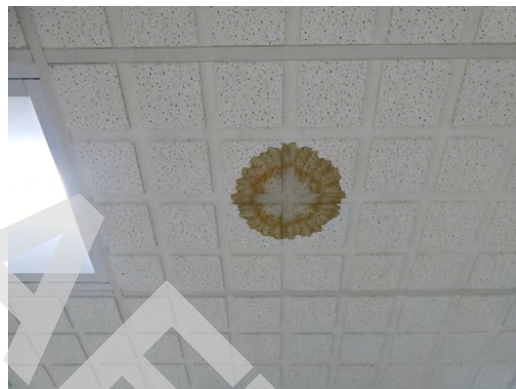
Interiors - Moisture stained ceiling tiles at south portion

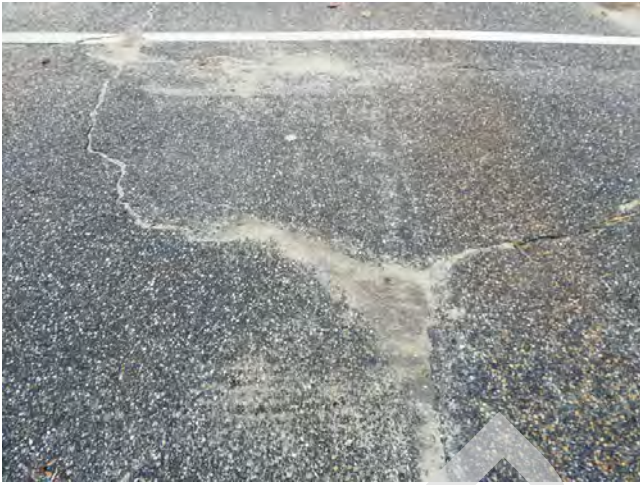
8. Site - Longitudinal cracking along south parking area

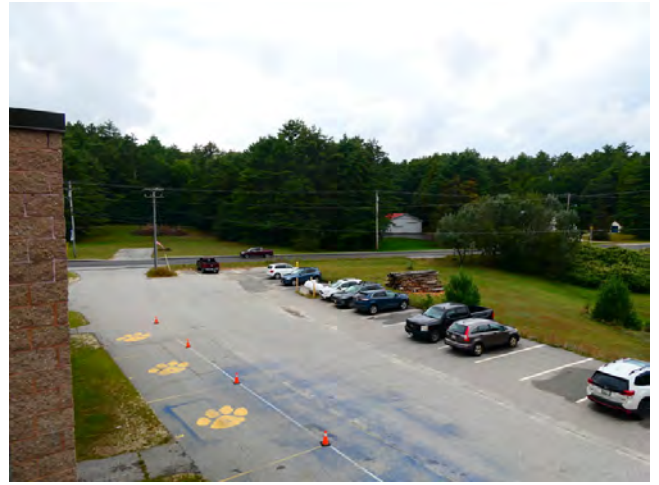
9. Site - Longitudinal cracking along south parking area

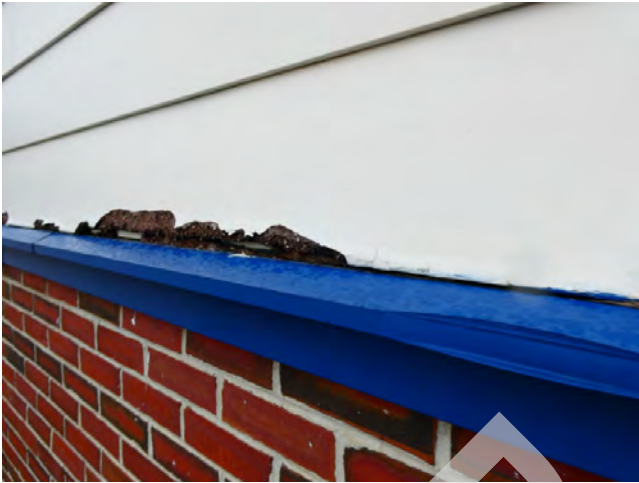
36. Exterior - Isolated deteriorated wood fiber siding (west elevation)

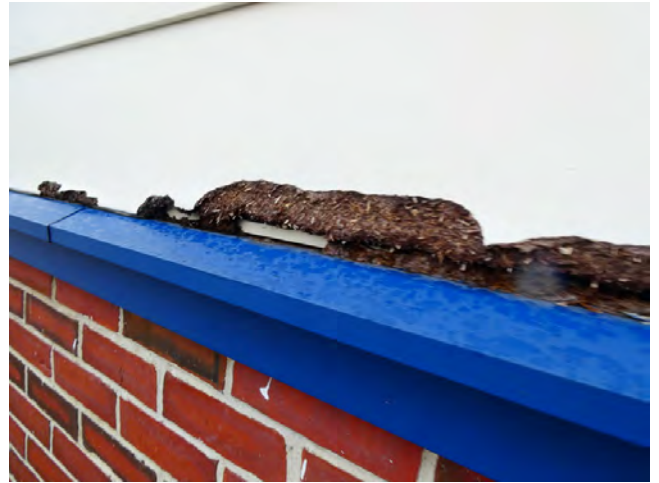
37. Exterior - Isolated deteriorated wood fiber siding (west elevation)

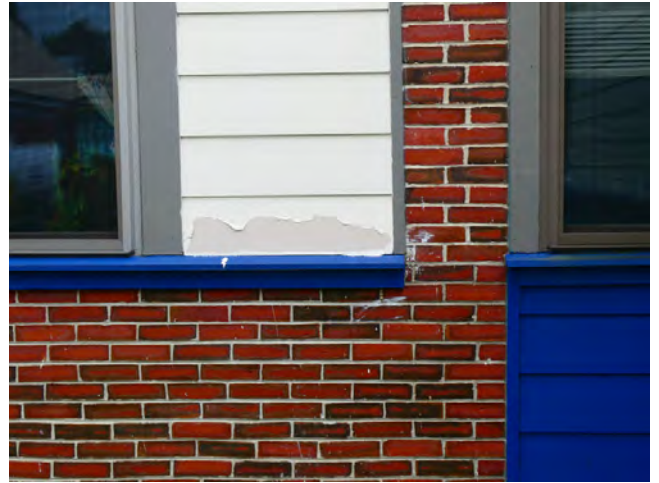
41. Exterior - Worn paint finish along north elevation

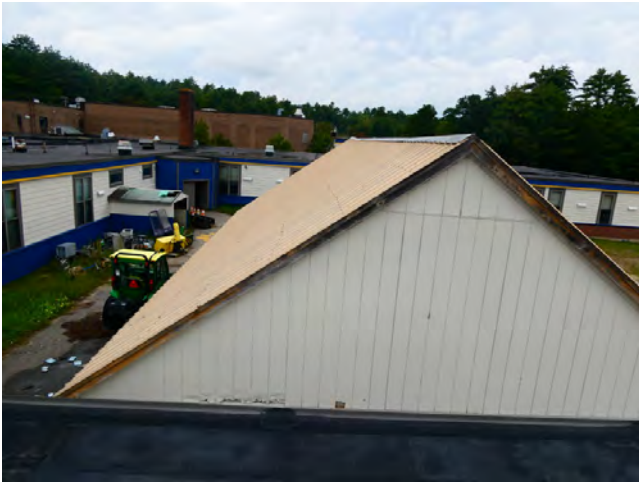
42. Exterior - Worn paint finish along north elevation

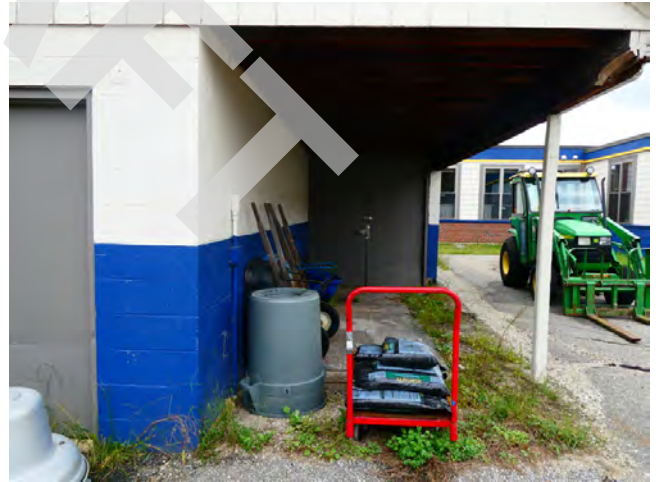
43. Exterior - Deteriorated siding and worn paint at maintenance structure

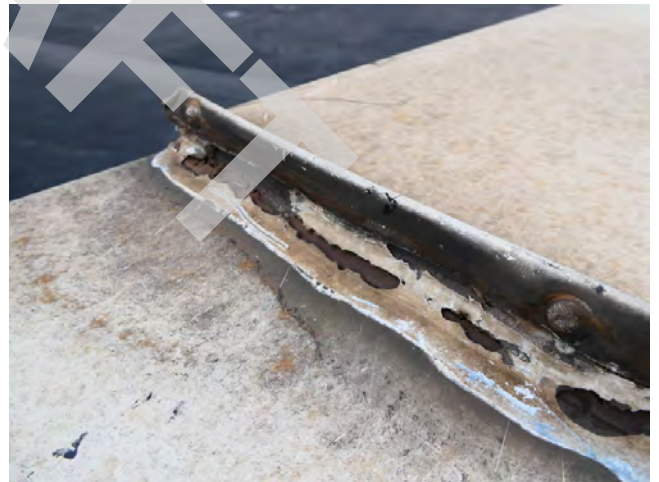
55. Roof - Isolated sections with organic growth present

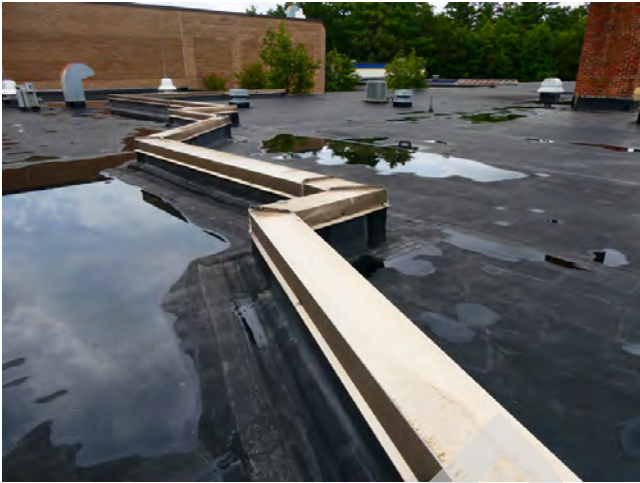
56. Roof - Deteriorated sealants at parapet wall flashing (central roof)

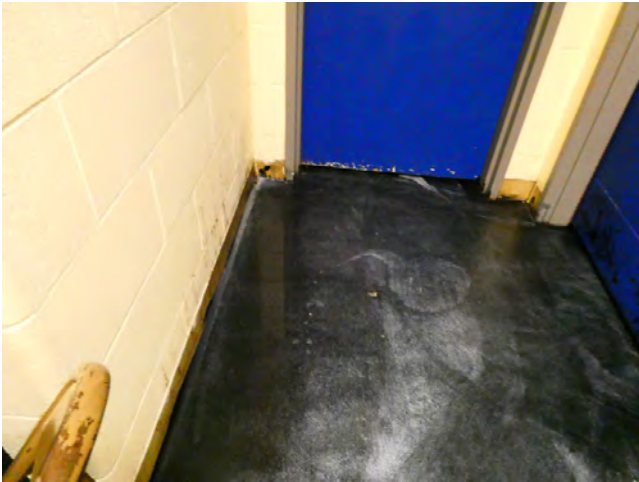
118. Interiors - Active roof leak at south portion

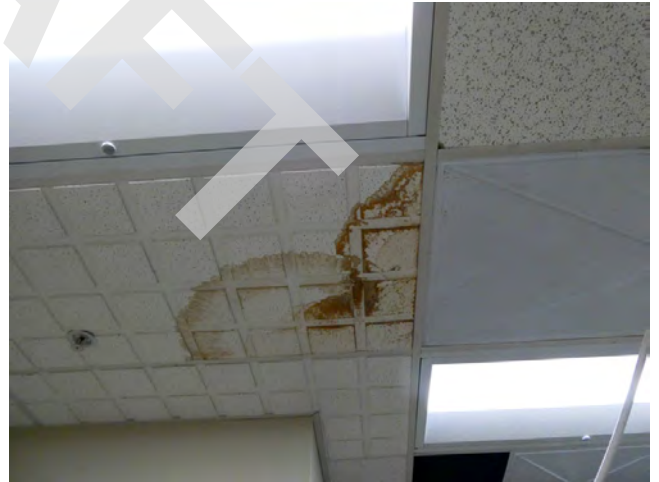
119. Interiors - Isolated leak at the kitchen bathroom area

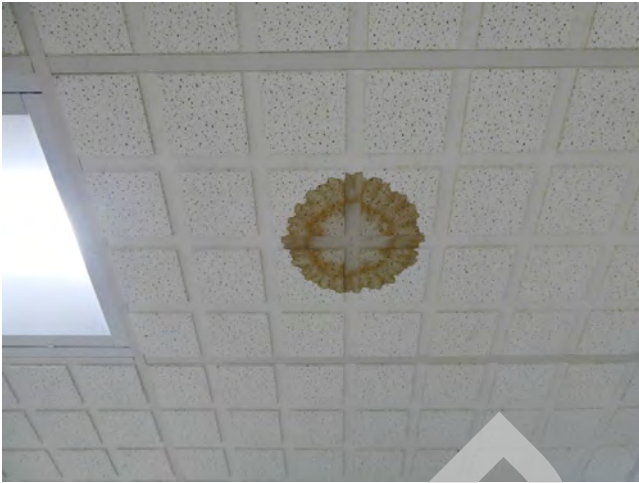
120. Interiors - Moisture stained ceiling tiles at south portion
