Facility Condition Assessment

Minot Consolidated School
23 Shaw Hill Road
Minot, Androscoggin County, Maine 04258

AEI Project No. 482354
Site Assessment Date: September 12, 2023

Subject: Facility Condition Assessment
Minot Consolidated School
23 Shaw Hill Road
Minot, Maine 04258
AEI Project No. 482354

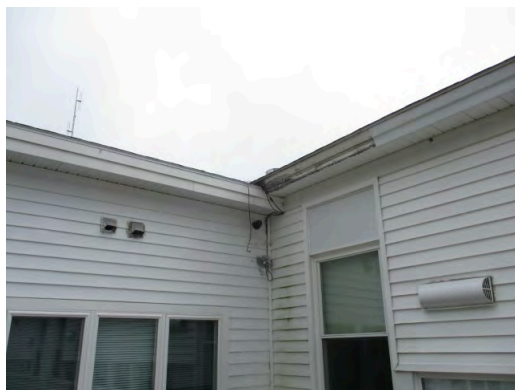
Damaged soffit at "problem" leak area near principal's office

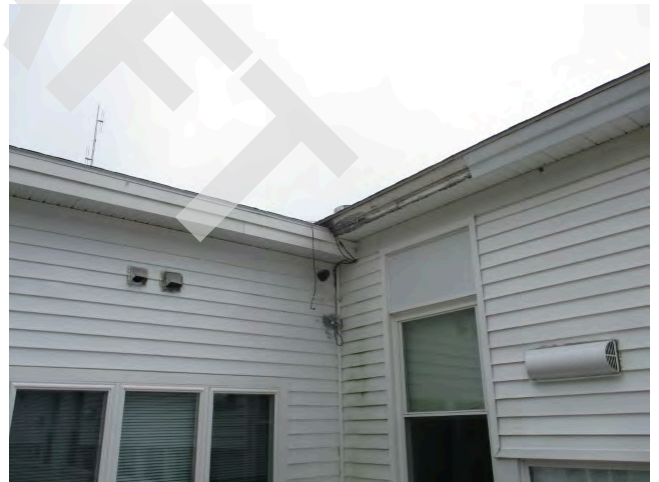
4. Damaged soffit at "problem" leak area near principal's office

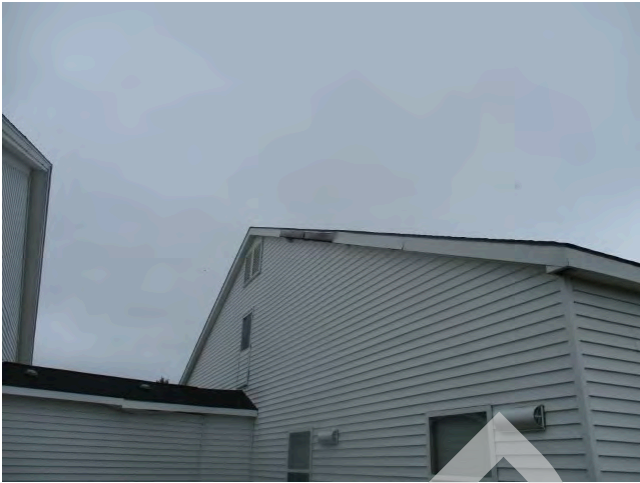
9. Damaged fascia on north end of 1996 addition

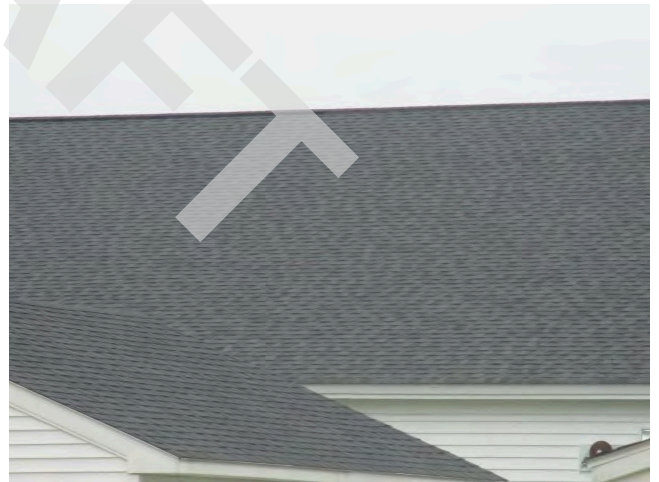
41. Roofing and heat tape at "problem" area near principal's office

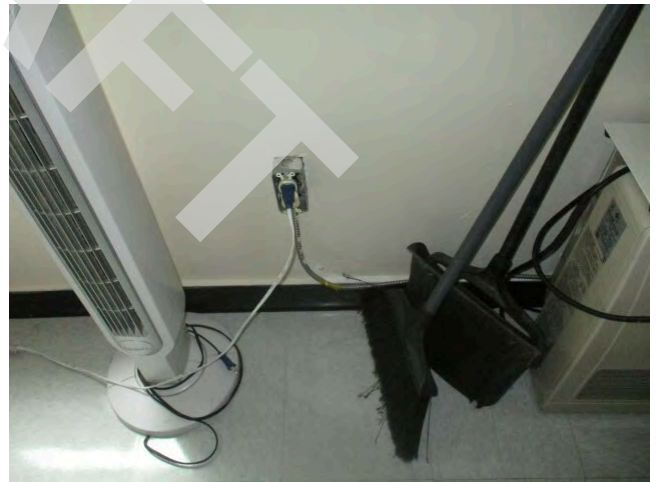
64. Classroom 226 exposed outlet

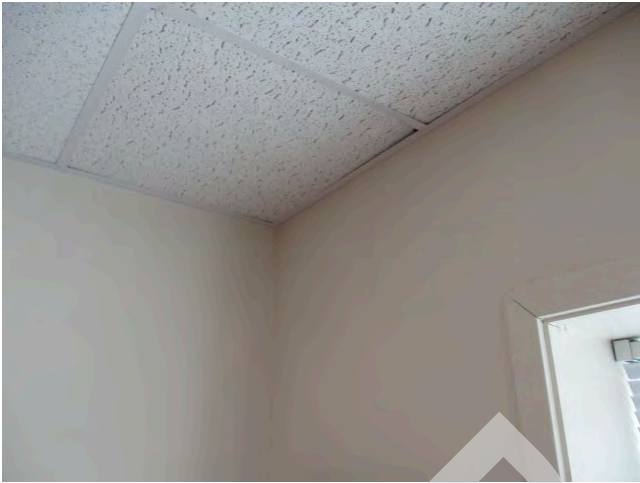
109. Site of reported ongoing leak in principal's office
