Facility Condition Assessment

Poland Regional High School/Whittier Middle School
1457 Maine Street
Poland, Androscoggin County, Maine 04274

AEI Project No. 482355
Site Assessment Date: September 13, 2023

Subject: Facility Condition Assessment
Poland Regional High School/Whittier Middle School
1457 Maine Street
Poland, Maine 04274
AEI Project No. 482355

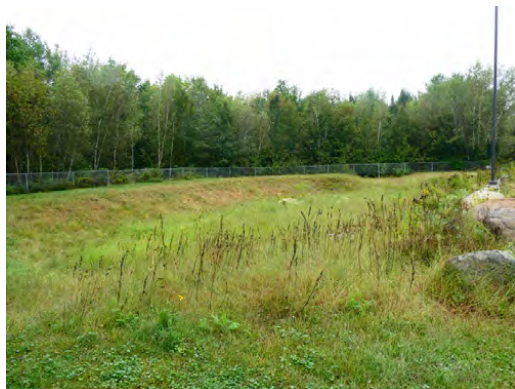
Site - Detention basin at south perimeter

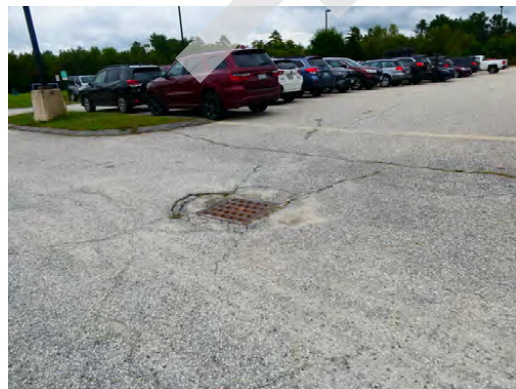
Site - Main parking surface condition

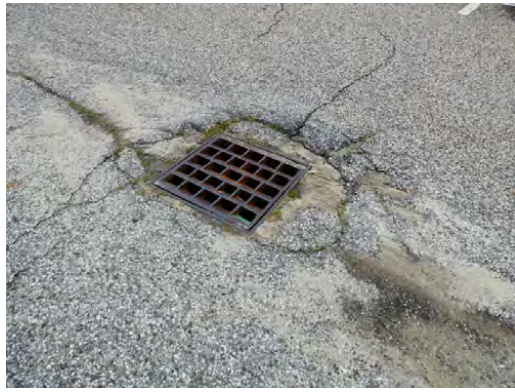
Site - Asphalt pavement condition at north parking area

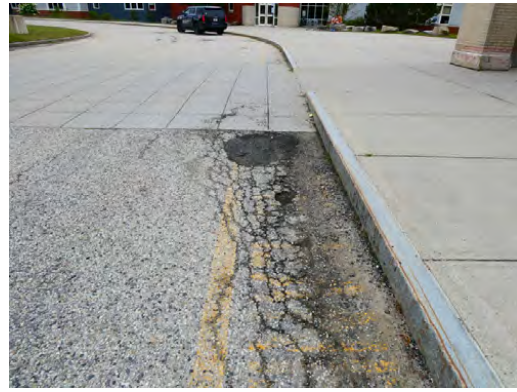
Site - Area of asphalt deterioration at main drive

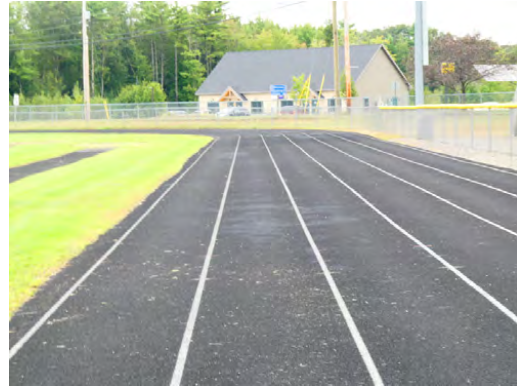
Site - Track surface condition

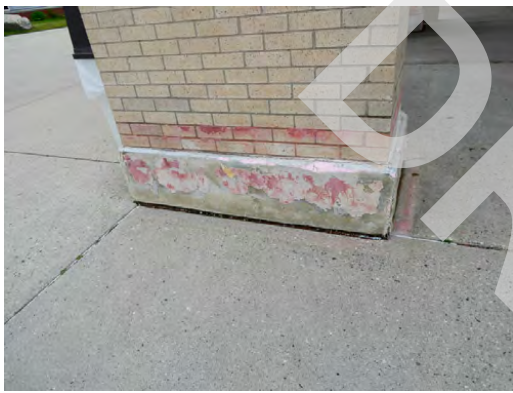
Exterior - Deteriorated EIFS at base of columns (main entrance)

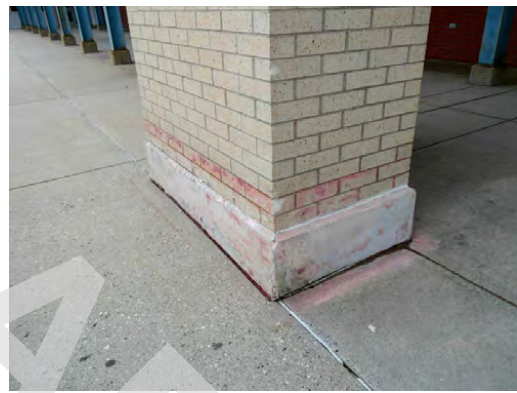
Exterior - Deteriorated EIFS at base of columns (main entrance)

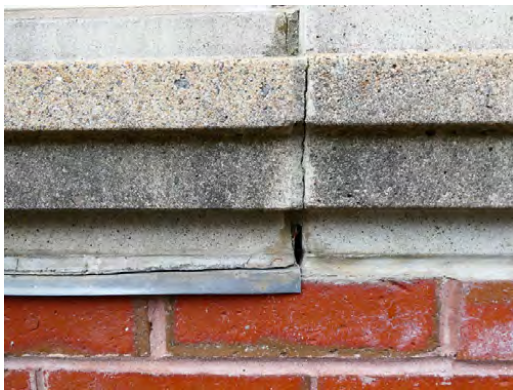
Exterior - Deteriorated mortar joints at courtyard exterior

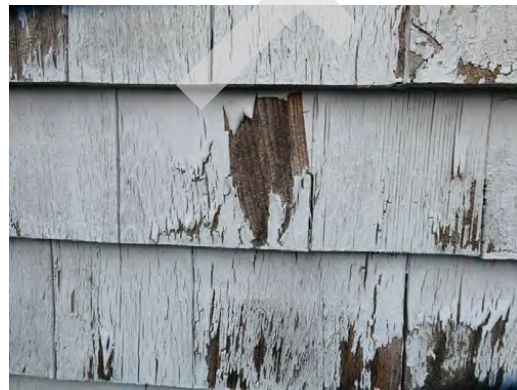
Exterior - Deteriorated stain finish at wood siding

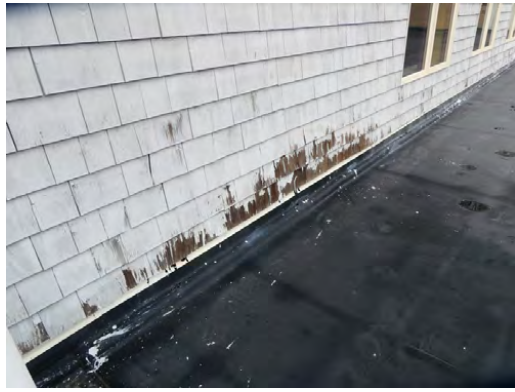
Exterior - Deteriorated stain finish at wood siding

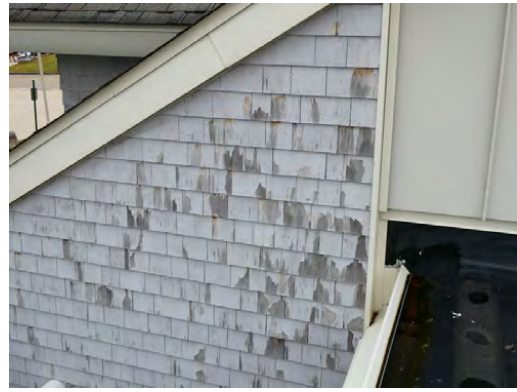
Exterior - Deteriorated stain finish at wood siding

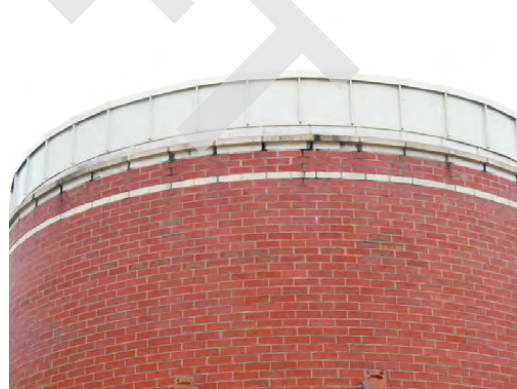
Exterior - Moisture staining along concrete details at middle school entry

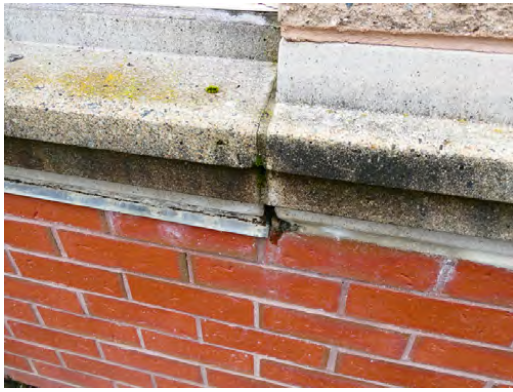
Exterior - Moisture staining along concrete window sill (courtyard)

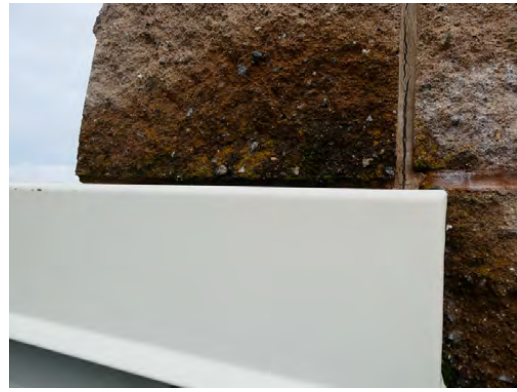
Exterior - Moisture staining and deteriorated sealants at east elevation (roofline)

The exterior sealants along all facades were observed to be in good to fair condition with areas of wear observed along the roofline. AEI recommends resealing the façades in the short-term. An opinion of cost for this work is included in the Tables.

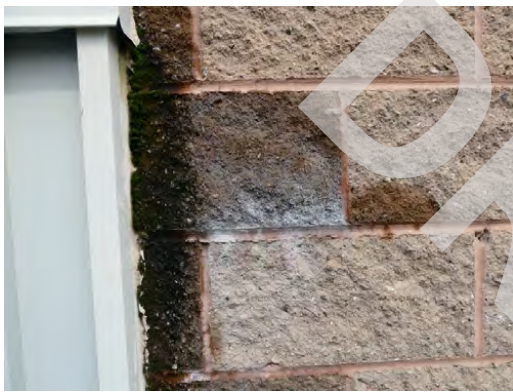
Exterior - Moisture staining at east elevation (roofline)

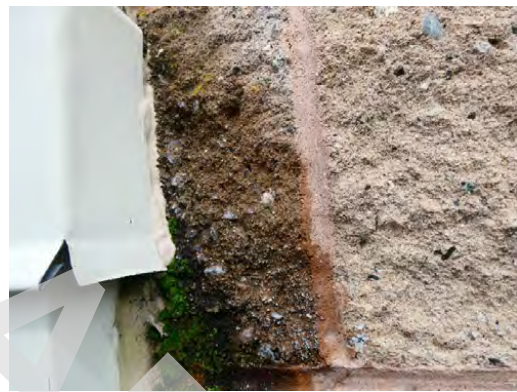
Exterior - Moisture staining at east elevation (roofline)

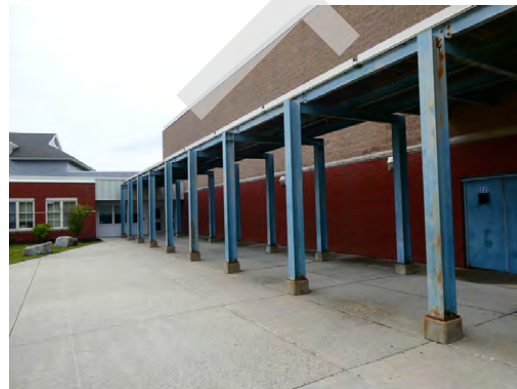
Exterior - Surface corrosion along steel framing for covered entryway

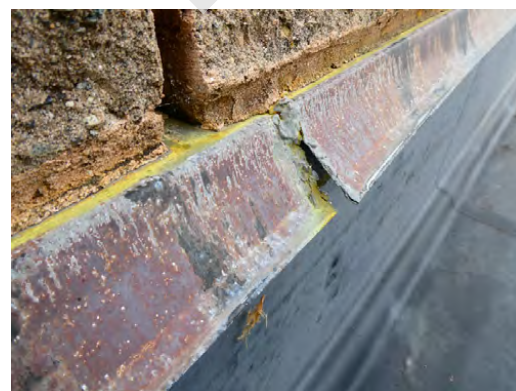
Roof - Deteriorated sealants at parapet flashing (south portion)

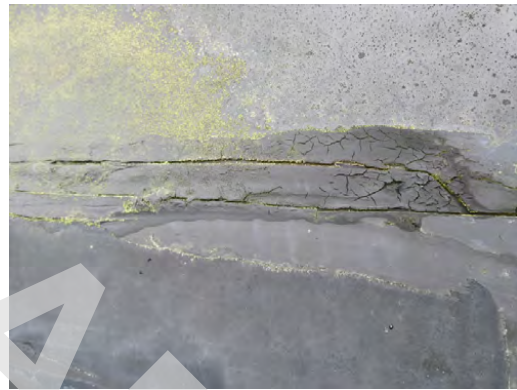
Roof - Isolated areas of deteriorated seals at membrane

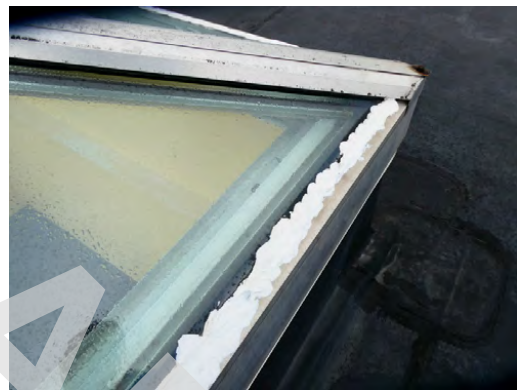
Roof - Skylights at central roof area with sealant replacement

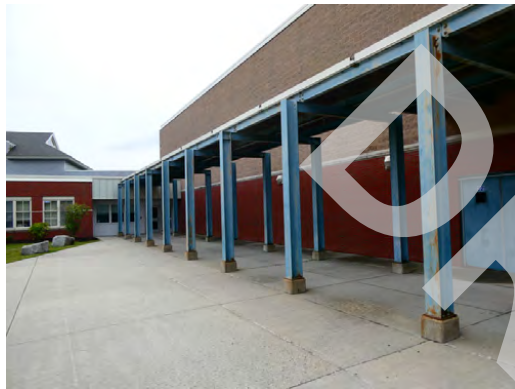
Exterior - Surface corrosion along steel framing for covered entryway

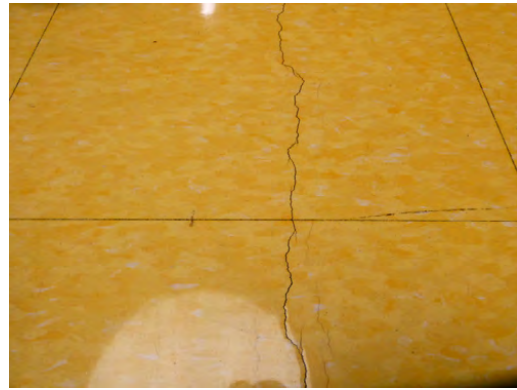
Interiors - Isolated areas of stress cracking at common area vinyl flooring

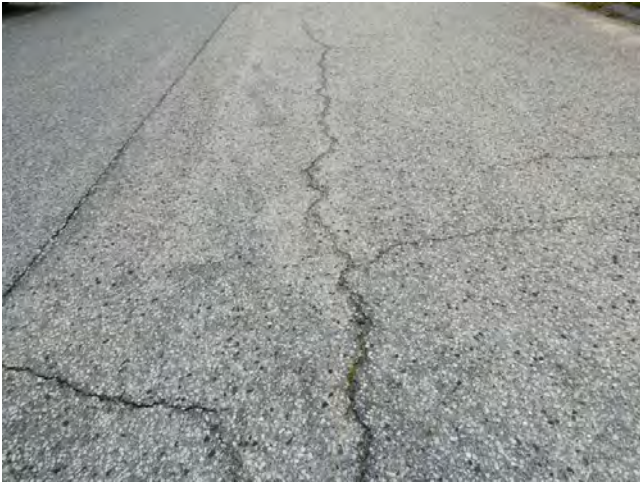
7. Site - Longitudinal cracking along asphalt pavement

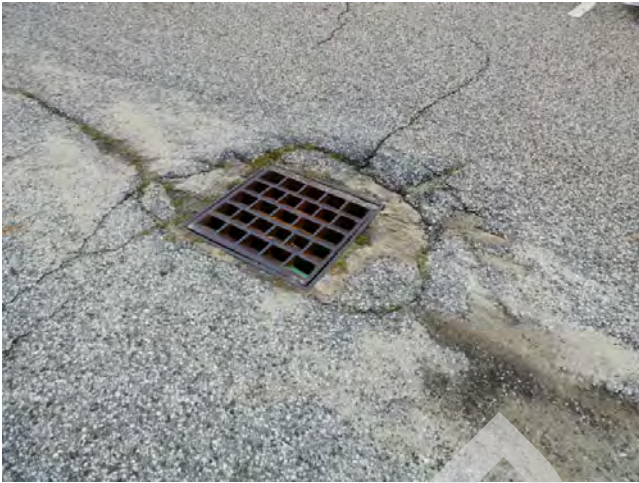
9. Site - Asphalt pavement condition at north parking area

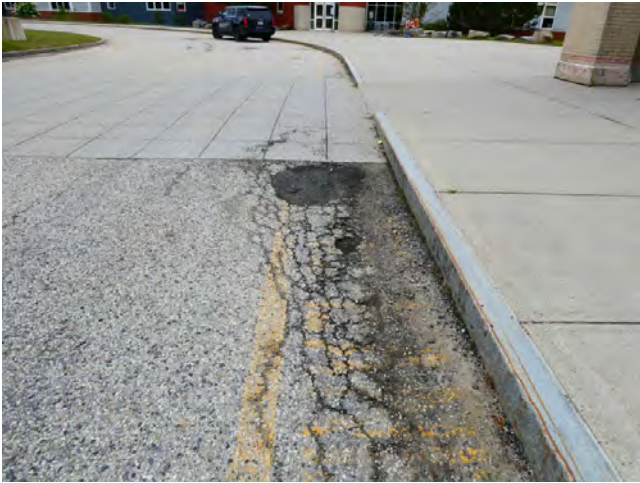
10. Site - Area of asphalt deterioration at main drive

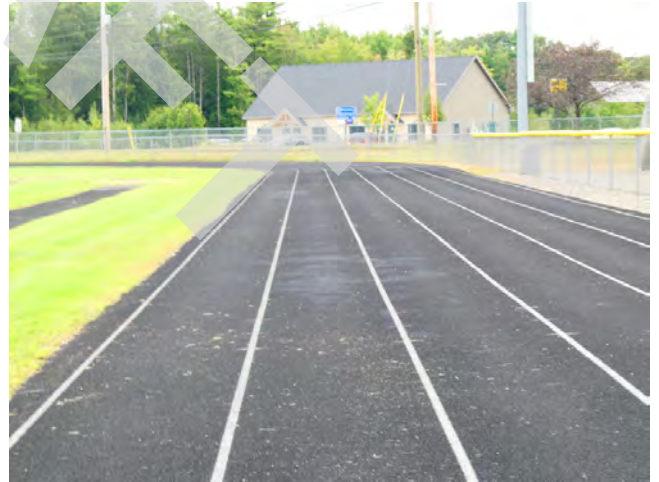
20. Site - Track surface condition

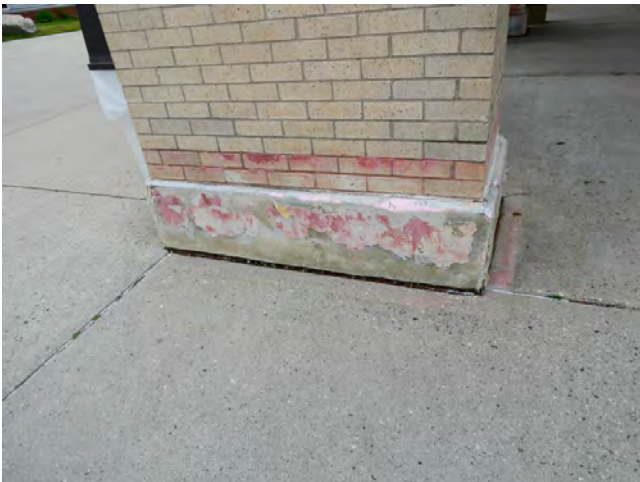
35. Exterior - Deteriorated EIFS at base of columns (main entrance)

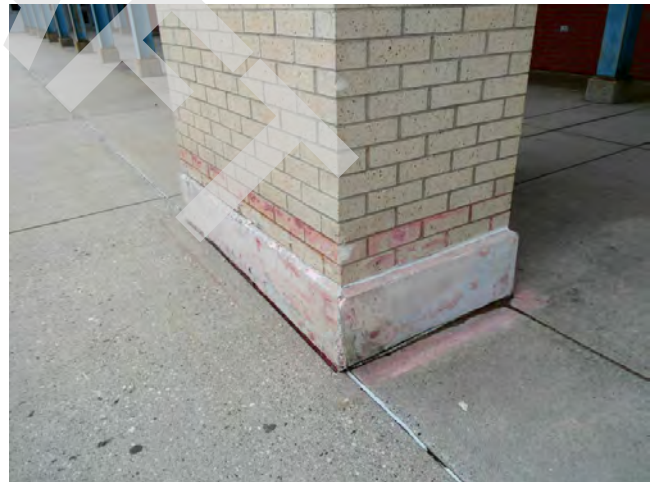
36. Exterior - Deteriorated EIFS at base of columns (main entrance)

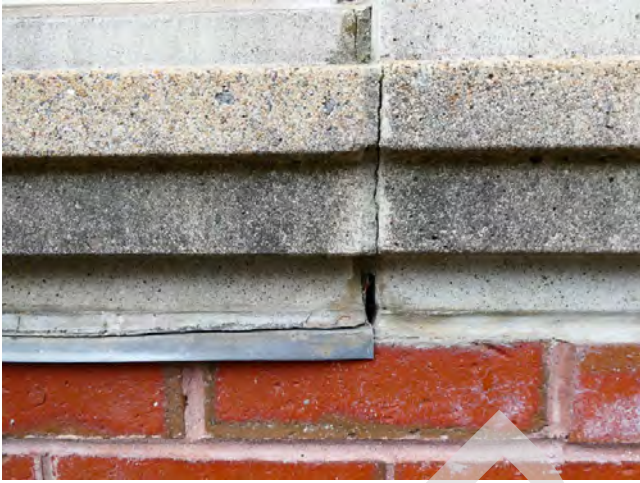
37. Exterior - Deteriorated mortar joints at courtyard exterior

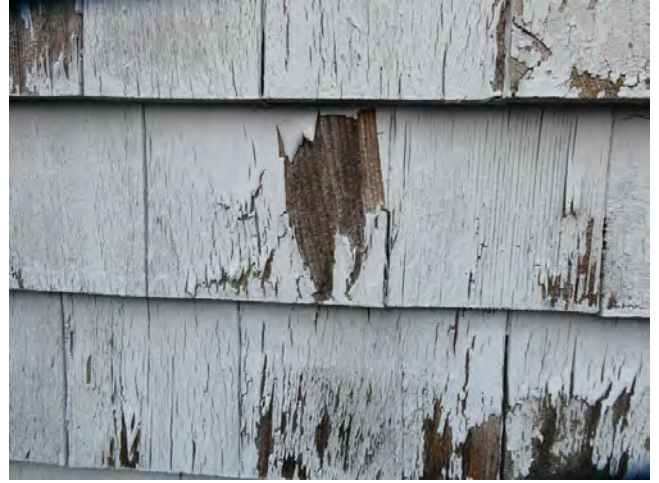
38. Exterior - Deteriorated stain finish at wood siding

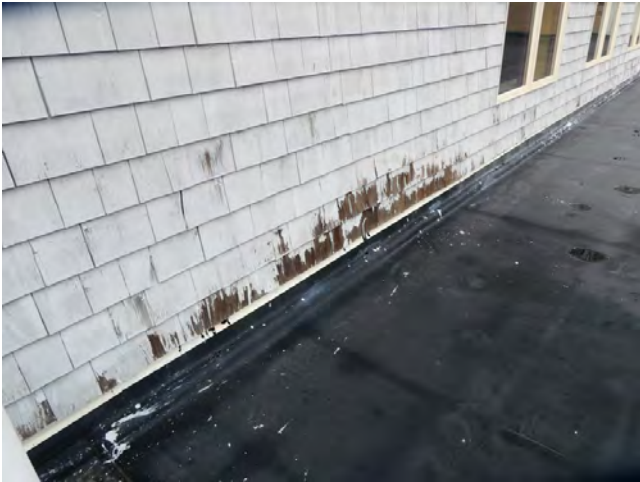
39. Exterior - Deteriorated stain finish at wood siding

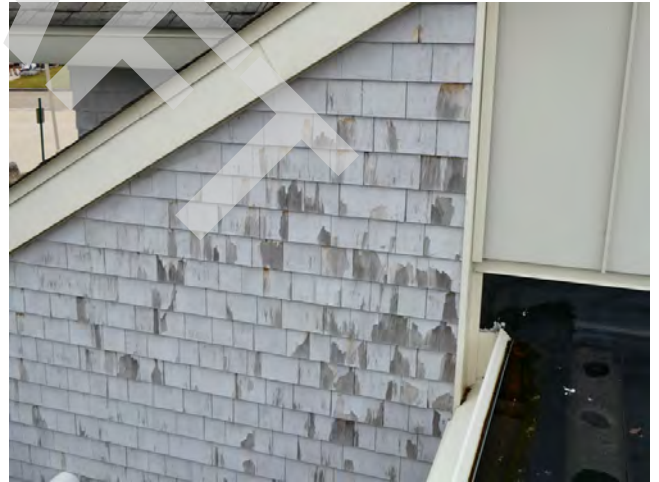
40. Exterior - Deteriorated stain finish at wood siding

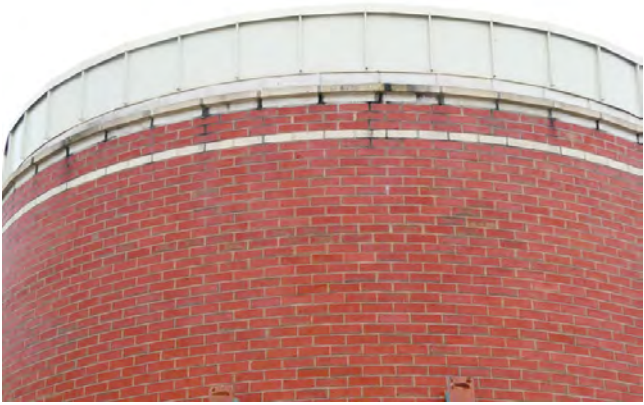
46. Exterior - Moisture staining along concrete details at middle school entry

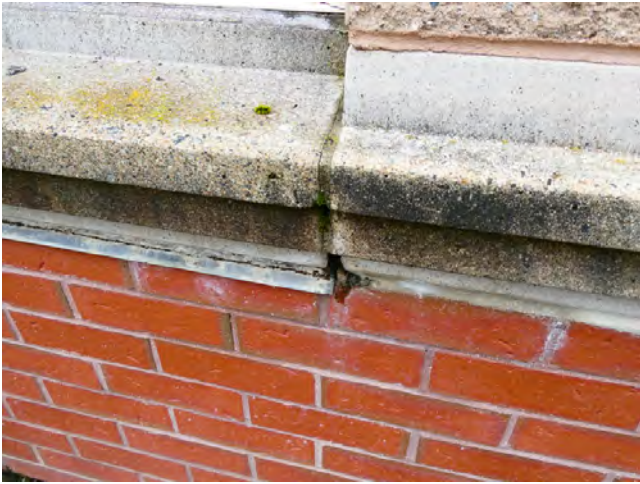
47. Exterior - Moisture staining along concrete window sill (courtyard)

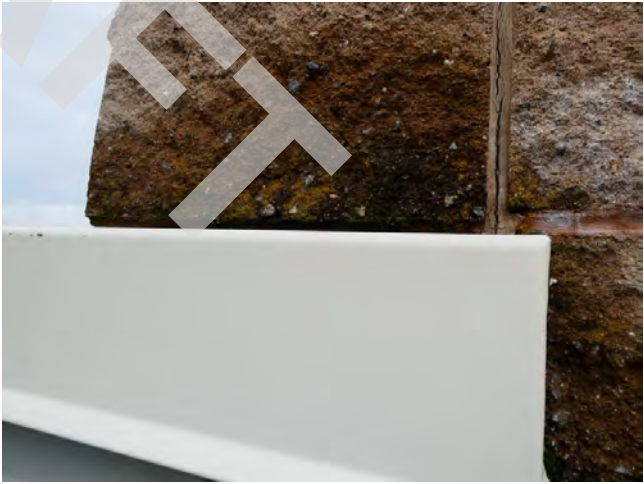
48. Exterior - Moisture staining and deteriorated sealants at east elevation (roofline)

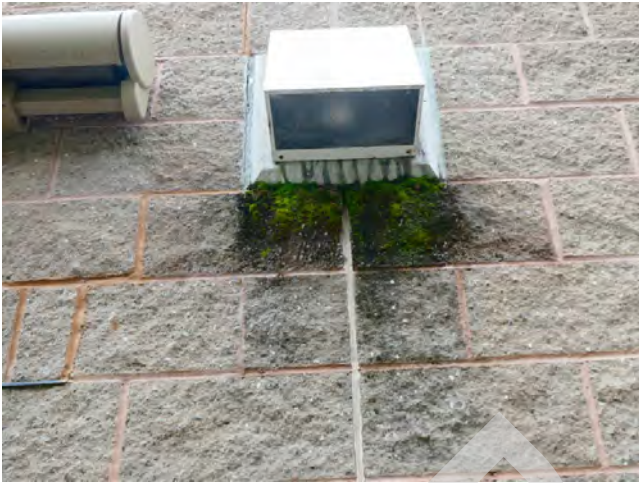
49. Exterior - Moisture staining and organic growth along CMU (courtyard)

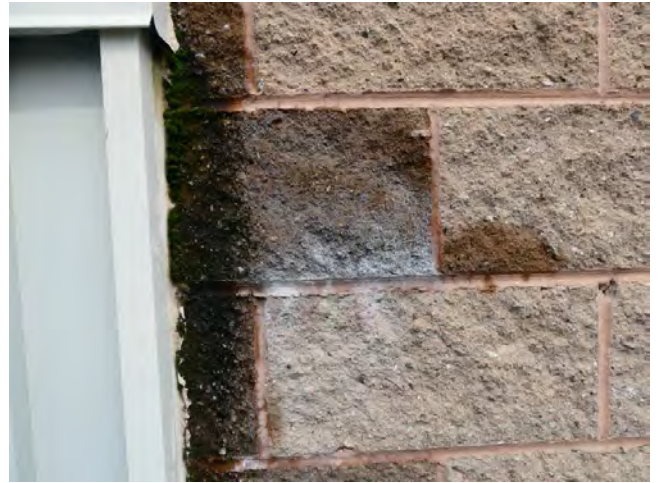
50. Exterior - Moisture staining at east elevation (roofline)

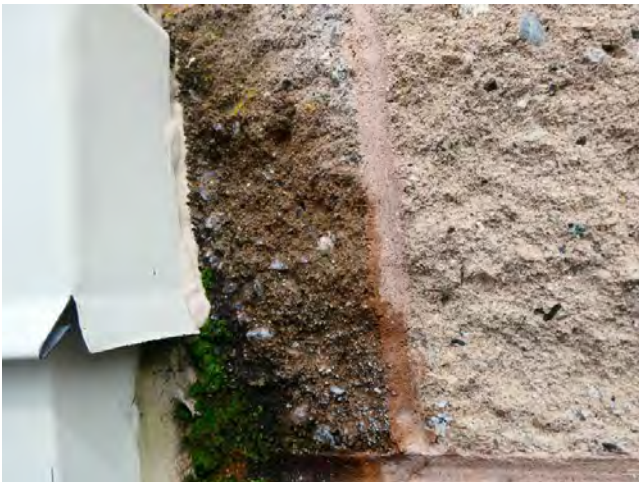
51. Exterior - Moisture staining at east elevation (roofline)

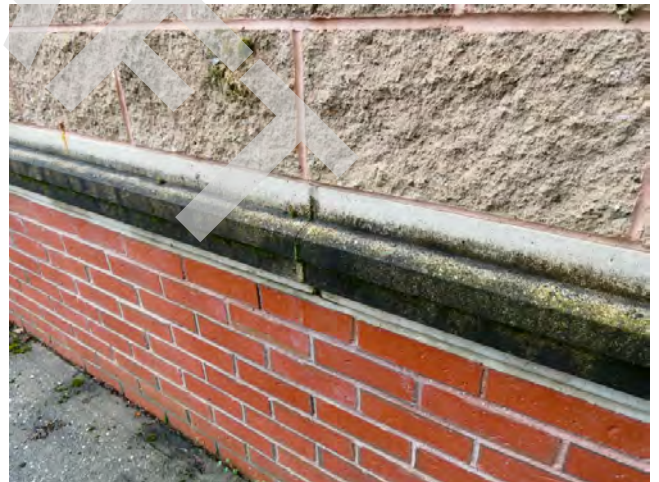
52. Exterior - Moisture staining along concrete band (courtyard)

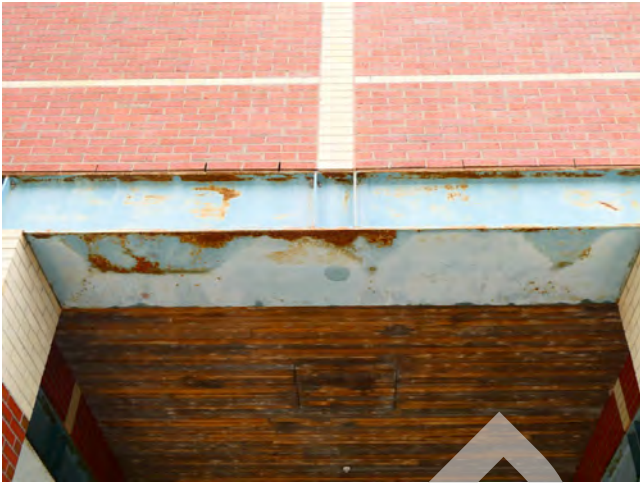
53. Exterior - Surface corrosion along steel framing for covered entryway

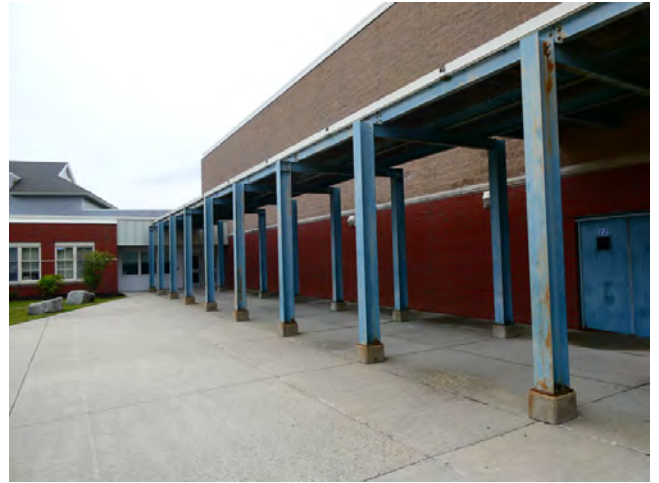
54. Exterior - Surface corrosion along steel framing for covered entryway

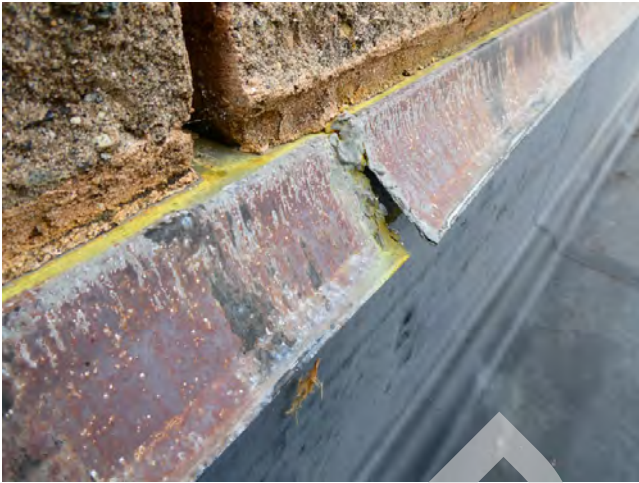
57. Roof - Deteriorated sealants at parapet flashing (south portion)

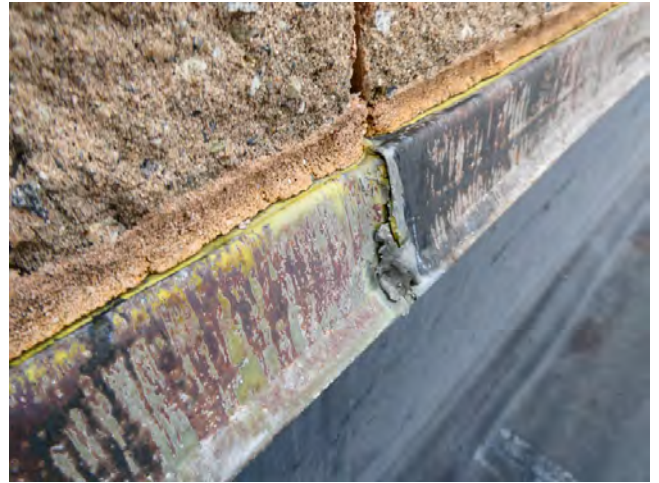
58. Roof - Deteriorated sealants at parapet flashing (south portion)

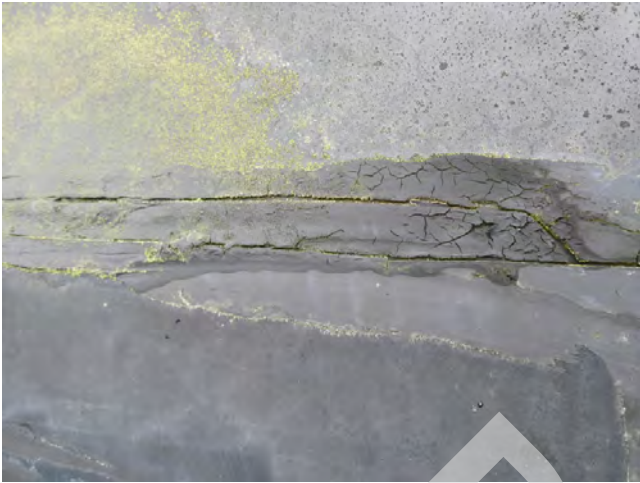
61. Roof - Isolated areas of deteriorated seals at membrane

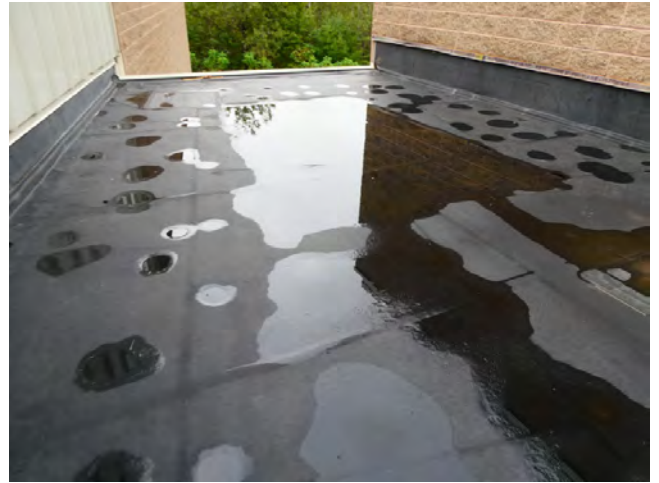
62. Roof - Isolated ponding water along southwest roof section

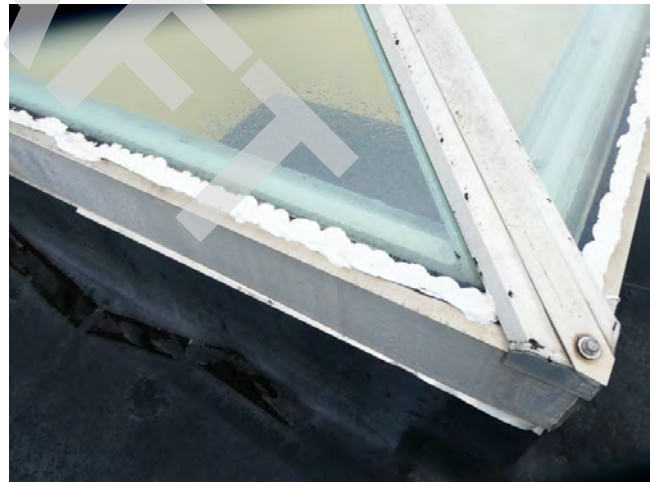
72. Roof - Skylights at central roof area with sealant replacement

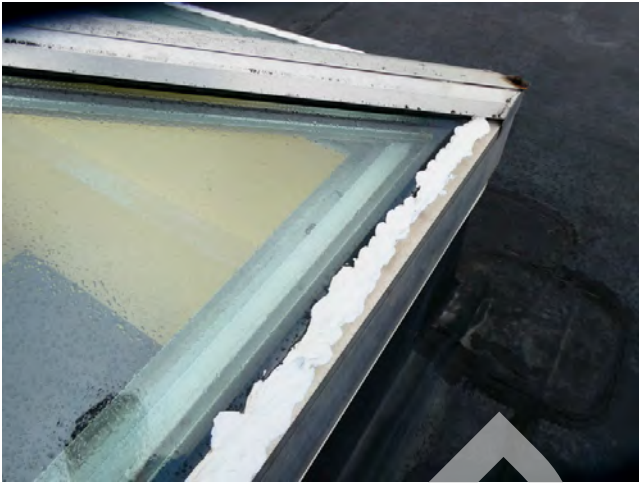
73. Roof - Skylights at central roof area with sealant replacement

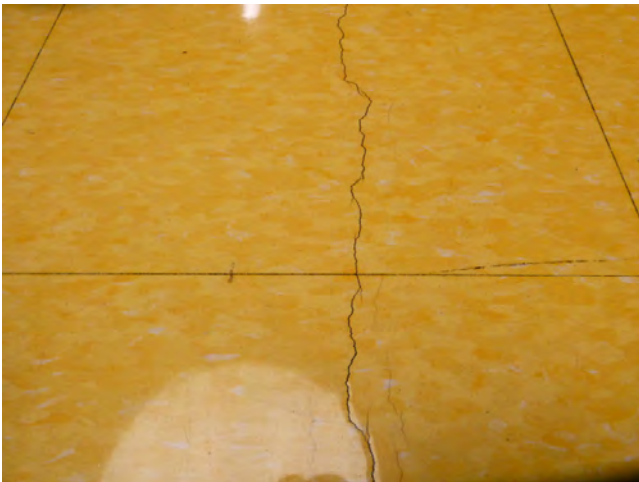
95. Interiors - Isolated areas of stress cracking at common area vinyl flooring

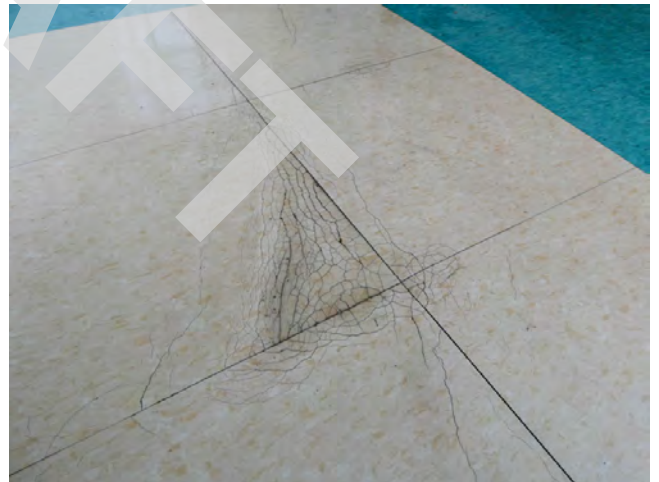
96. Interiors - Isolated areas of stress cracking at common area vinyl flooring

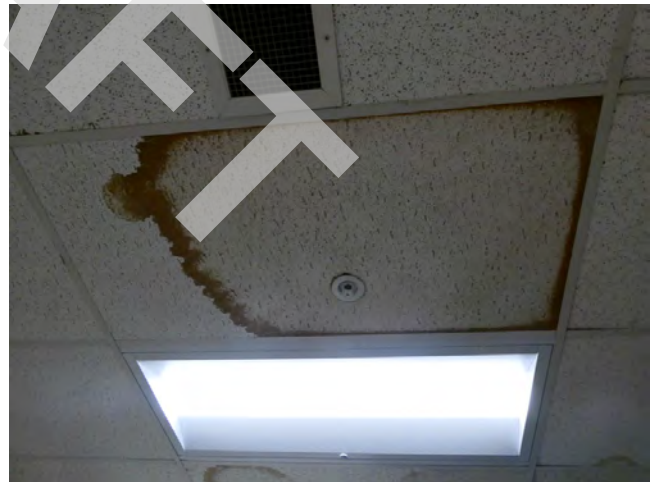
156. Interiors - Moisture damaged ceiling panel from prior leak
