Facility Condition Assessment

REPORT DATE: September 20, 2023

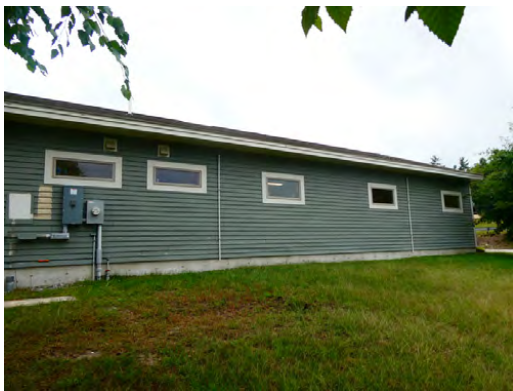
Elevations - West facing elevation

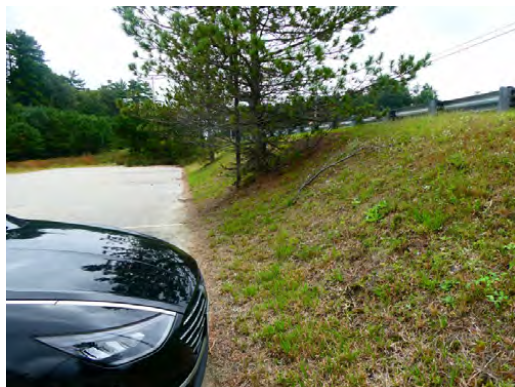
Site - Sloped grade along south perimeter

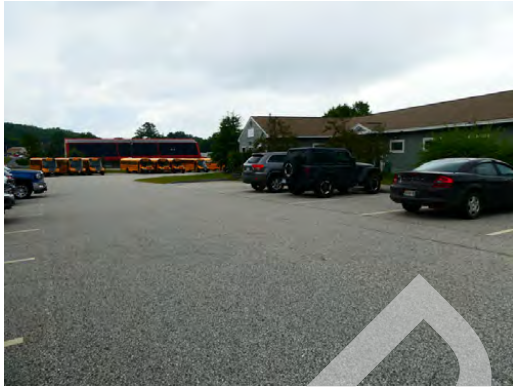
Site - South parking area and pavement condition

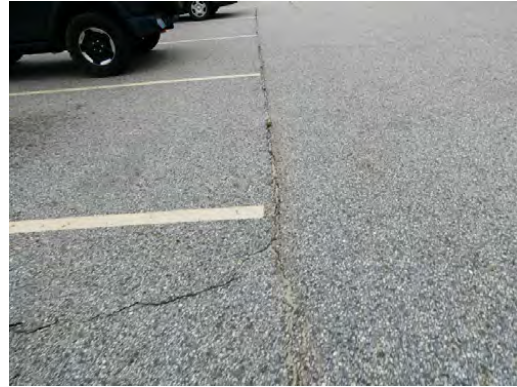
Site - Isolated longitudinal cracking along south parking area

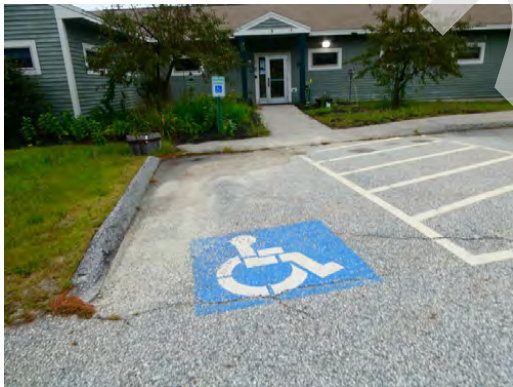
Site - Accessible parking space at main entrance

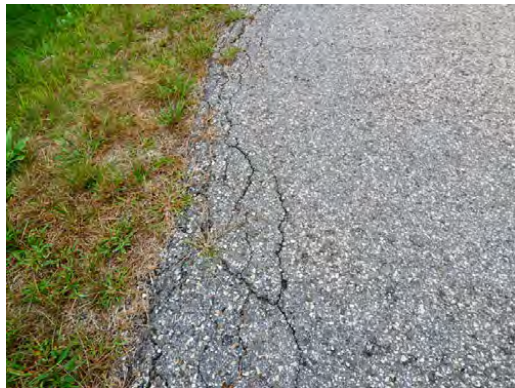
Site - Deterioration along asphalt paved walkway

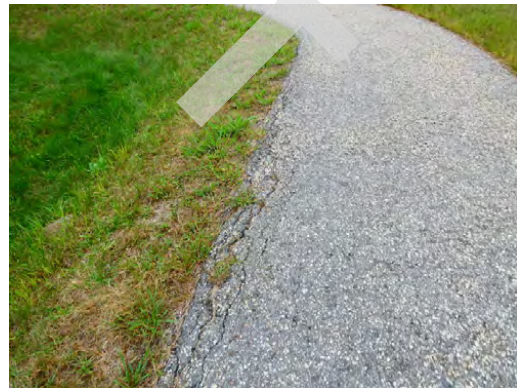
Site - Deterioration along asphalt paved walkway

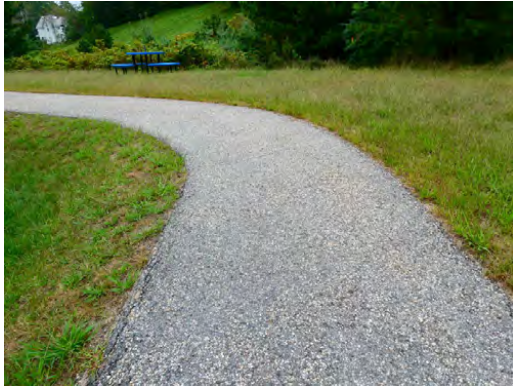
Site - Asphalt paved pedestrian walkway at north perimeter

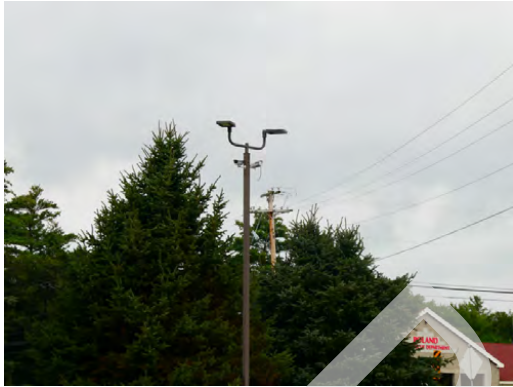
Site - Pole mounted light fixtures at parking area perimeter

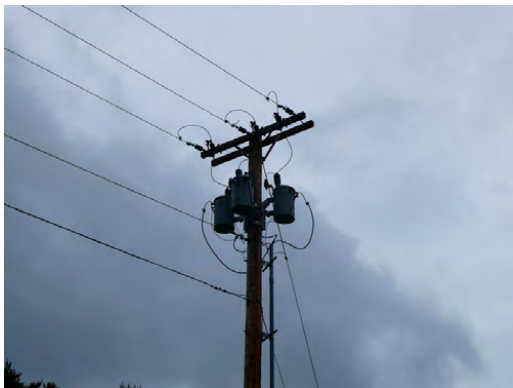
MEP - Pole mounted electrical transformer

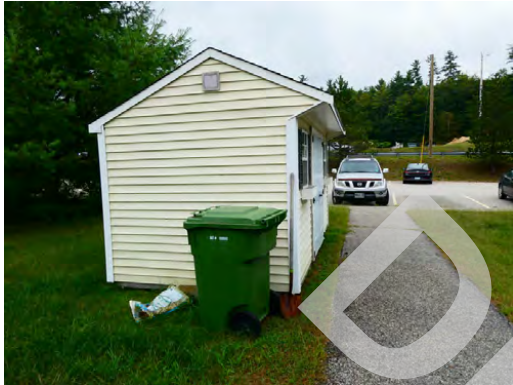
Site - Storage structure along the east perimeter

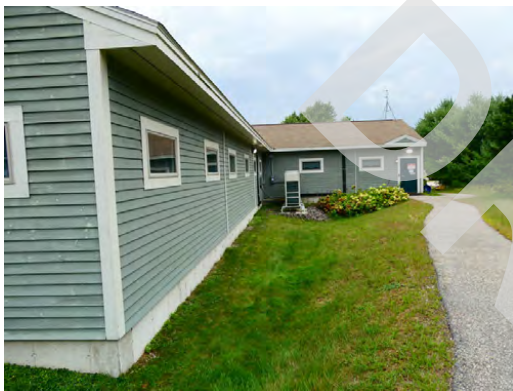
Elevations - North facing elevation

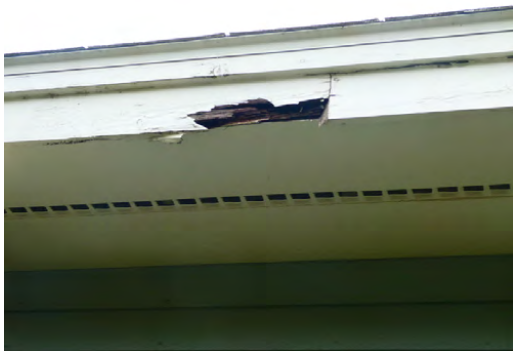
Exterior - Sectional deterioration at fascia board

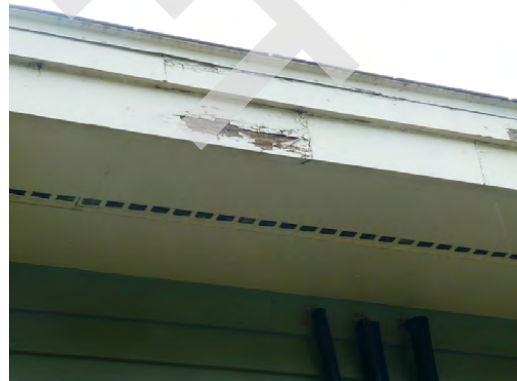
Exterior - Worn paint finish at fascia board

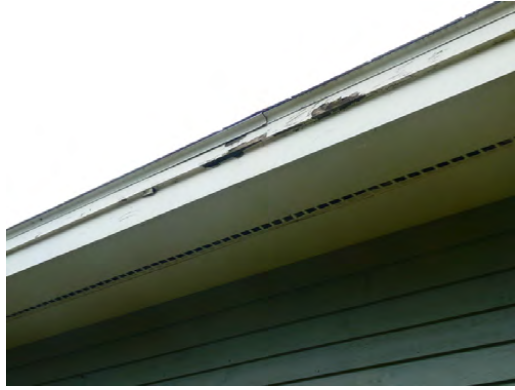
Exterior - Worn paint finish at fascia board

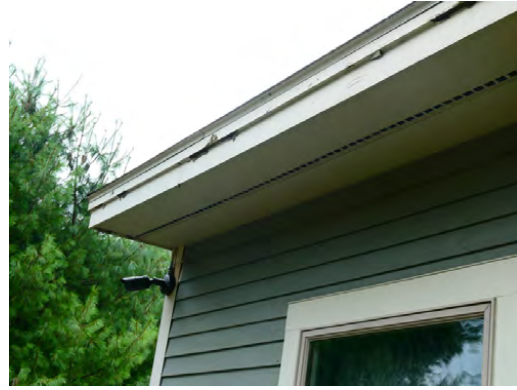
Exterior - Worn paint finish at fascia board

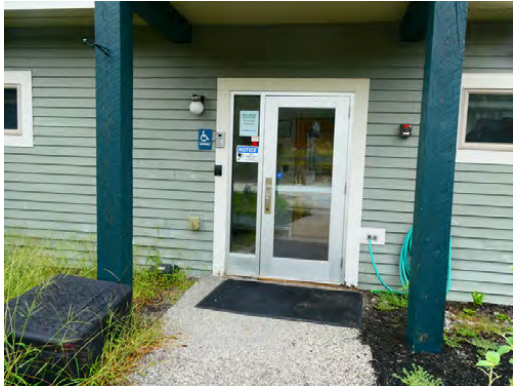
Exterior - Main entrance along south elevation

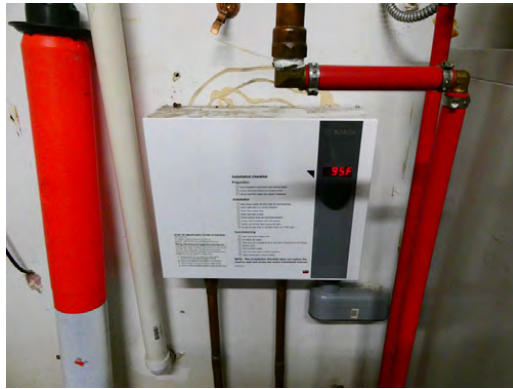
MEP - Electric tankless water heater

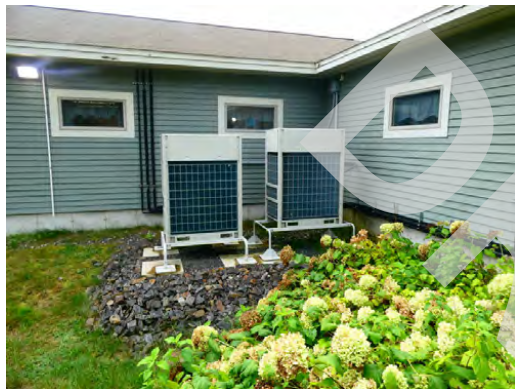
MEP - VRV exterior units

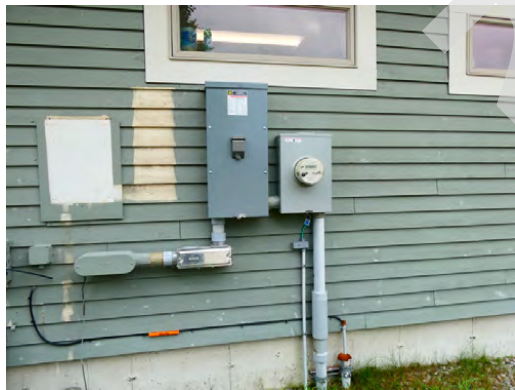
MEP - Main service panel along west elevation

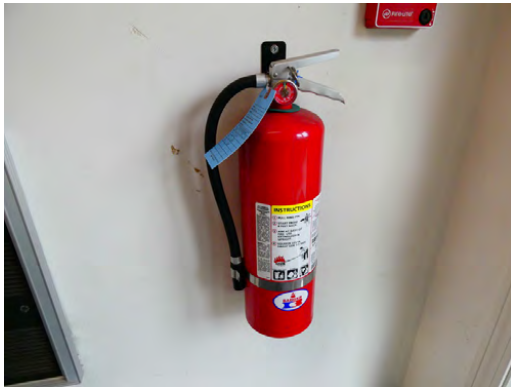
FLS - Wall mounted fire extinguishers

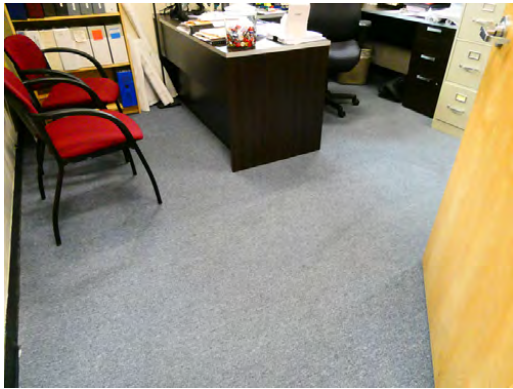
Interiors - Office with original carpeting type

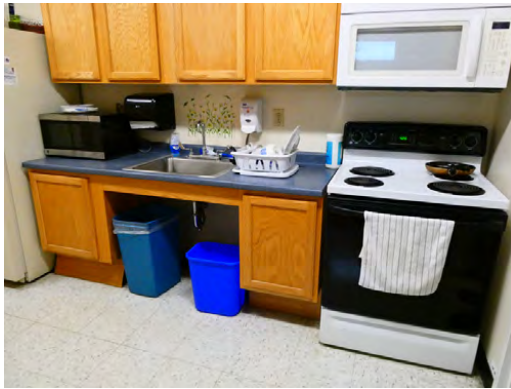
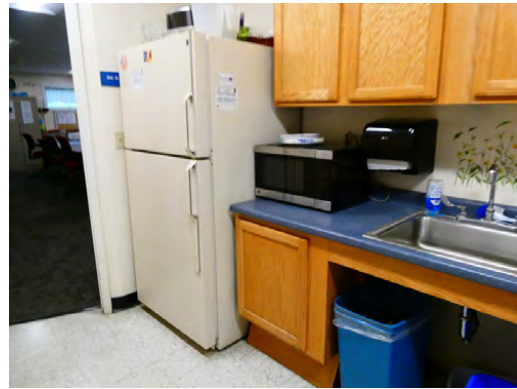
Interiors - Breakroom finishes and appliances

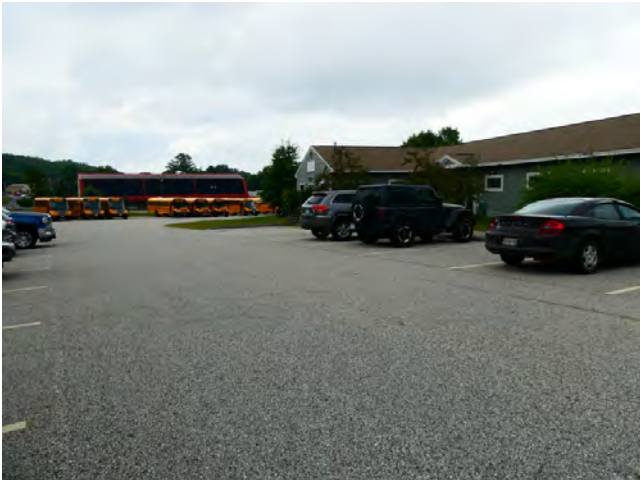
3. Site - South parking area and pavement condition

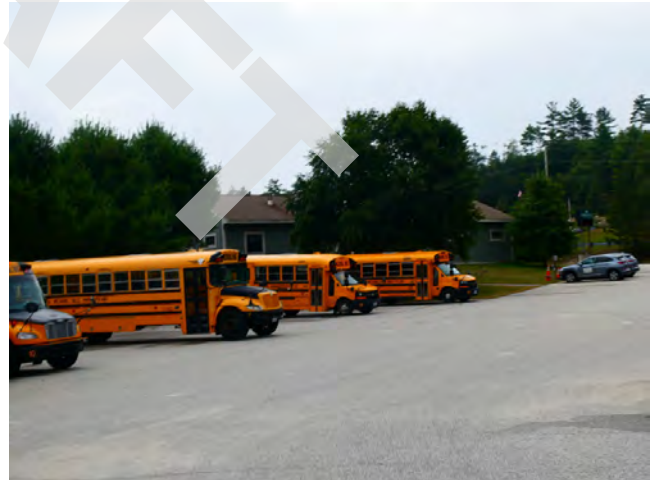
4. Site - Bus parking area along west perimeter

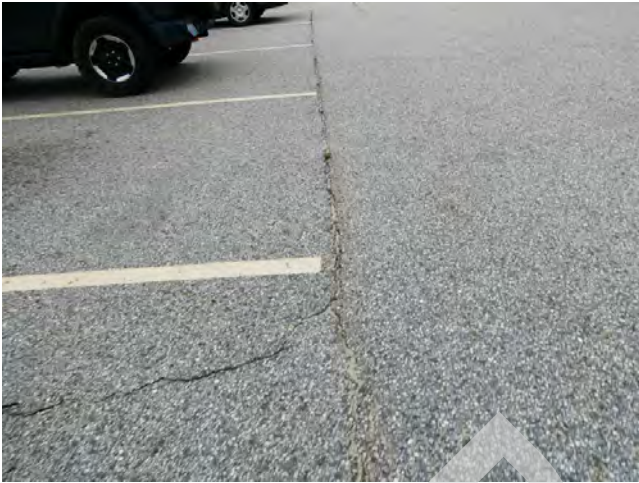
5. Site - Isolated longitudinal cracking along south parking area

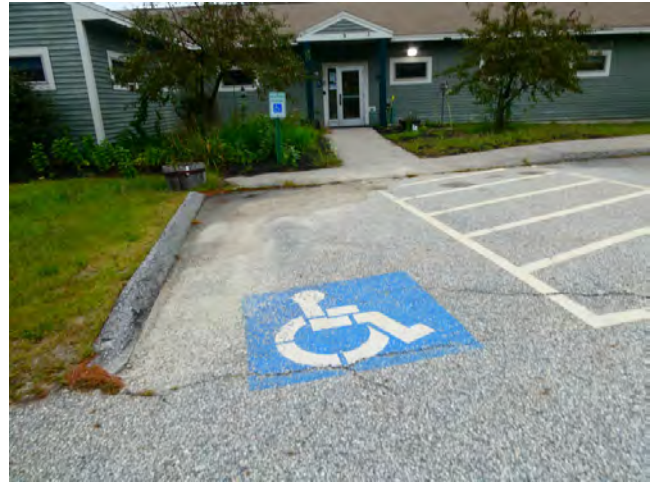
6. Site - Accessible parking space at main entrance

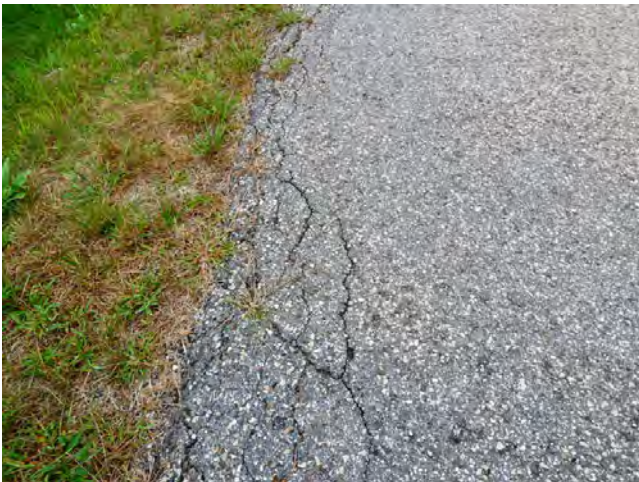
7. Site - Deterioration along asphalt paved walkway

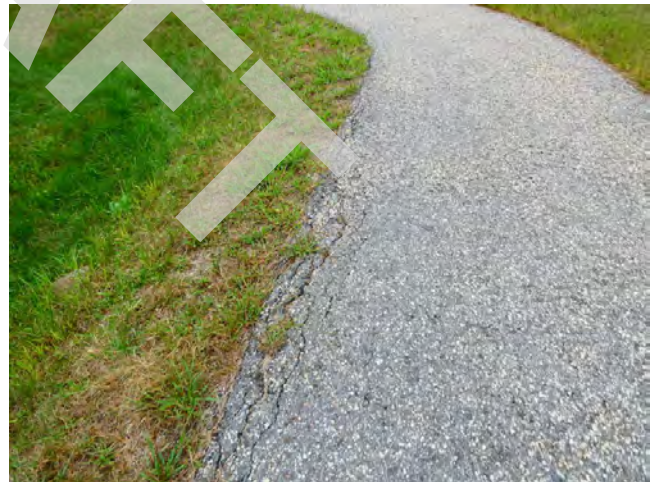
8. Site - Deterioration along asphalt paved walkway

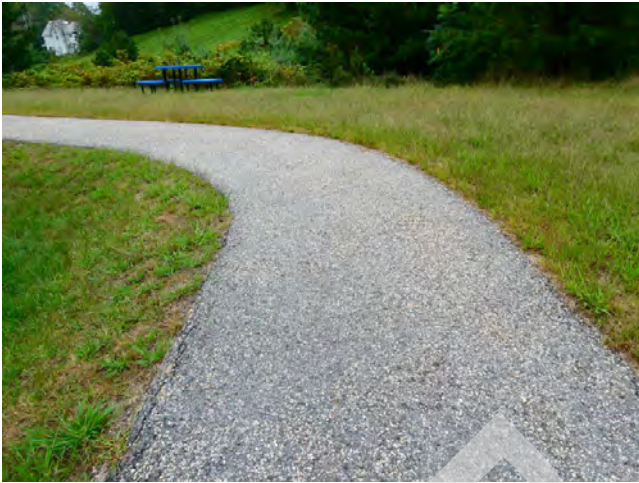
9. Site - Asphalt paved pedestrian walkway at north perimeter

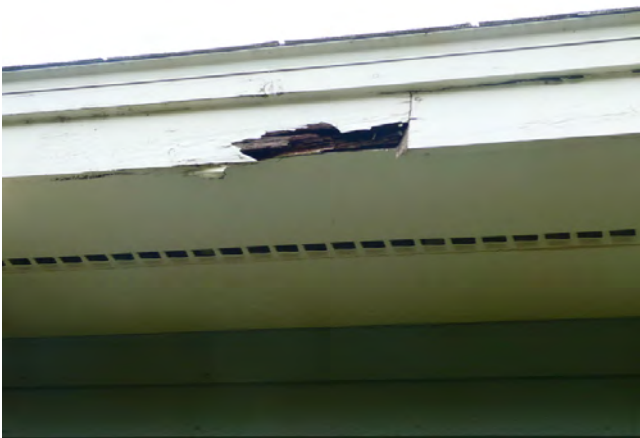
19. Exterior - Sectional deterioration at fascia board

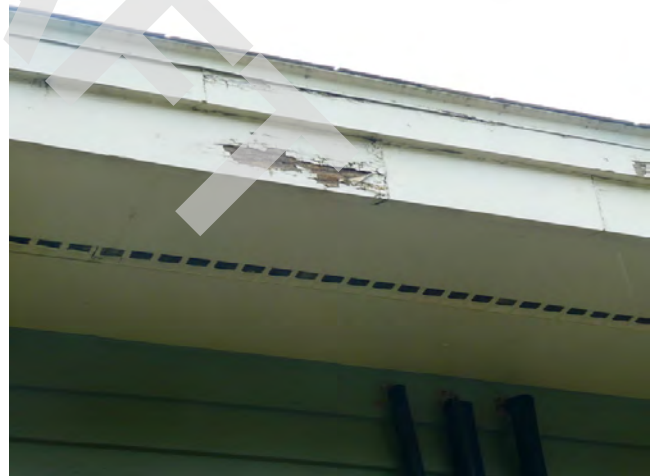
20. Exterior - Worn paint finish at fascia board

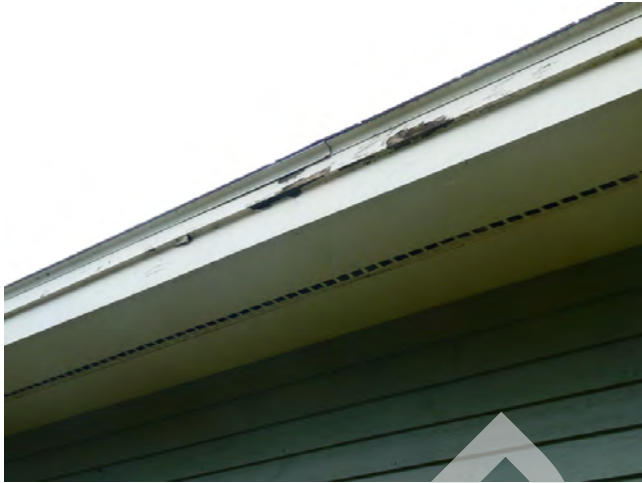
21. Exterior - Worn paint finish at fascia board

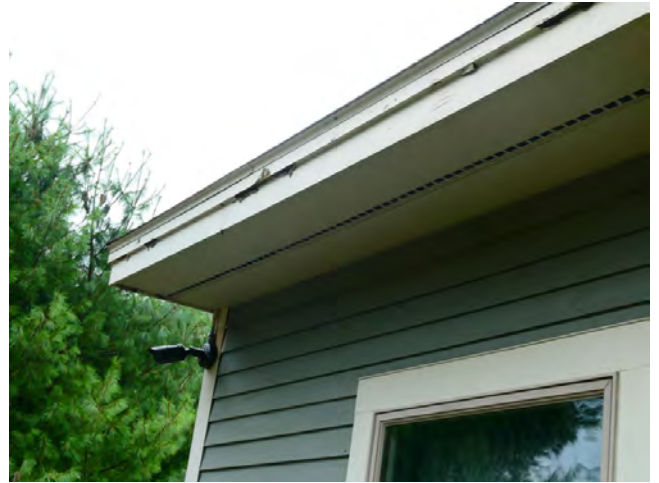
22. Exterior - Worn paint finish at fascia board

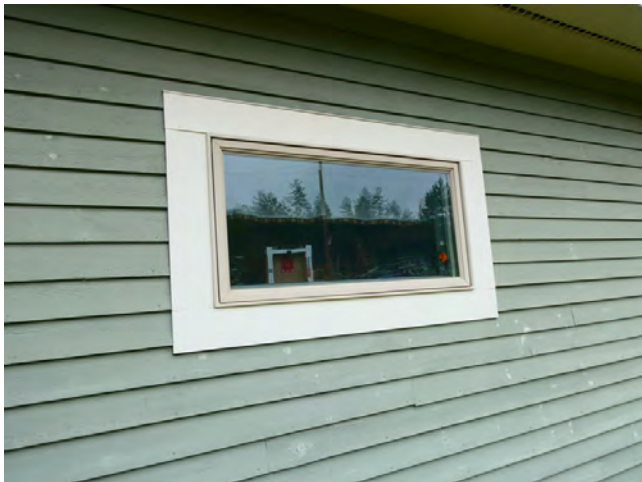
23. Exterior - Awning window type with vinyl framing

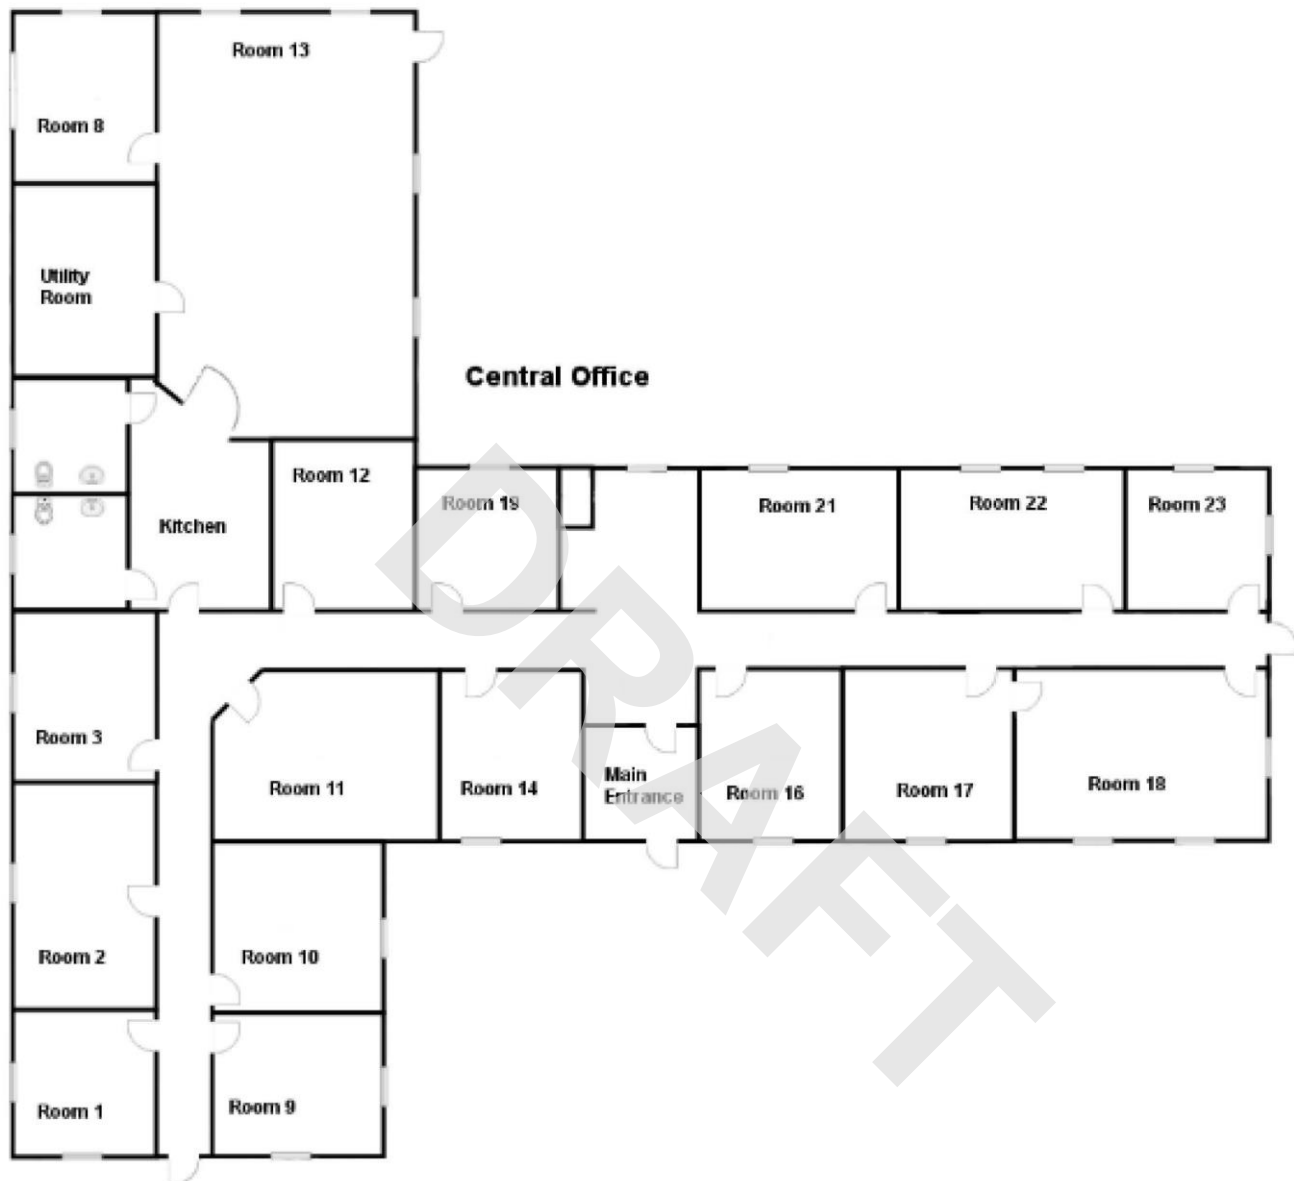
Interviewee / Title: John Hawley, Director of Operations **Date:** 9/19/23
