Facility Condition Assessment

Poland Community School
1250 Maine Street
Poland, Androscoggin County, Maine 04274

AEI Project No. 482353
Site Assessment Date: September 13, 2023

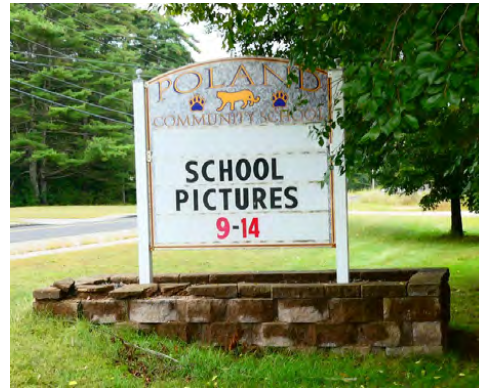
Site - Retaining wall with displaced/damaged sections

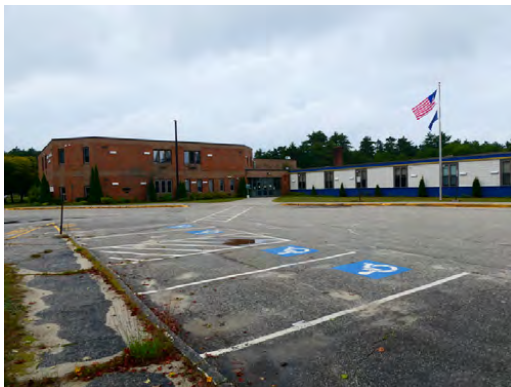
The asphalt pavement along the east and south perimeters appears to be reaching the end of its effective useful life. Areas of deterioration, longitudinal cracking, and pothole formation were observed. Asphalt maintenance is typically addressed by applying a 2" overlay surface to the asphalt as it approaches its effective useful life and before structural cracking occurs. An overlay application is not a repair solution but rather is a proactive maintenance recommendation to avoid system failure. If an overlay is applied, it should be applied before significant stress cracking occurs. Ideally, the wear (top) course of asphalt should be milled 2" or the perimeter of the pavement should be milled to avoid changing surface drainage patterns and to allow the new asphalt surface to integrate into the surrounding surfaces such as curbs and sidewalks. An opinion of cost for this work is included in the Tables.

Site - South parking area condition

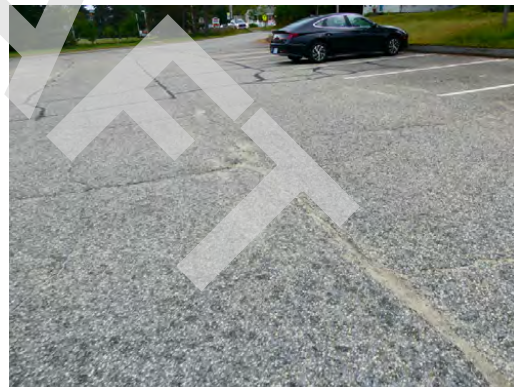
Site - South parking area condition

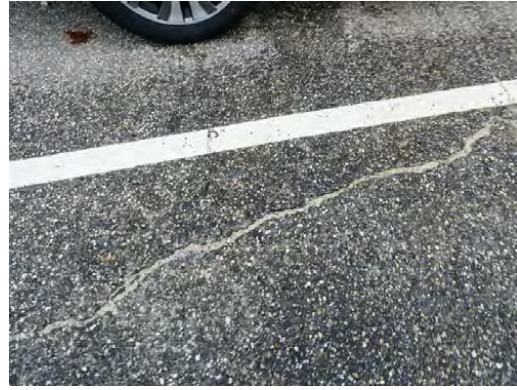
Site - Longitudinal cracking along south parking area

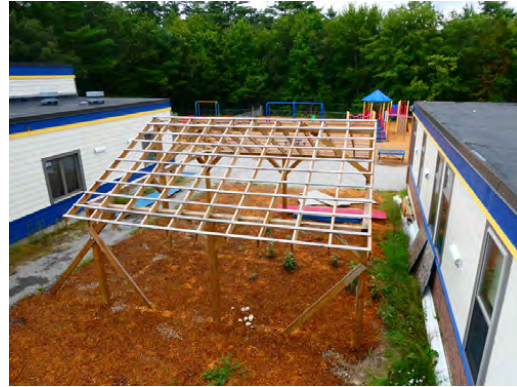
A wood framed structure is located at the north portion of the courtyard area. Reportedly the structure is still under construction and will be used as an outdoor learning structure. AEI recommends that the structure be completed, however, completion of the structure is at the discretion of Management.

Site - Outdoor learning area structure under construction

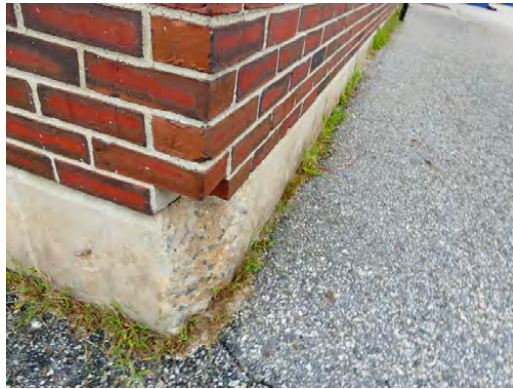
Structure - Damaged section of exposed concrete slab and missing brick

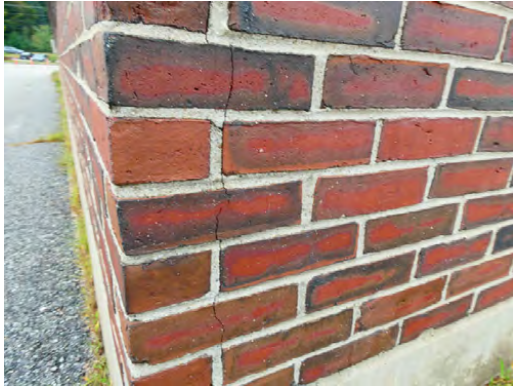
Structure - Vertical cracking along brick facade (northeast corner)

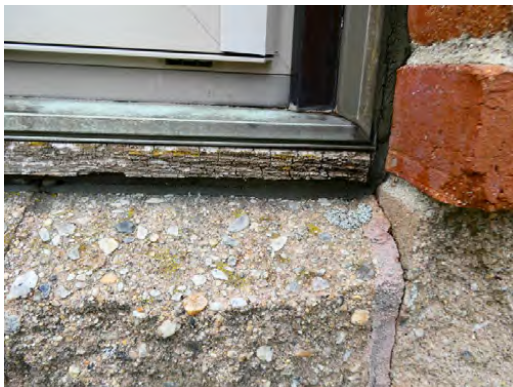
Exterior - Deteriorated mortar at southeast elevation

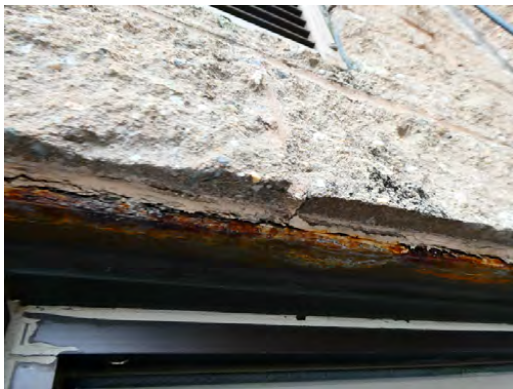
The exterior sealants along all facades were observed to be in fair condition with areas of wear observed along the north elevations, and along the north facing roofline. AEI recommends resealing the façades in the short-term, with additional resealing during the term. An opinion of cost for this work is included in the Tables.

Exterior - Corrosion at steel lintels at roofline and deteriorated sealants

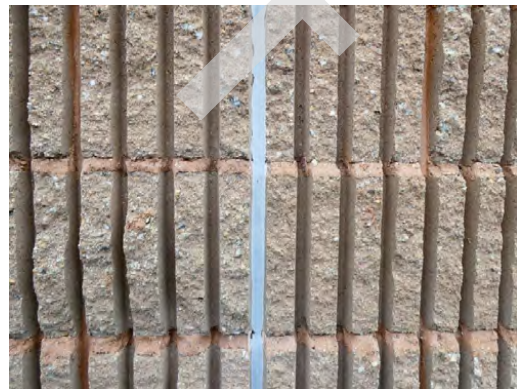
Exterior - Vertical sealant condition

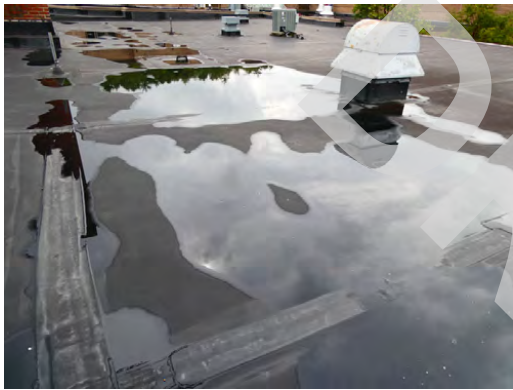
Roof - Standing water at central roof surface

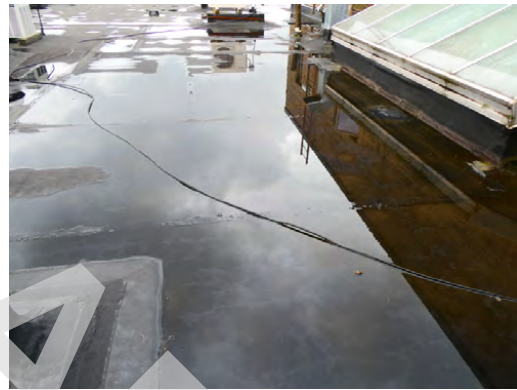
Roof - Standing water at central roof surface

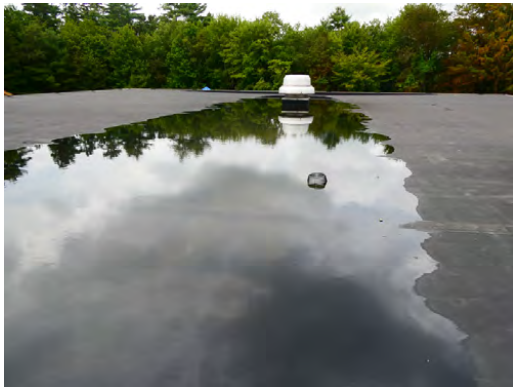
Roof - Standing water at northeast roof surface

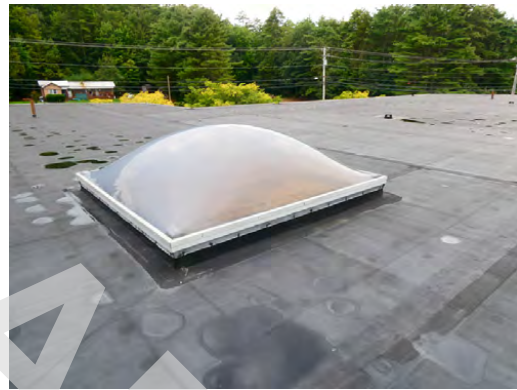
Roof - Curb mounted skylight at south roof area

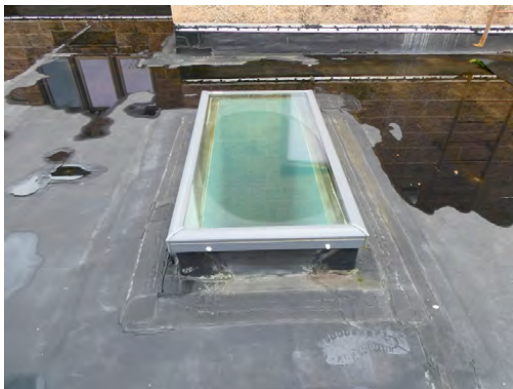
Roof - Newer curb mounted skylight

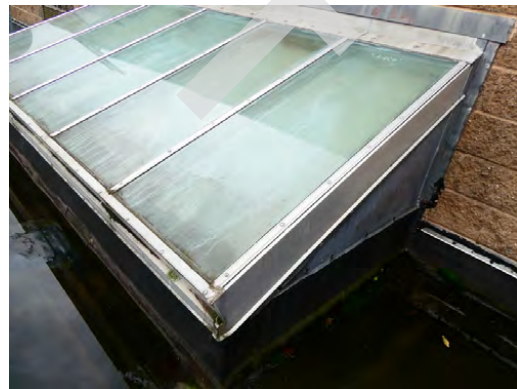
Roof - Skylight assembly at south roof area

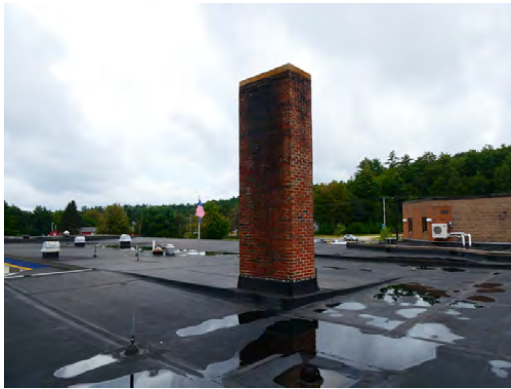
Architectural appurtenances are limited to a brick masonry chimney stack for the boiler systems. No notable deficiencies or indications of deferred maintenance of the chimney were observed or reported. The RULs of this feature is expected to exceed the evaluation period.

Roof - Brick clad chimney structure for boilers

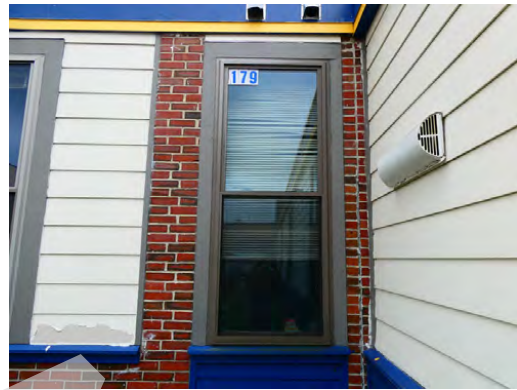
The double hung windows were observed to be in overall good condition. No notable deficiencies or indications of deferred maintenance of the window systems were observed or reported. The RULs of these features are expected to exceed the evaluation period.

Exterior - Aluminum framed double hung windows

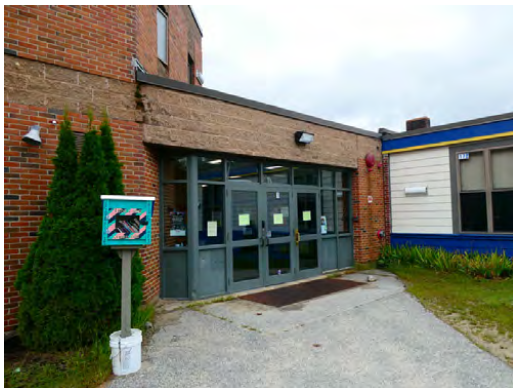
The main entry consists of aluminum framed storefront doors with glazing. Secondary egress is provided via double metal framed doors with glazing. Painted metal doors are provided service entrances/exits. The storefront system at the main entrance was observed to be in a worn and aged condition, with surface damages present. AEI recommends replacement during the term. An opinion of cost for this work is included in the Tables.

Exterior - Storefront system at main entrance

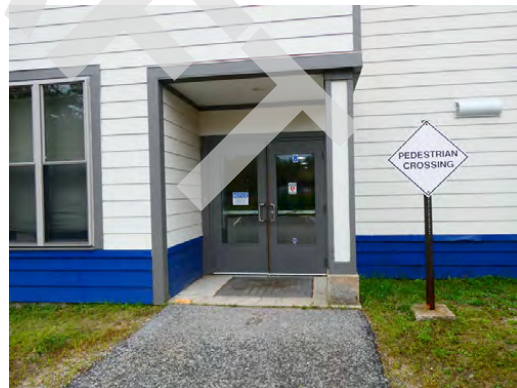
Exterior - Secondary storefront systems

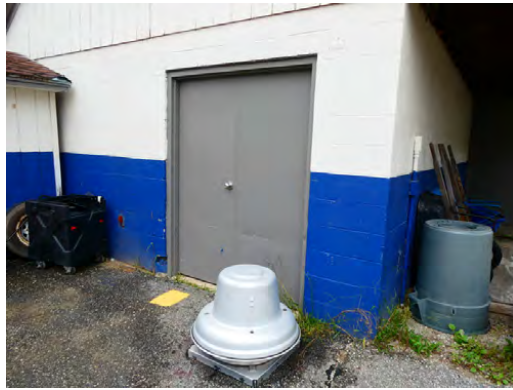
The secondary glazed doors are expected to exceed the evaluation period. Based on the condition and EUL of metal service doors, AEI recommends replacement during the term. An opinion of cost for this work is included in the Tables.

Exterior - Steel clad service door type

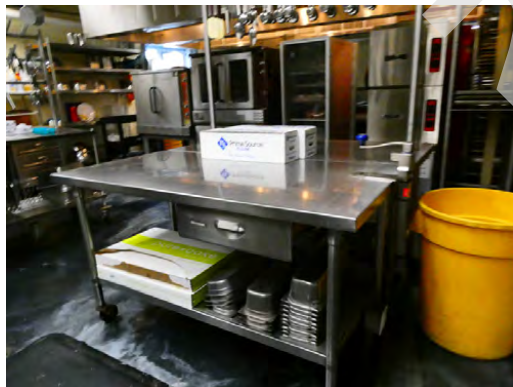
The commercial area kitchen equipment was observed to be in generally good to fair condition. Based on the EUL of commercial kitchen equipment, budgeting for on-going replacements of the kitchen equipment during the evaluation period is anticipated. An opinion of cost is included in the Tables.

Interiors - Commercial kitchen area and equipment

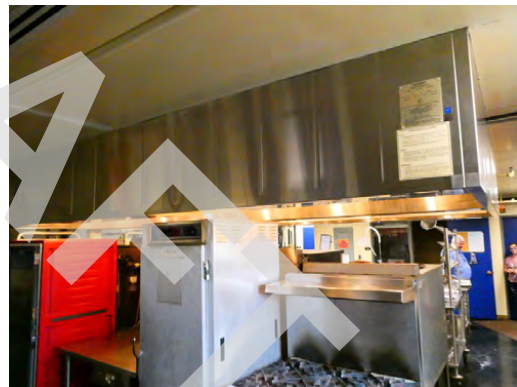
Interiors - Range hood with fire suppression system

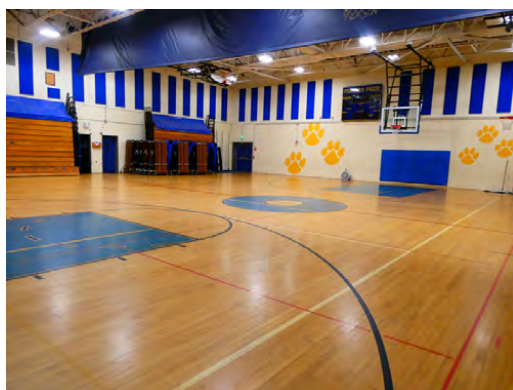
The gymnasium is in good to fair overall condition. The flooring is discussed in *Section 3.4.3 Finishes* for cost reference. The seating is provided by manually operated accoridian style bleachers, that pull out from the wall. Based on the age of and AEI's observations, the mechanisms are older and elements of the wood appear to be worn. Planning for replacement of the bleachers is recommended. An allowance for this work is included in the Tables.

Interiors - Gymnasium finishes and fixtures

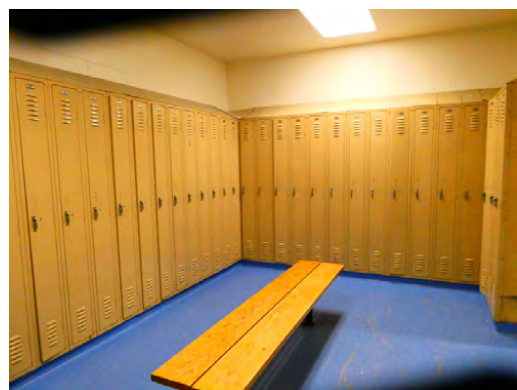
The locker rooms were observed to be in generally good condition. Management reported that the locker rooms are not regularly used. The finishes and fixtures appeared to be in older but serviceable condition. No further action is required at this time.

Interiors - Locker room finishes and fixtures

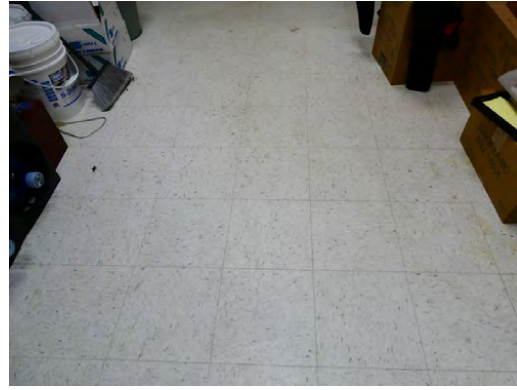
Interiors - VCT flooring type in service area

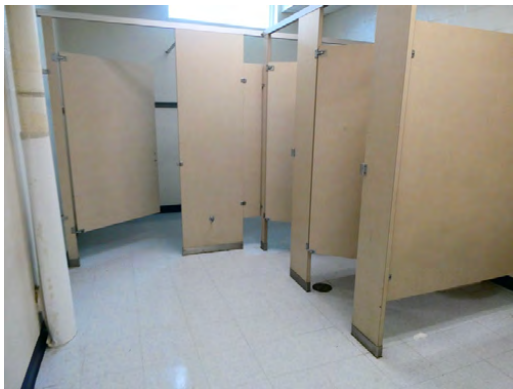
The Subject is provided with 8 multi-use toilet rooms, and 4 single-use toilet rooms. Finishes consist of ceramic tile flooring, stall fixtures, wall mounted sinks or sinks within laminate countertops, and various other fixtures. Ceramic tile is generally durable and has a useful life of 30+ years depending on quality of installation, usage, and maintenance activities. Though, durable, the ceramic tile can become outdated and show wear with age and usage. Vinyl flooring, though durable, has a useful life of 15 to 25 years. The bathroom partitions and fixtures were generally older, showing usage and wear. Various levels of renovation could be considered from full refurbishment, to light renovation and replacement of partitions and fixtures. The decision to renovate these areas is primarily a function of necessity and monies available, rather than upgrading to meet design criteria. Based on AEI's observations, planning for refurbishment at some level is anticipated during the term. As the exact scope of work would need to be determined, AEI has included a budgetary amount to complete the renovations.

Interiors - Multi use toilet room finishes and fixtures

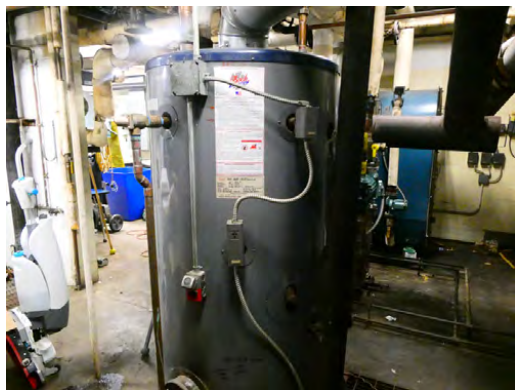
MEP - Gas fired domestic water heater

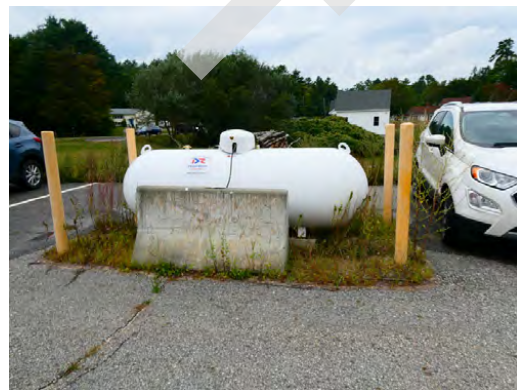
MEP - Onsite propane tank

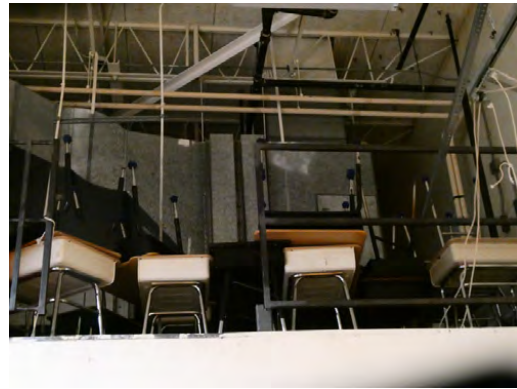
MEP - Commercial air handling unit

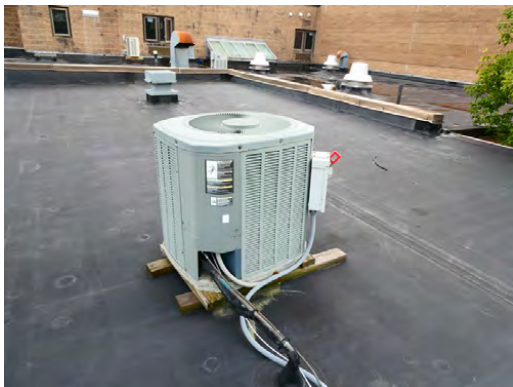
MEP - Roof mounted condensing unit

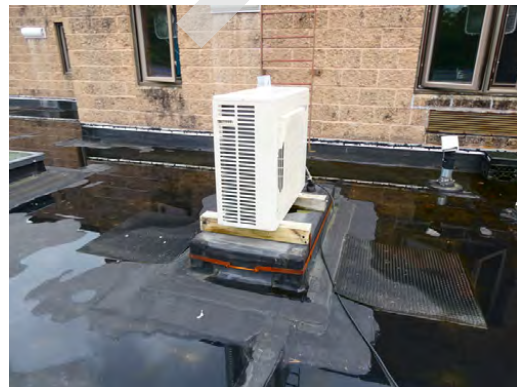
MEP - Roof mounted condenser for mini split system

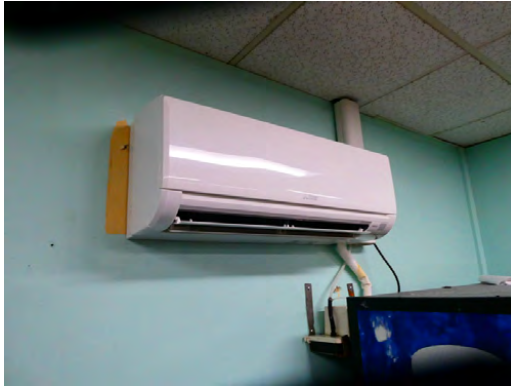
MEP - Mini split system interior AHU

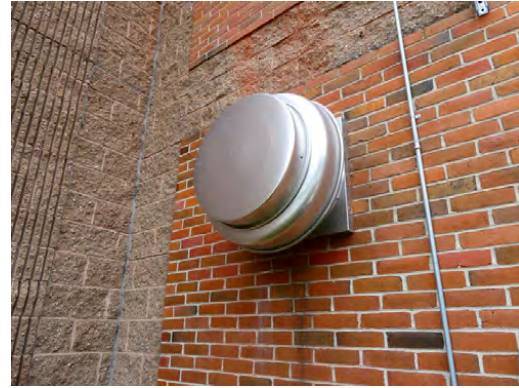
MEP - Kitchen exhaust fan

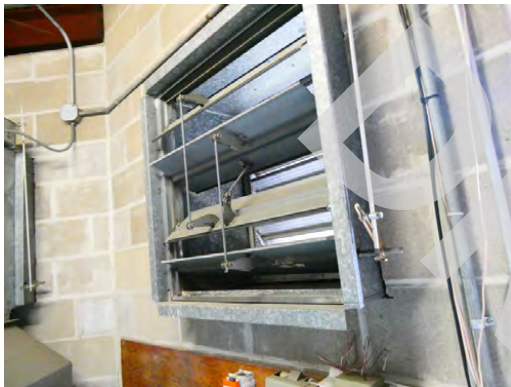
MEP - Natural ventilation exhaust in generator room

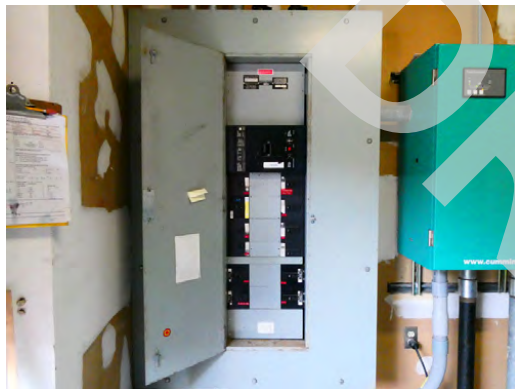
MEP - Main electrical disconnect panel

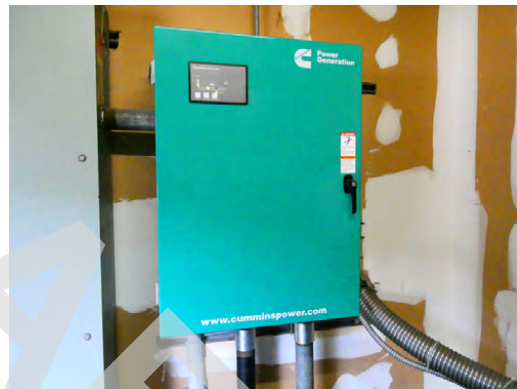
MEP - Emergency generator transfer switch

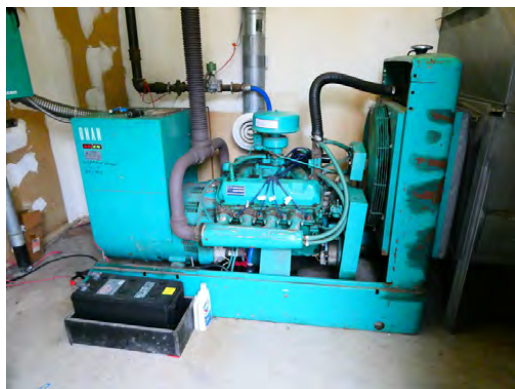
MEP - Natural gas-fired emergency generator

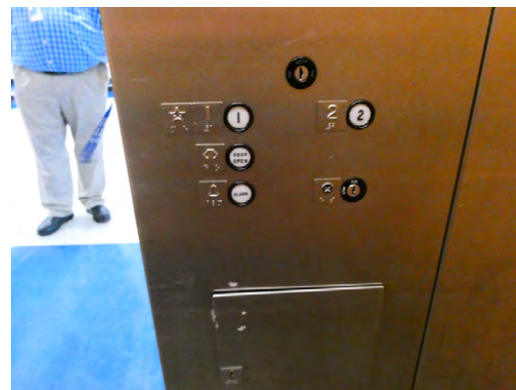
Vertical Transportation - Elevator controls

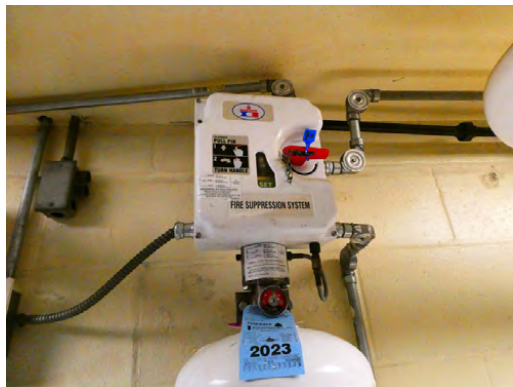
FLS - ANSUL fire suppression system tank

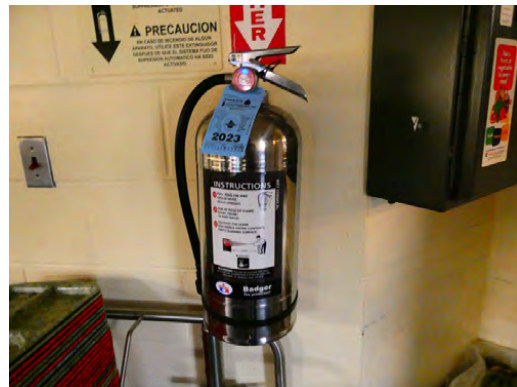
FLS - Chemical fire suppression extinguisher

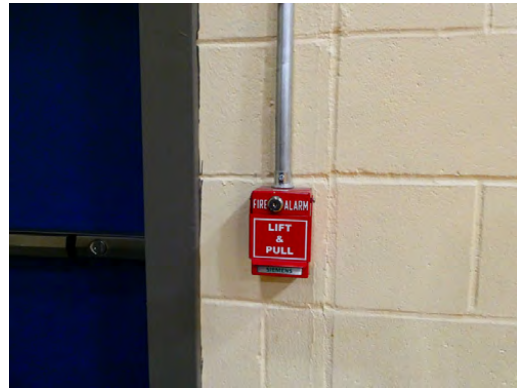
FLS - Fire pull stations located throughout

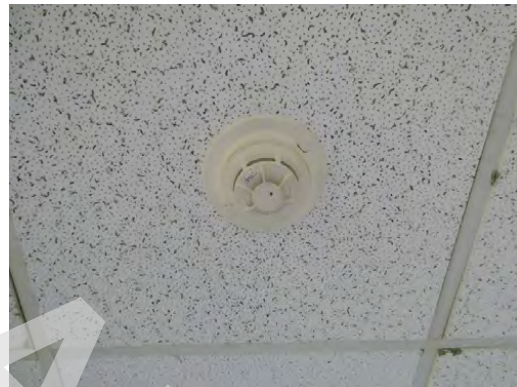
FLS - Hardwired ceiling mounted smoke detectors

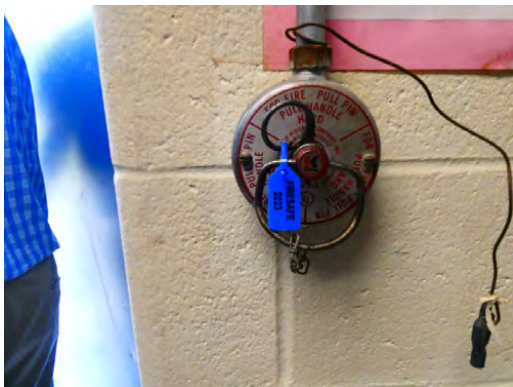
FLS - Kitchen ANSUL fire pull station

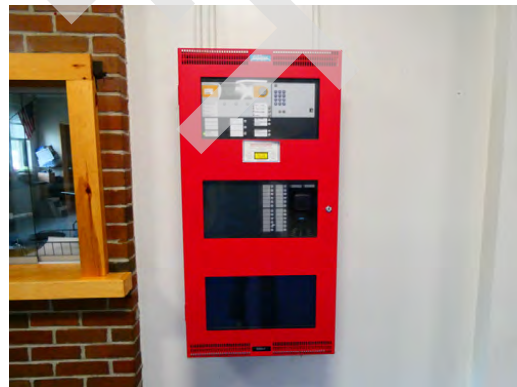
Based on the EUL of fire alarm panels, AEI anticipates that the fire alarm will require replacement during the term. An opinion of cost is included in the Tables.

FLS - Main fire alarm control panel

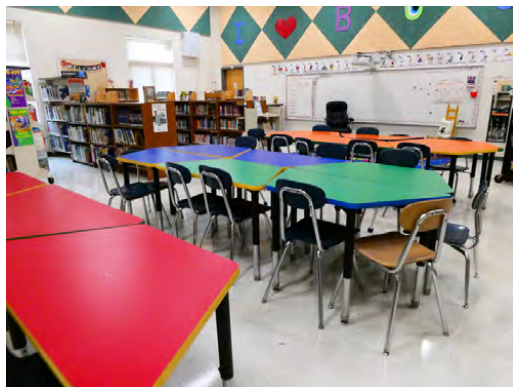
Interiors - Classroom interior finishes and furnishings (northwest section)

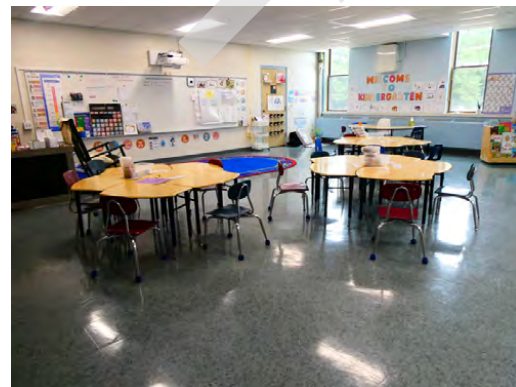
Interiors - Classroom interior finishes and furnishings (northeast section)

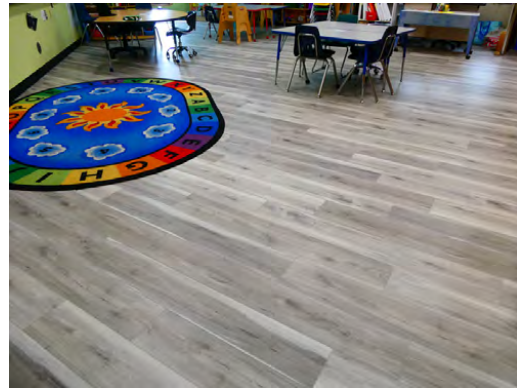
Overall, the finishes were found to be in good overall condition. Management reported that partial flooring replacements have been completed in the classrooms. Based on the EUL of vinyl flooring finishes, ongoing replacements during the term is recommended. An opinion of cost is included in the Tables.

Interiors - New vinyl flooring in south classroom area

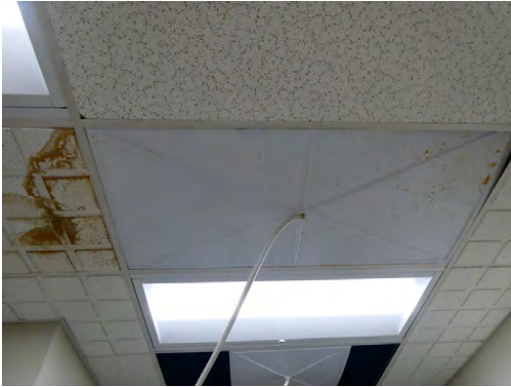
Mandy Shepherd was aware of active roof leaks. More specifically, active roof leaks were reported and observed in the central corridor and an office space at the south portion of the Subject. Additionally, an active leak was observed along the floor adjacent to the employee toilet room in the kitchen area. See further discussion of the roof leaks in *Section 3.2.4 Roof Systems*.

Interiors - Active roof leak at south portion

- Repairing the active leak in the employee toilet room (kitchen area)
- Replacing all moisture damaged finishes from active roof leaks

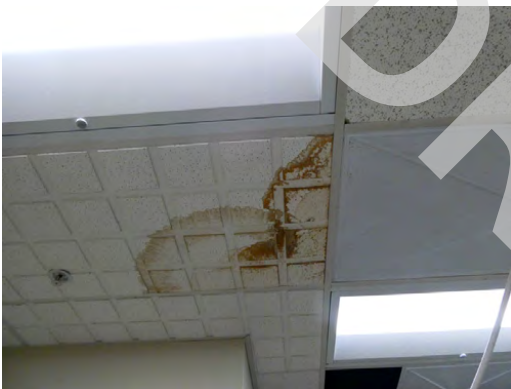
Interiors - Moisture stained ceiling tiles at south portion

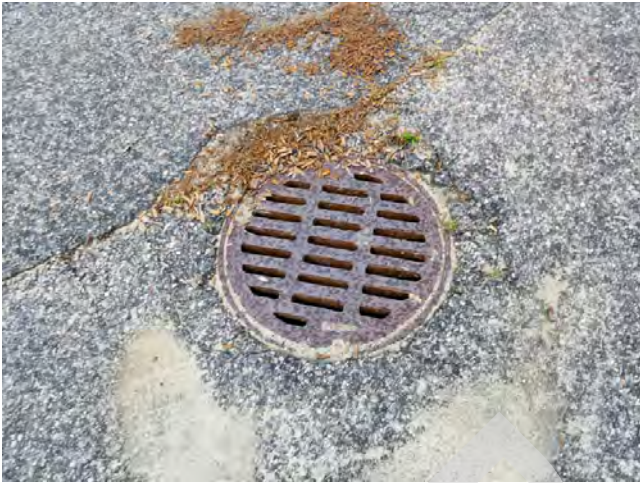
1. Site - Stormwater surface drains at parking areas

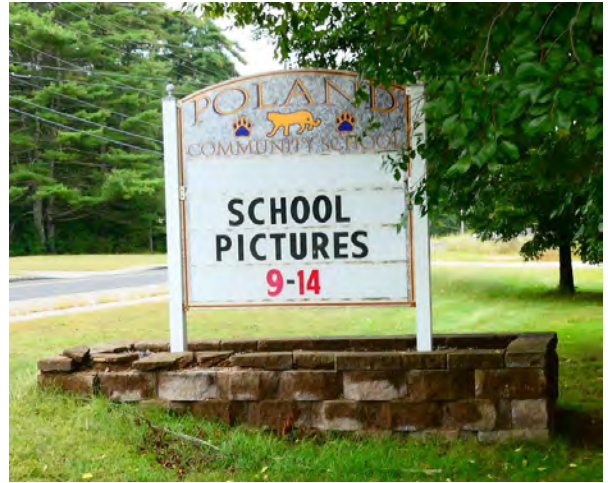
2. Site - Retaining wall with displaced/damaged sections

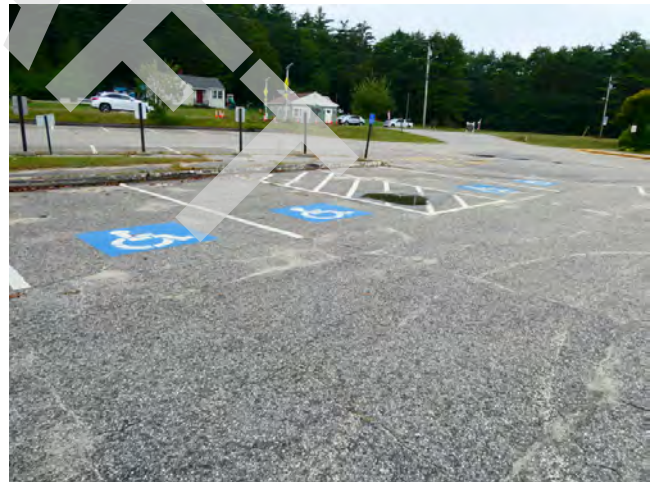
4. Site - South parking area with accessible spaces

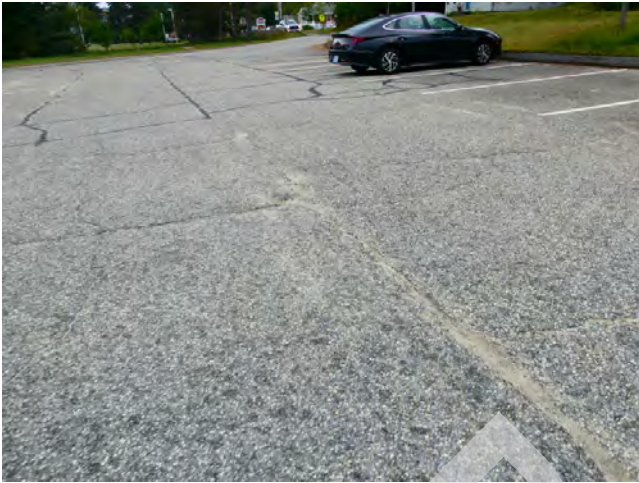
5. Site - South parking area condition

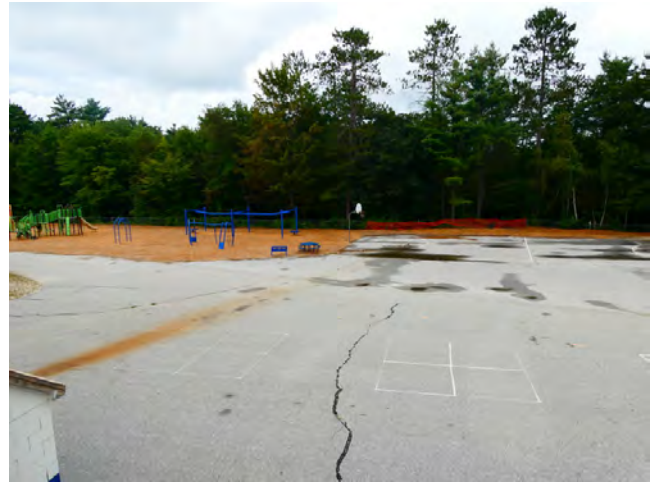
6. Site - North parking area and basketball court

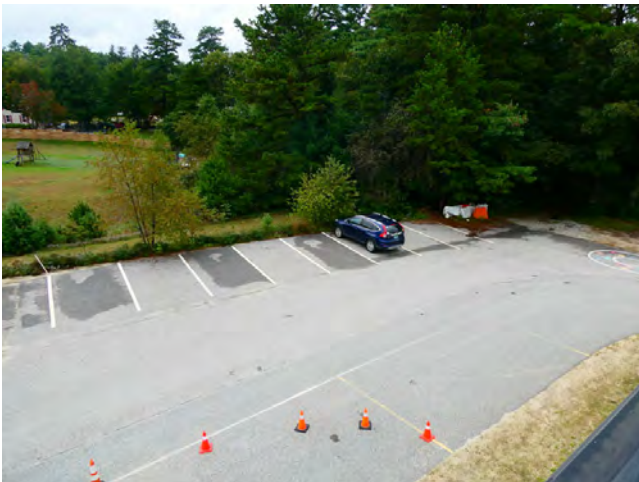
7. Site - West parking area surface

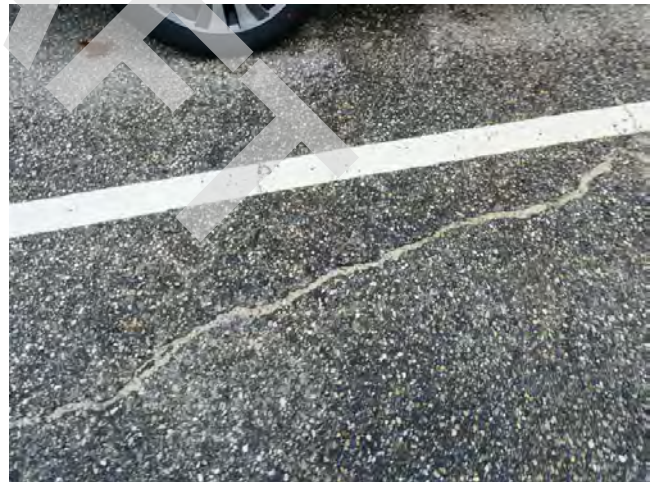
8. Site - Longitudinal cracking along south parking area

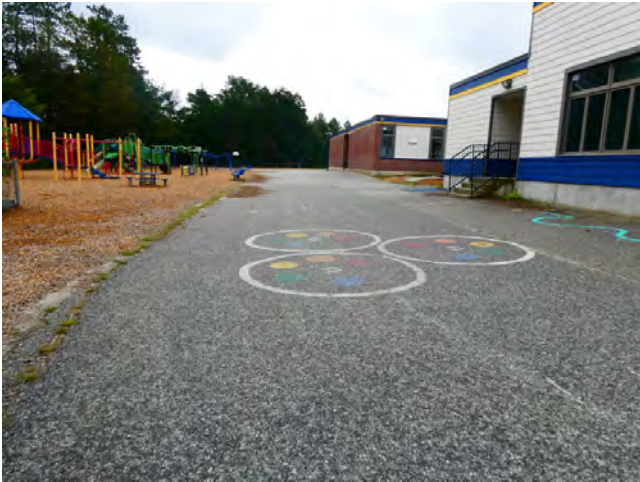
11. Site - Asphalt paved drive along north perimeter

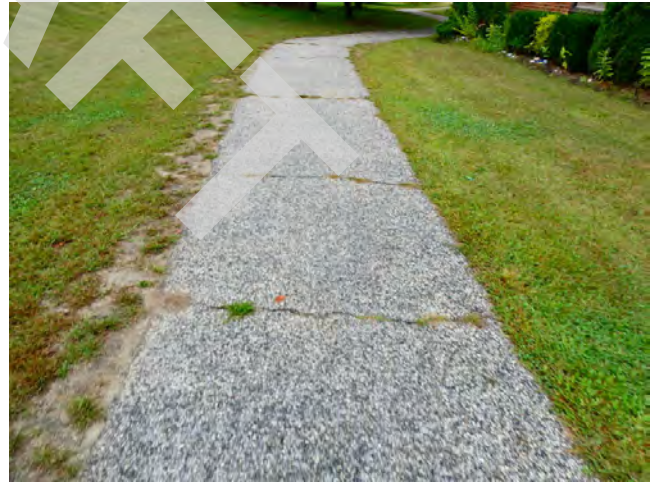
12. Site - Asphalt paved pedestrian walkways condition

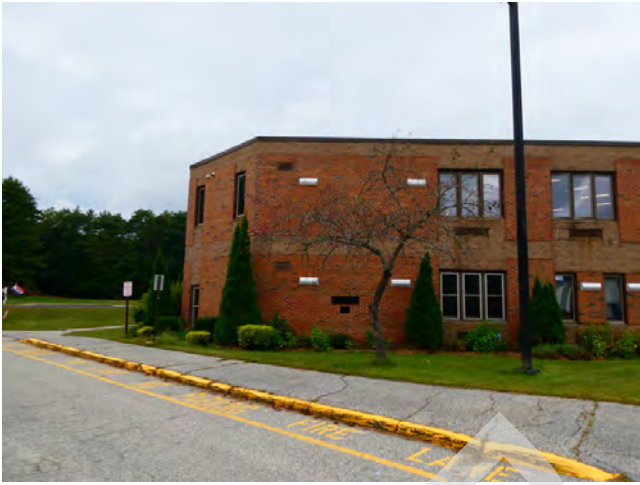
13. Site - Curb condition along south perimeter

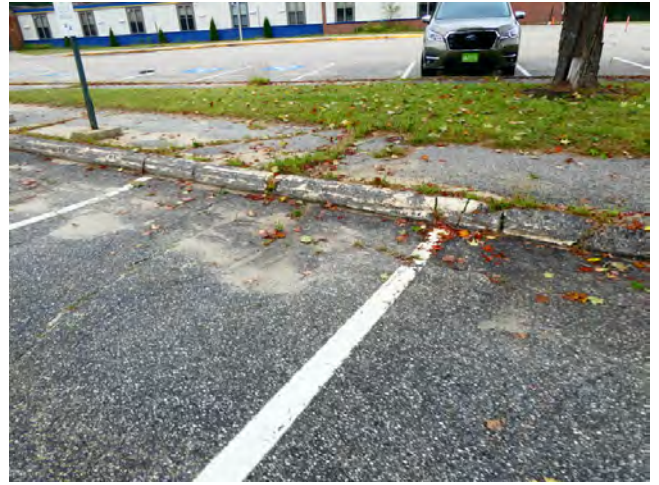
14. Site - Curb condition along south perimeter

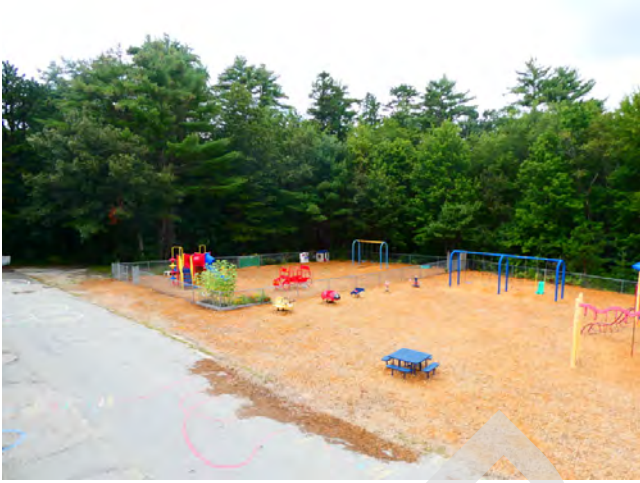
17. Site - Mature trees and perimeter fencing

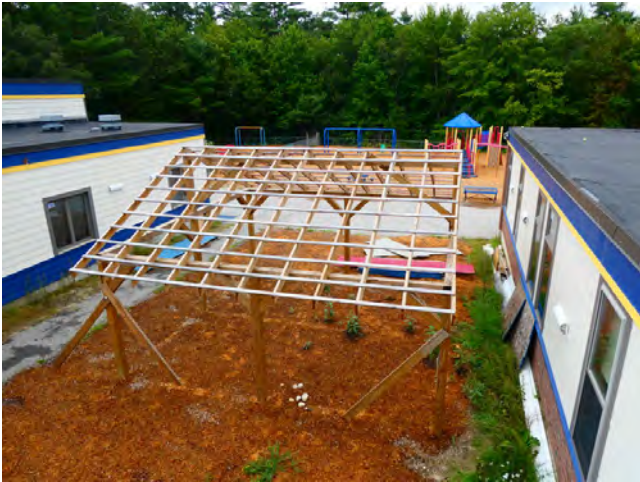
19. Site - Outdoor learning area structure under construction

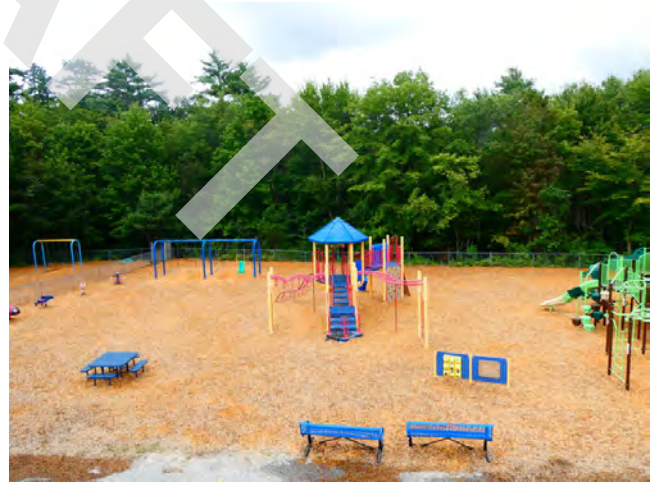
20. Site - Playground equipment along north perimeter

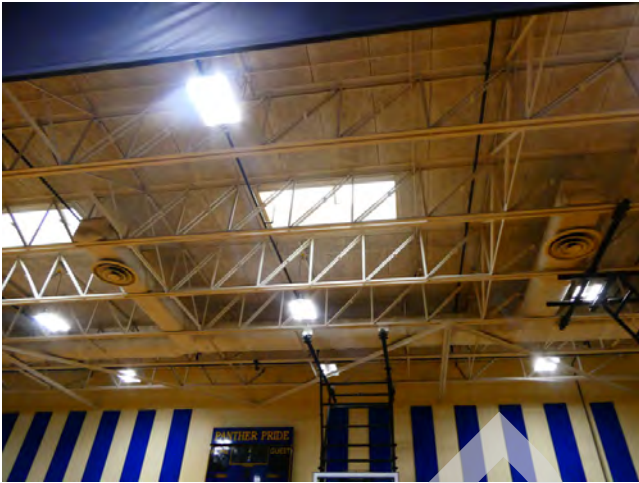
21. Structure - Open web steel joists roof framing

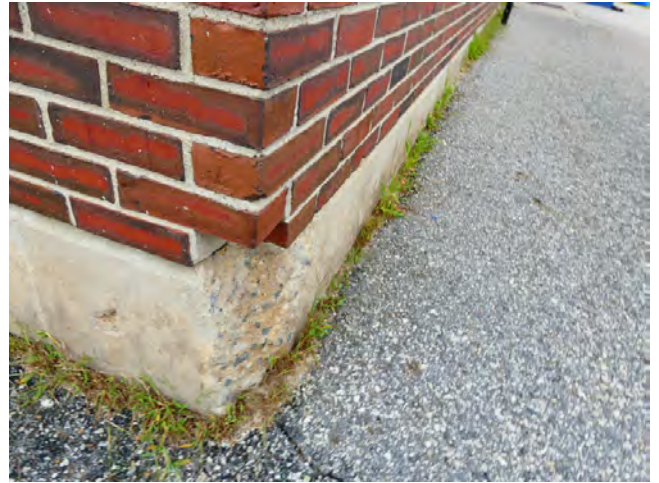
22. Structure - Damaged section of exposed concrete slab and missing brick

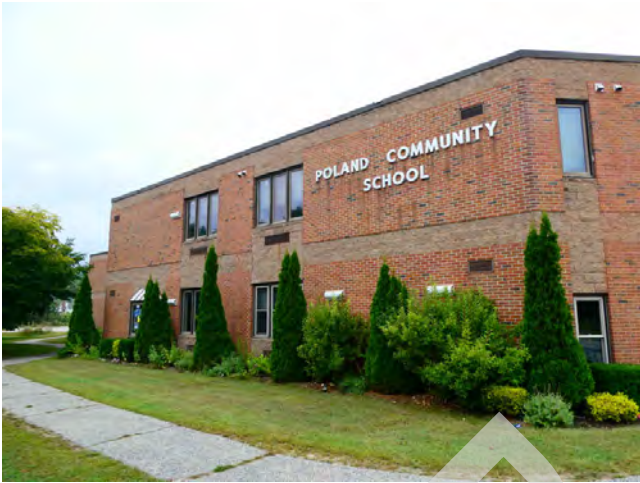
25. Elevations - South facing elevation and property signage

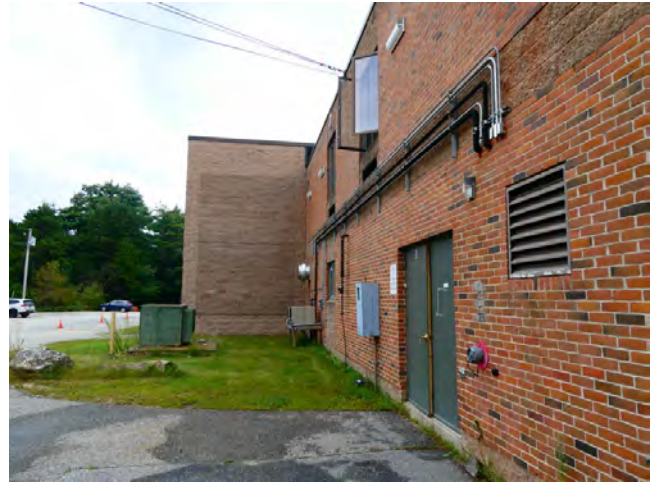
30. Elevations - West facing elevation and service entry

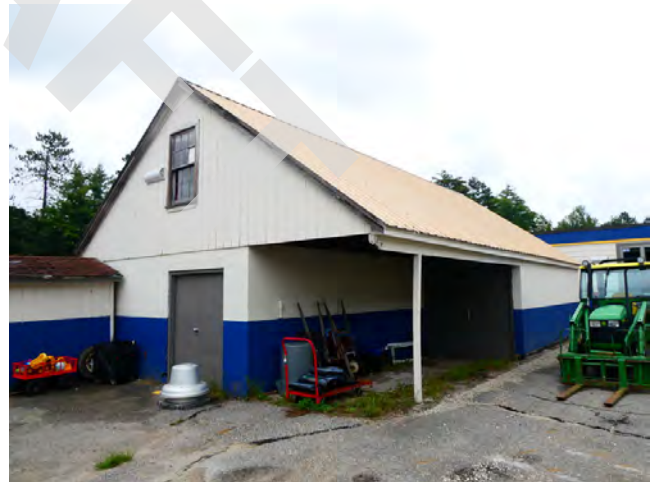
31. Elevations - West facing elevation with split face CMU

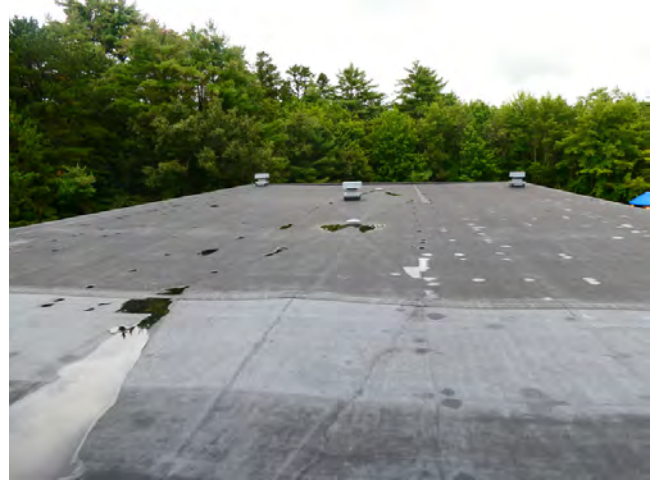
45. Roof - EPDM roof membrane (connecting corridor)

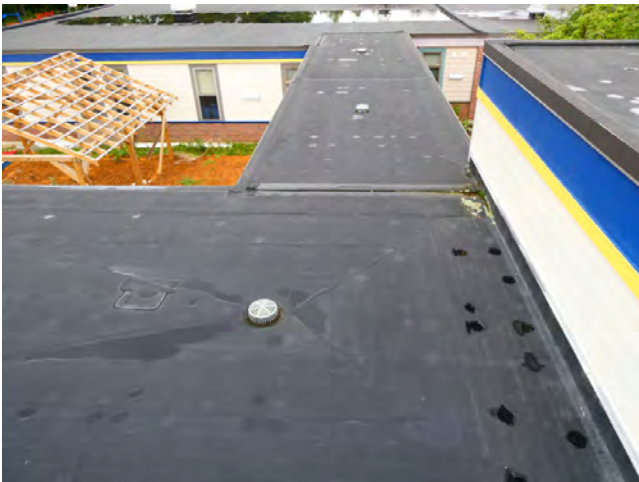
46. Roof - EPDM roof membrane (north facing)

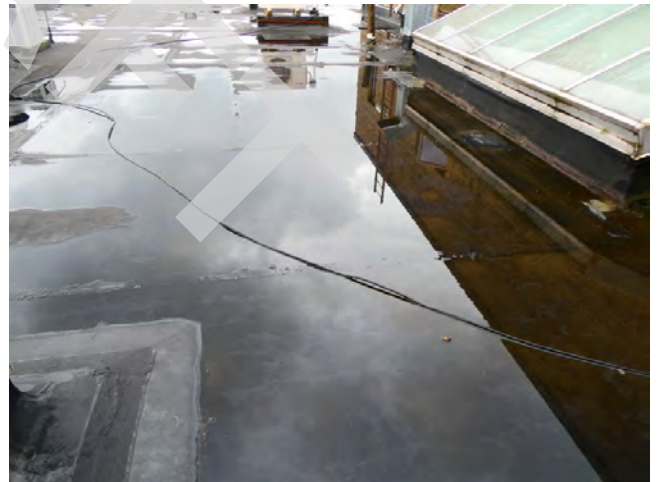
51. Roof - Standing water at central roof surface

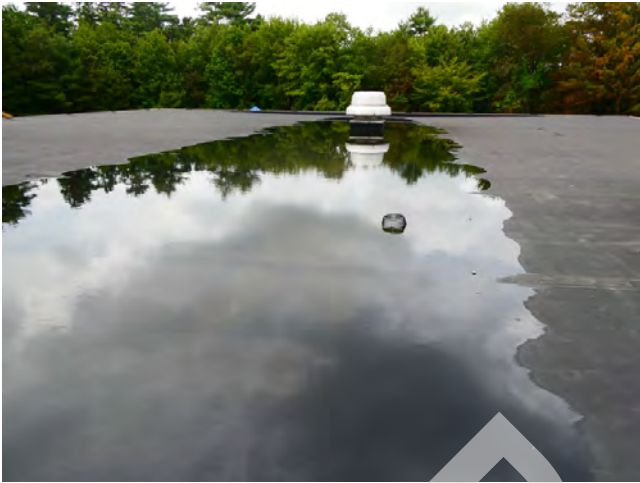
52. Roof - Standing water at central roof surface

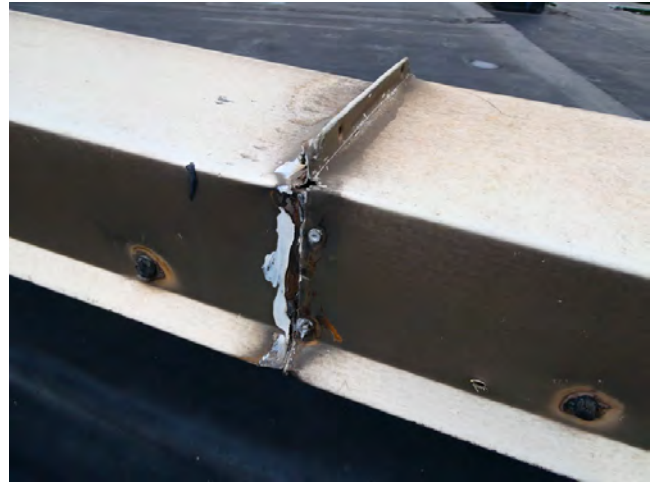
57. Roof - Parapet wall flashing type

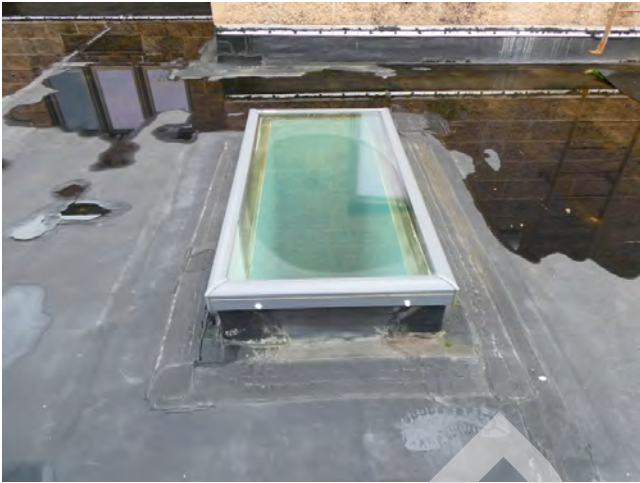
60. Roof - Curb mounted skylight at south roof area

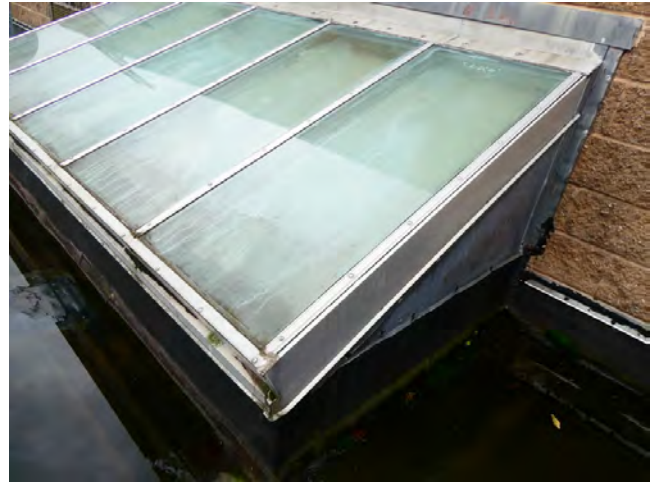
61. Roof - Newer curb mounted skylight

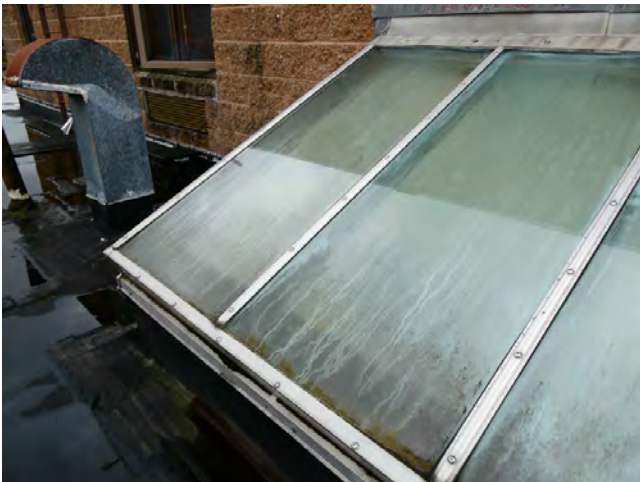
62. Roof - Skylight assembly at south roof area

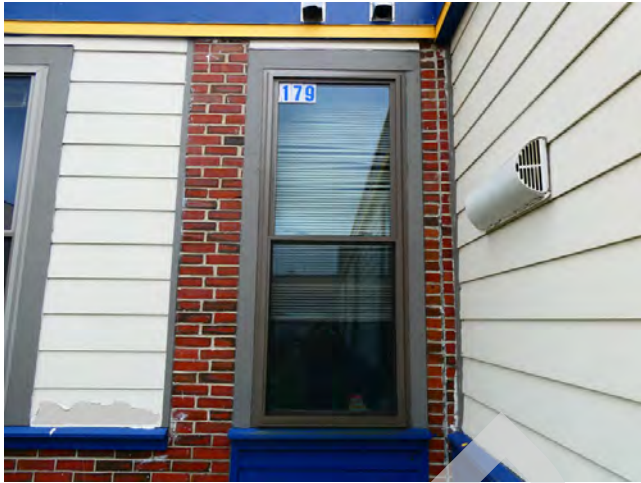
64. Exterior - Aluminum framed casement window type

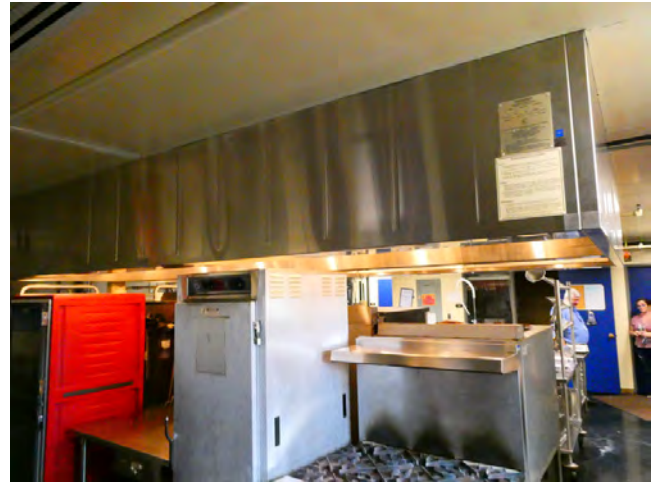
69. Interiors - Commercial kitchen area and equipment

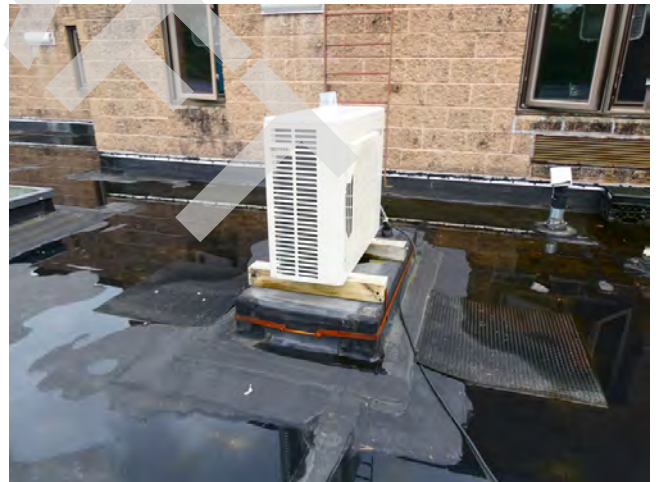
83. MEP - Roof mounted condensing unit

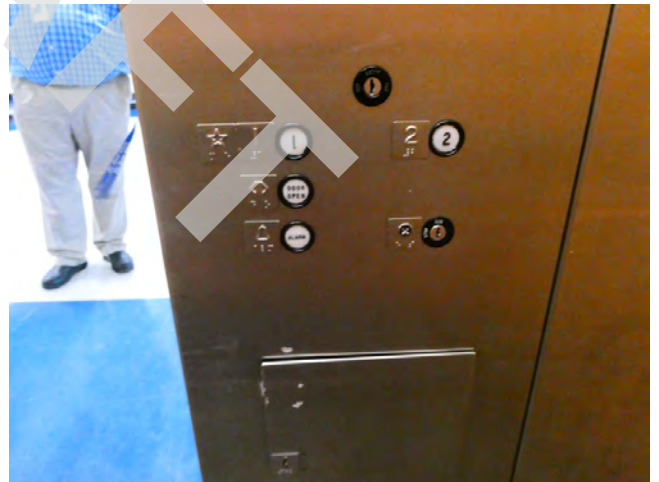
95. Vertical Transportation - Hydraulic elevator at south portion

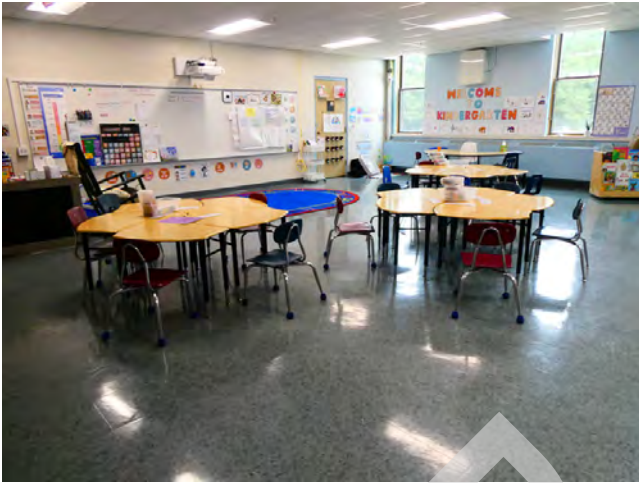
108. Interiors - Classroom interior finishes and furnishings (northwest section)
