Facility Condition Assessment

Poland Community School
1250 Maine Street
Poland, Androscoggin County, Maine 04274

AEI Project No. 482353
Site Assessment Date: September 13, 2023

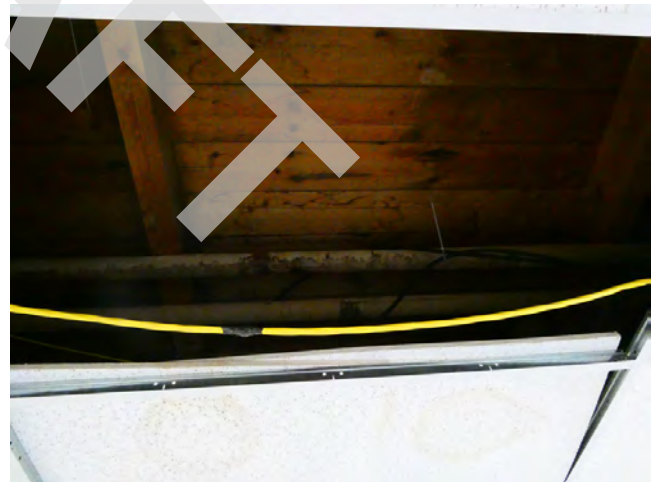
111. Interiors - Classroom interior finishes and furnishings (south section)

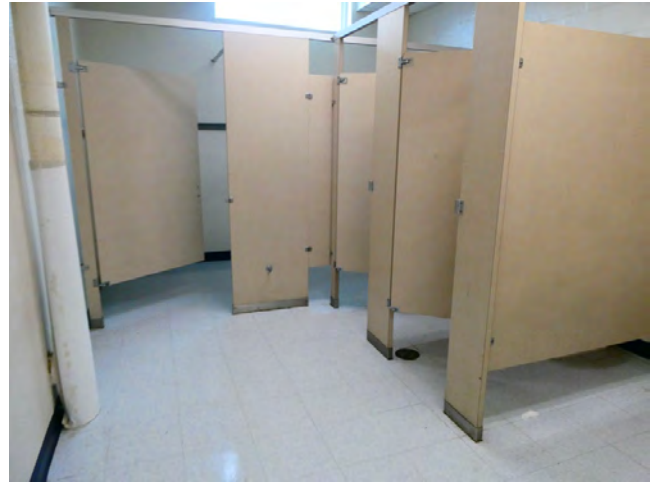
113. Interiors - Employee toilet room finishes

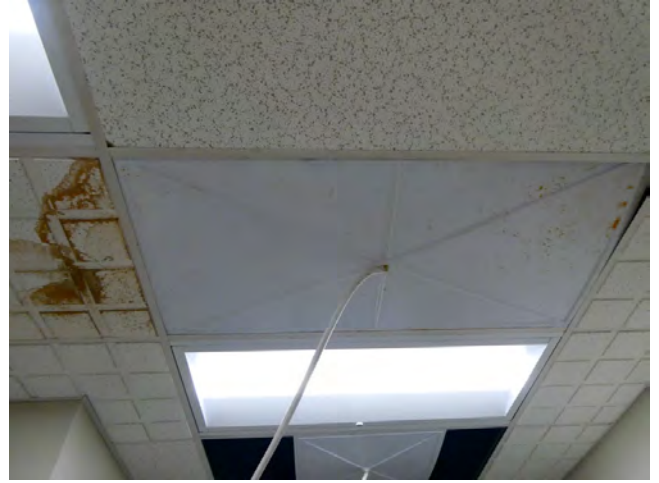
117. Interiors - Teacher breakroom area finishes and furnishings
