Facility Condition Assessment

Minot Consolidated School
23 Shaw Hill Road
Minot, Androscoggin County, Maine 04258

AEI Project No. 482354
Site Assessment Date: September 12, 2023

Subject: Facility Condition Assessment
Minot Consolidated School
23 Shaw Hill Road
Minot, Maine 04258
AEI Project No. 482354

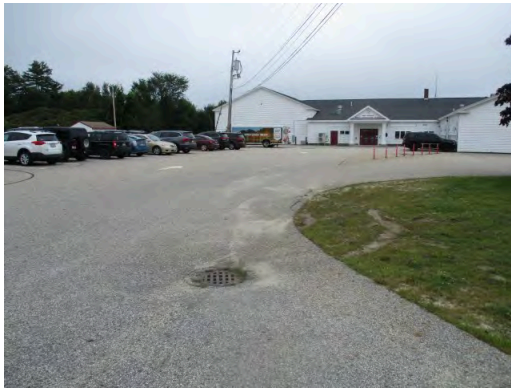
Pavement at east Property entrance from Shaw Hill Road

AEI also recommends periodic crack-filling, seal coating and re-striping of the asphalt paving during the evaluation period. An opinion of cost is included in the Tables.

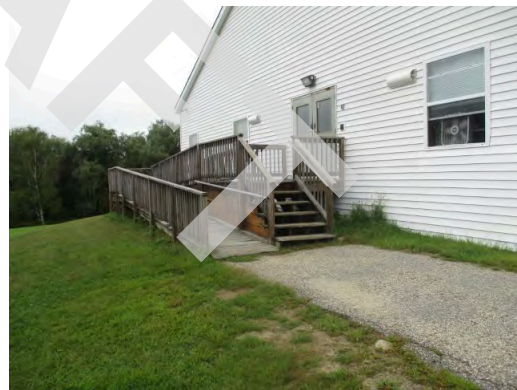
The wooden stairway and ADA ramp at the south entrance to the 1996 addition appears to be reaching end of useful life. The pressure-treated wood utilized in construction exhibits weathering and general deterioration. Further, weathered pressure-treated wood represents a potential health hazard from splinters. AEI recommends the wooden stairway and ADA ramp be replaced. An opinion of cost for this work is included in the Tables.

ADA ramp on south end of 1996 addition

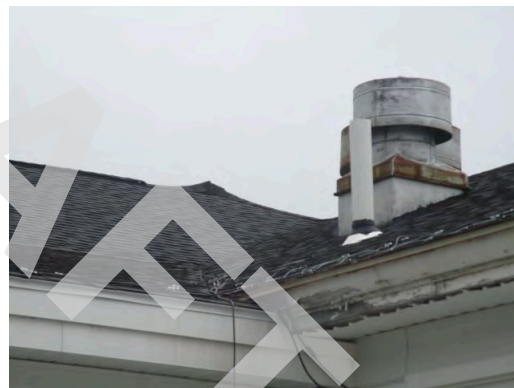
Roofing and heat tape at "problem" area near principal's office

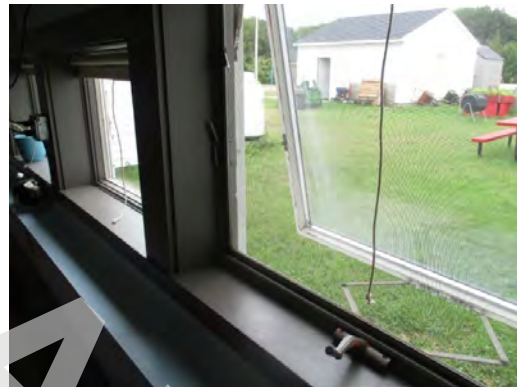
Typical awning-style window

Budgeting for replacement of remaining awning-style windows is recommended. An opinion of cost is included in the Tables.

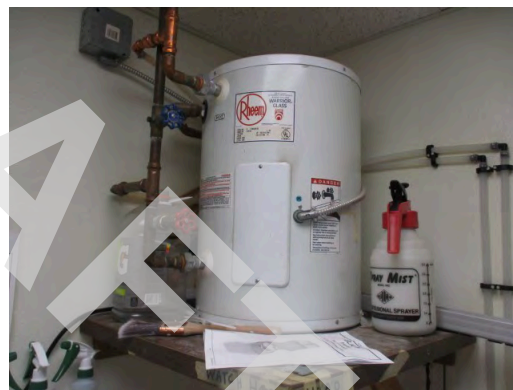
A total of 1 oil-fired and 2 electric water heaters were observed. Condition of the water heaters observed by AEI was good with no significant deficiencies. The temperature and pressure relief valves on units observed appeared properly piped. Based on the effective ages and EULs of existing water heaters, replacement of the heaters during the evaluation period is anticipated; an opinion of cost is included in the Tables.

Water heater in 1996 addition

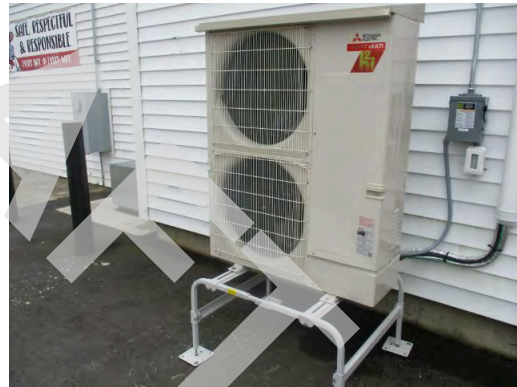
No central cooling is provided to the Subject. Supplemental heating and cooling to select offices and conference rooms is provided via ductless mini split system air conditioners and heat pumps. The split systems varied in age and condition. Based on the EUL of the split systems, replacement during the term is anticipated. An opinion of cost is included in the Tables.

Split system condenser near main entrance

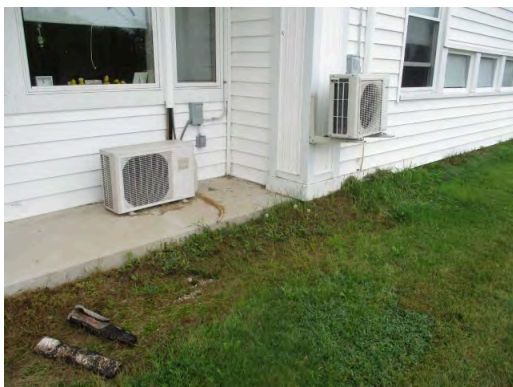
Split system condensing units on west side of building

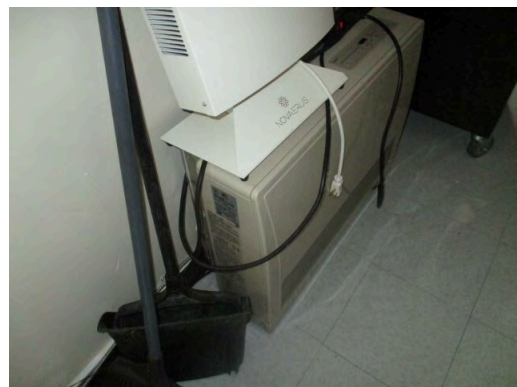
Typical Rinnai heater in classroom 226

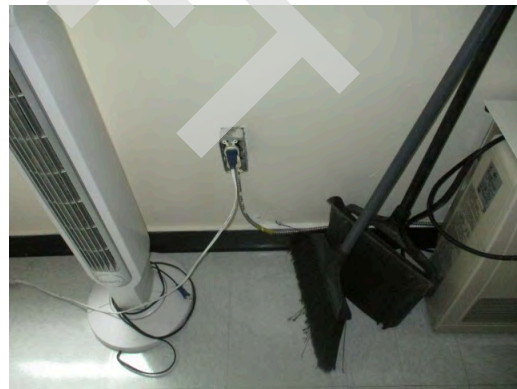
An exposed outlet was observed in Classroom 226. The outlet should be replaced in accordance with electrical code. An allowance for this work is included in the Tables.

Classroom 226 exposed outlet

Cost Recommendation	EUL	EFF AGE	RUL	Year	Cost
Repair Exposed Outlet	-	-	-	Immediate	\$200
Total					\$200

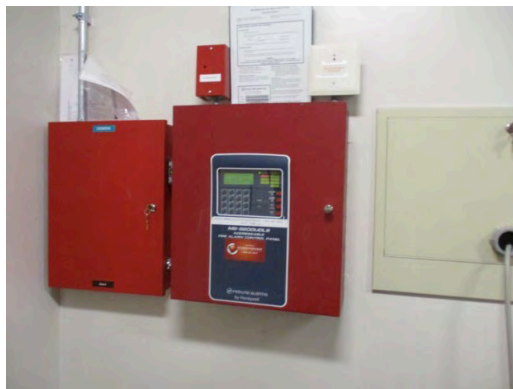
Based on the EUL of fire alarm panels, AEI anticipates that the fire alarm will require replacement during the term. An opinion of cost is included in the Tables.

Fire alarm panel in main office

Cost Recommendation	EUL	EFF AGE	RUL	Year	Cost
Fire Sprinkler System, Inspect	-	-	-	Immediate	\$1,500
Central Fire Alarm Panel. Replace	20	11	9	9	\$12,500
Total					\$14,000

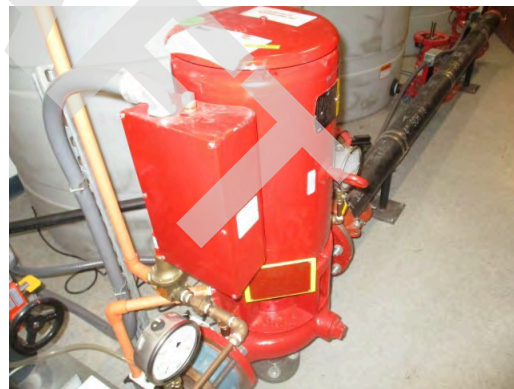
Fire pump in sprinkler room

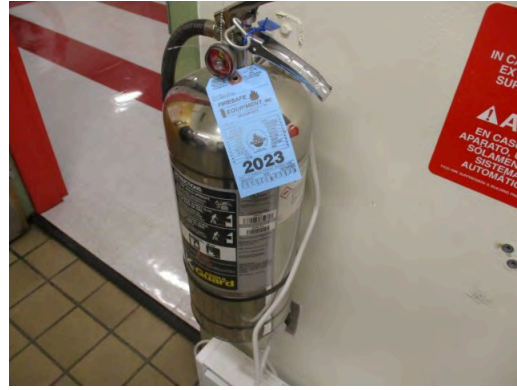
The fire extinguishers were observed to carry current inspection tags (Last inspected June 2023).

Typical fire extinguisher

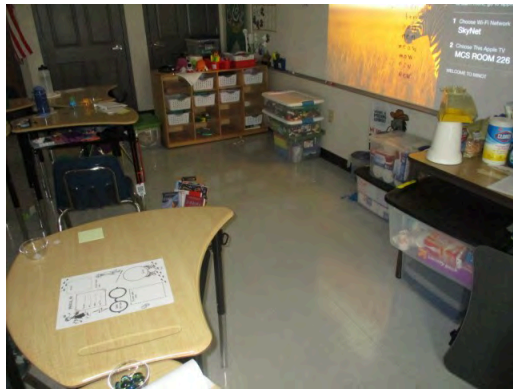
Classroom 226

Overall, the finishes were found to be in good overall condition. Management reported that partial flooring replacements have been completed in the classrooms. Based on the EUL of vinyl flooring finishes, ongoing replacements during the term is recommended. An opinion of cost is included in the Tables.

Cost Recommendation	EUL	EFF AGE	RUL	Year	Cost
Vinyl tile. Replace	20	15	5	5	\$259,532
Carpet, Replace	7	4	3	3	\$750
				10	\$750
Total					\$261,032

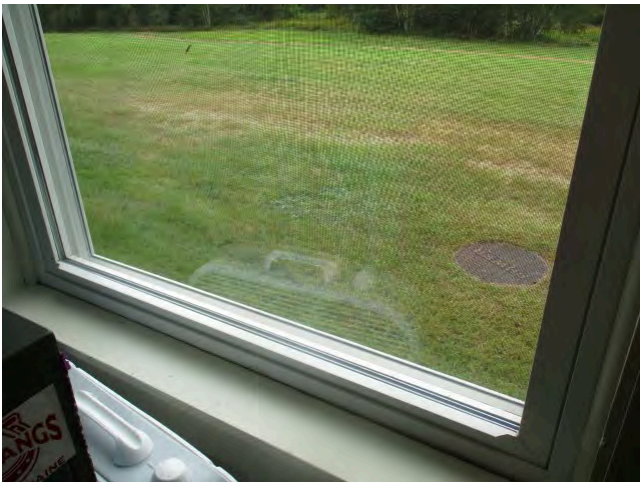
111. Typical windows in classroom 211

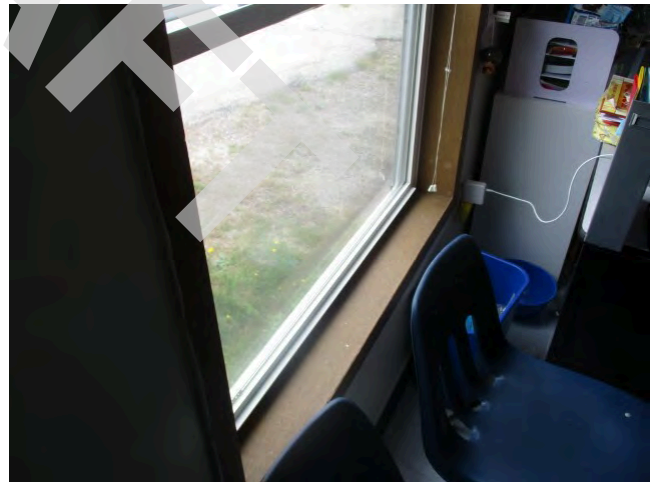
112. Typical windows in classroom 226
