Facility Condition Assessment

Poland Regional High School/Whittier Middle School
1457 Maine Street
Poland, Androscoggin County, Maine 04274

AEI Project No. 482355
Site Assessment Date: September 13, 2023

Subject: Facility Condition Assessment
Poland Regional High School/Whittier Middle School
1457 Maine Street
Poland, Maine 04274
AEI Project No. 482355

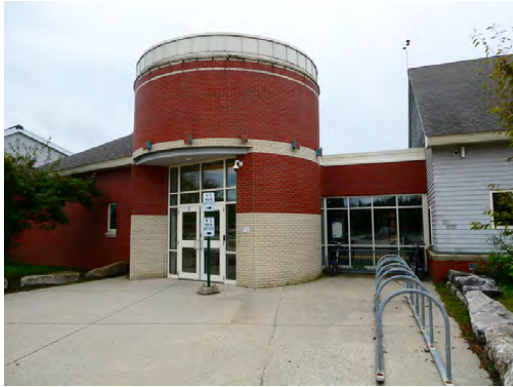
Exterior - Main entry to the middle school

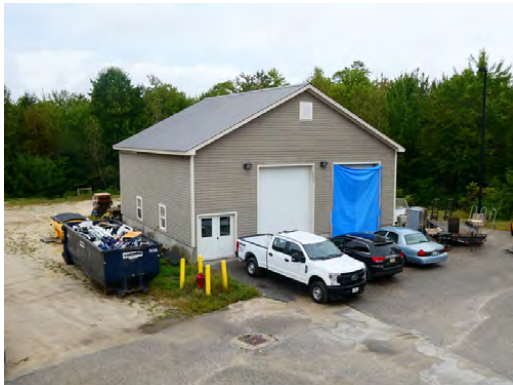
Exterior - Building for the biomass heating system

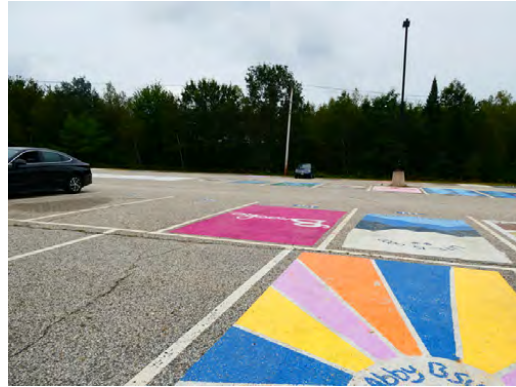
Site - North parking surface condition

Crack sealing, seal coating, and re-striping of all of the asphalt paving is recommended in the short-term as well as periodically during the evaluation period. An opinion of cost for this work is included in the Tables.

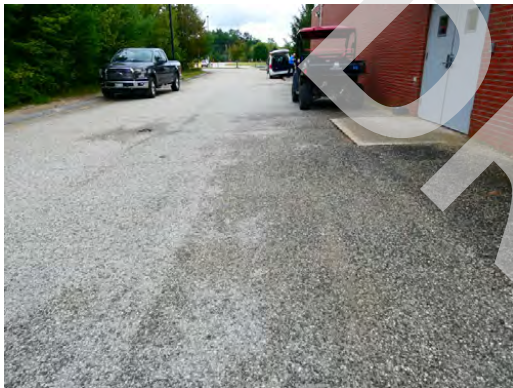
Site - Asphalt paved drives throughout

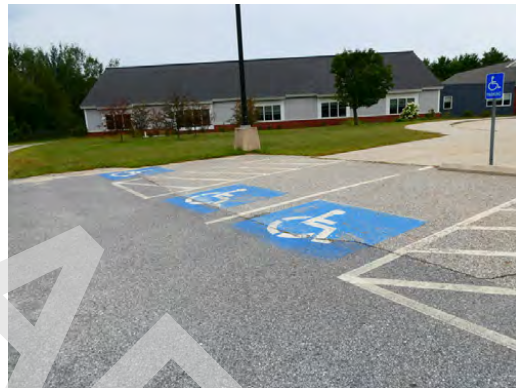
Site - Accessible parking spaces at main parking area

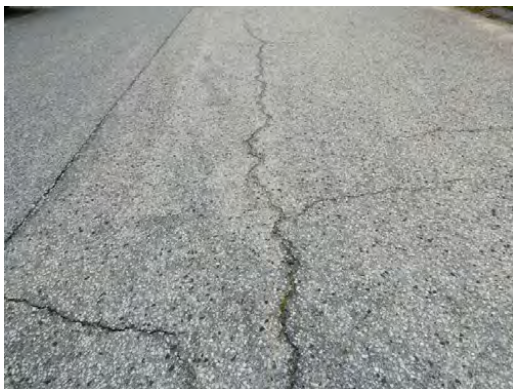
Site - Longitudinal cracking along asphalt pavement

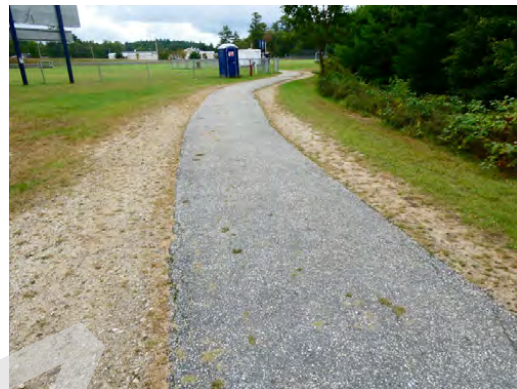
Site - Asphalt paved walkways to sports fields

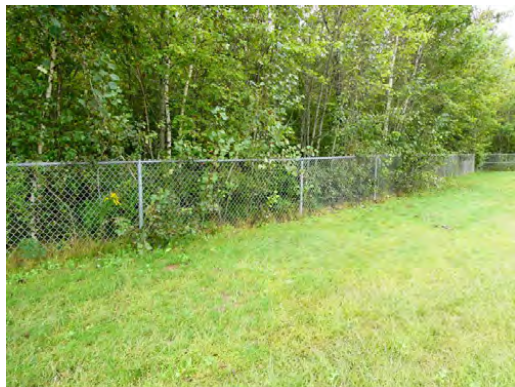
The chain link fencing surrounding the athletic fields was observed to be in generally good condition. Replacement is not anticipated during the term.

Site - Chain link fencing at south perimeter

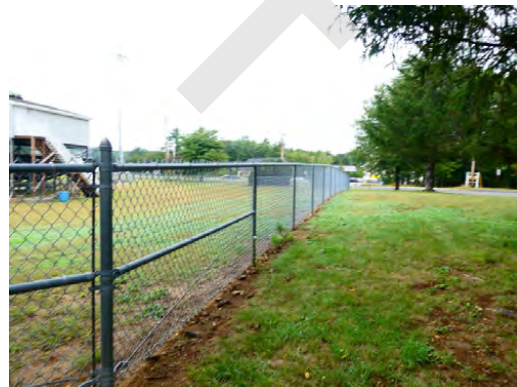
Site - Chain link perimeter fencing along track and football field

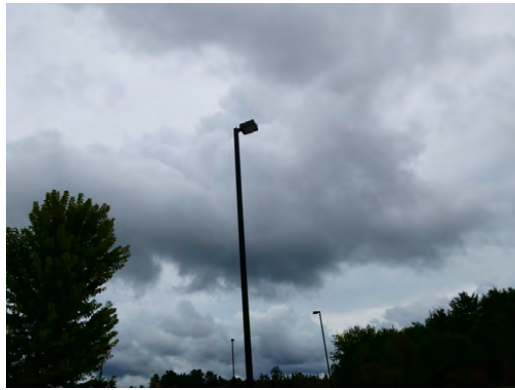
Site - Pole mounted lighting fixtures for parking area

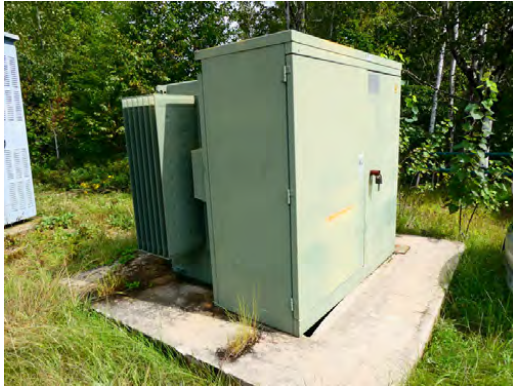
No notable deficiencies or indications of deferred maintenance of utilities were observed or reported. The RULs of these features are expected to exceed the evaluation period.

MEP - Pad mounted electrical transformer

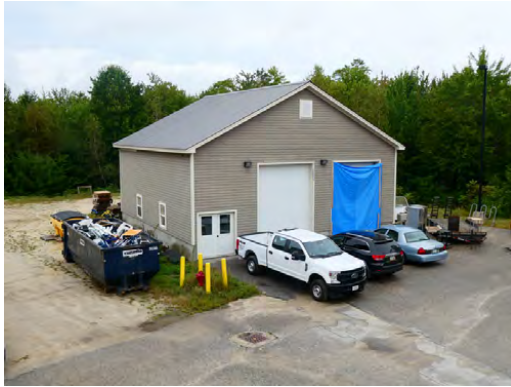
Exterior - Building for the biomass heating system

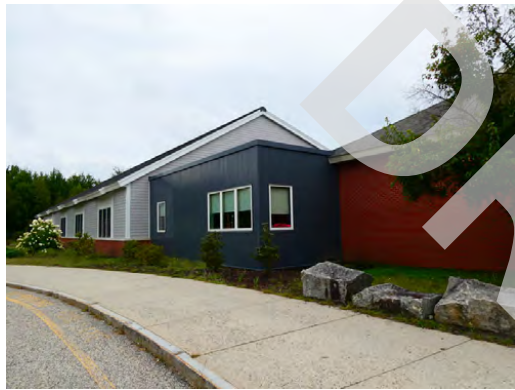
Exterior - Facade finishes for middle school

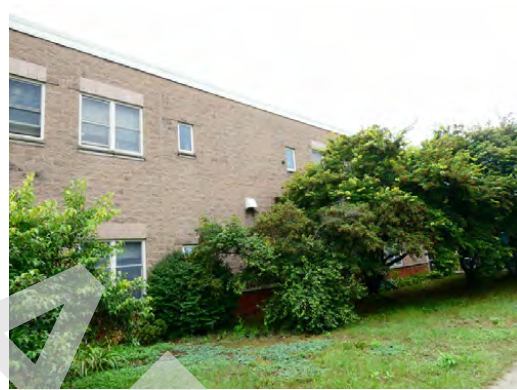
Exterior - Split face CMU facade finishes

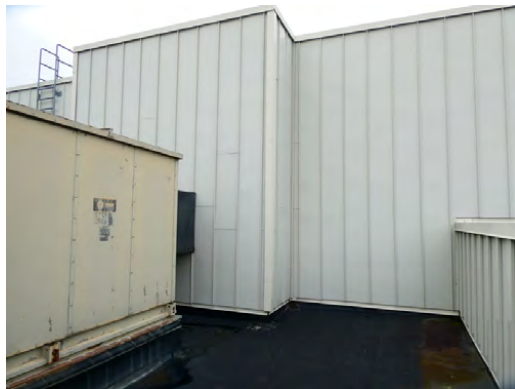
Exterior - Metal panels at south elevation (roofline)

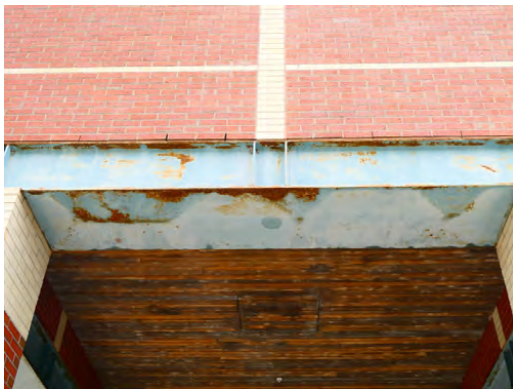
Exterior - Surface corrosion along steel framing for covered entryway

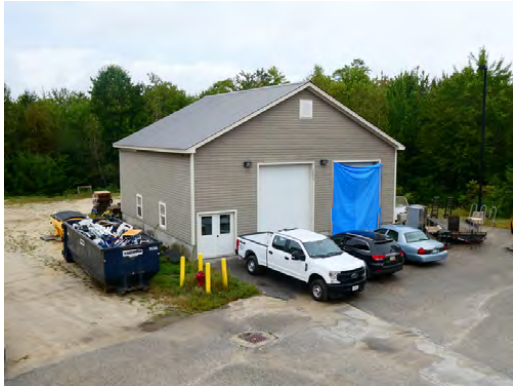
Exterior - Building for the biomass heating system

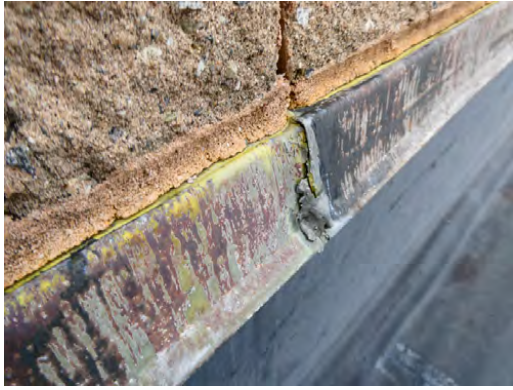
Roof - Deteriorated sealants at parapet flashing (south portion)

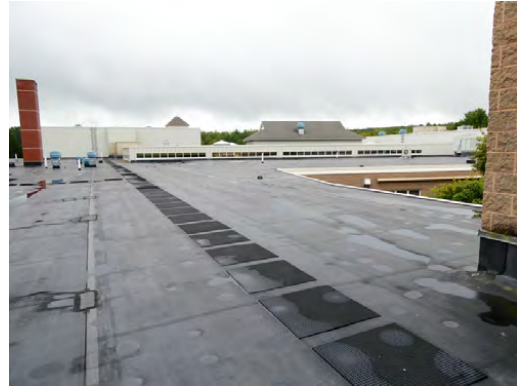
Roof - High school roof area facing east

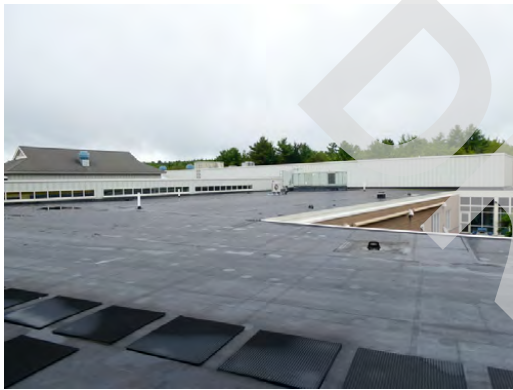
Roof - High school roof area facing south

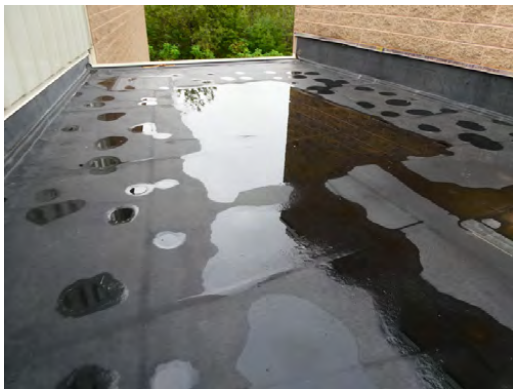
Roof - Isolated ponding water along southwest roof section

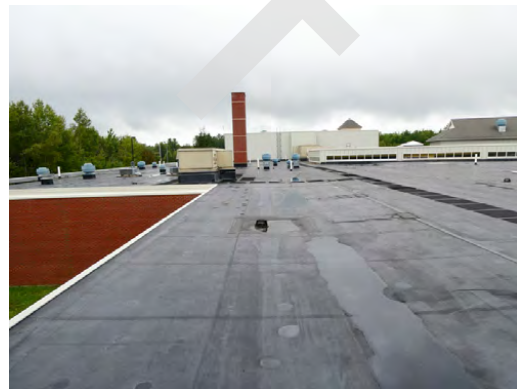
Roof - Mechanically fastened EPDM membrane

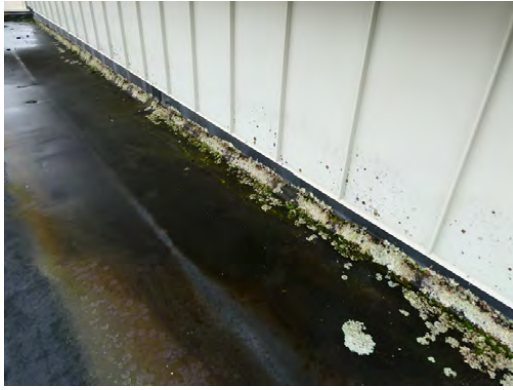
Roof - Organic growth along central roof section

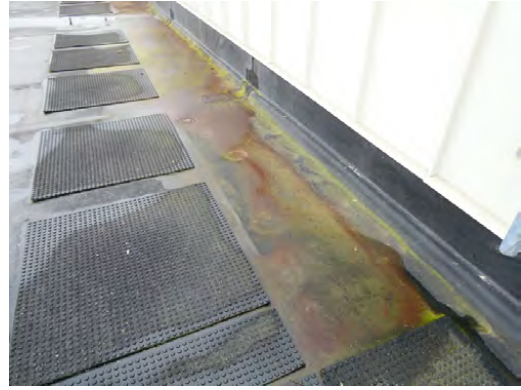
Roof - Organic growth along central roof section

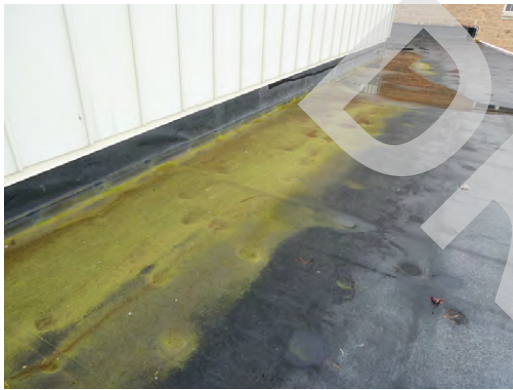
Roof - Organic growth along southwest roof section

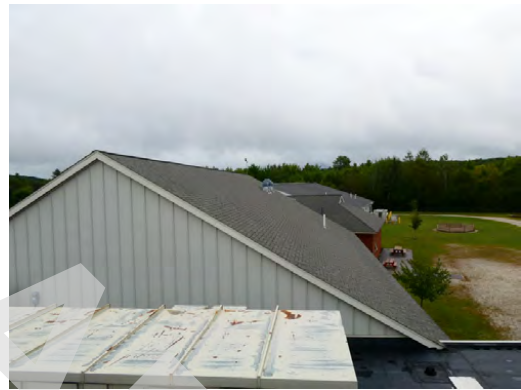
Roof - Overview of the middle school roof area

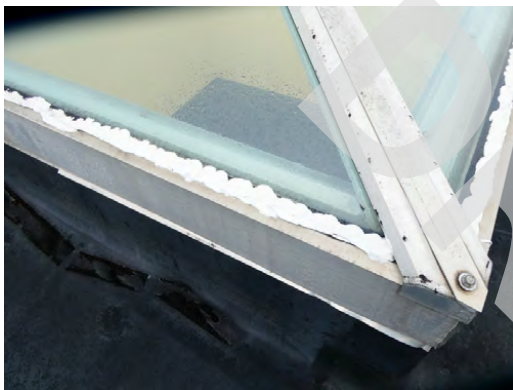
Roof - Skylights at central roof area with sealant replacement

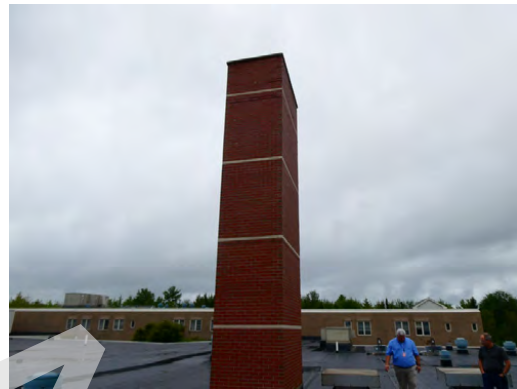
Roof - Brick clad chimney for the boilers

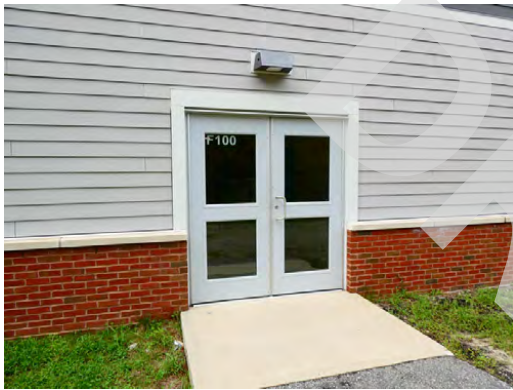
Of note, some of the metal clad service doors were observed to have worn paint finish. AEI recommends that the doors be repainted in conjunction with the exterior painting event. See *Section 3.2.3 Cladding*.

Exterior - Double secondary door type for middle school

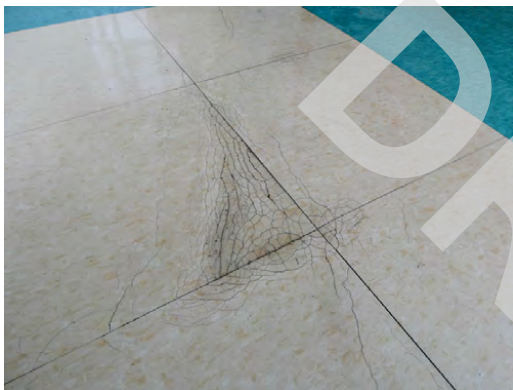
The age of the vinyl and carpeted flooring in the high school common area corridors were reported to be original to construction. Based on the EUL and observed condition of the VCT and carpeted flooring, replacement during the term is recommend.

Interiors - Isolated areas of stress cracking at common area vinyl flooring

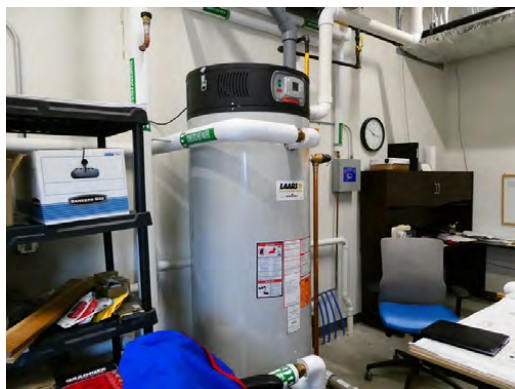
Supplementary domestic hot water for the middle school is provided by one propane gas-fired water heater located in the maintenance office. The water heater is manufactured by Larrrs in 2019 with a 100 gallon capacity. Based on the Expected Useful Life (EUL) of this type of water heater, replacement is not anticipated during the evaluation period.

MEP - Propane sourced domestic water heater for middle school

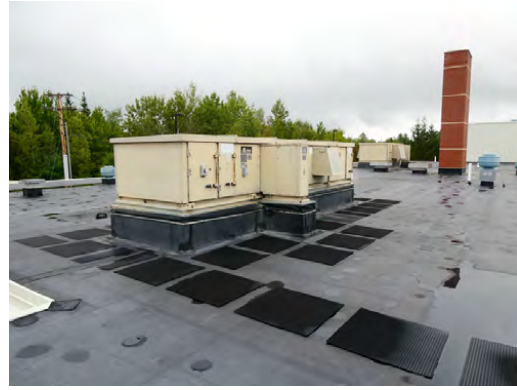
MEP - Packaged roof top unit

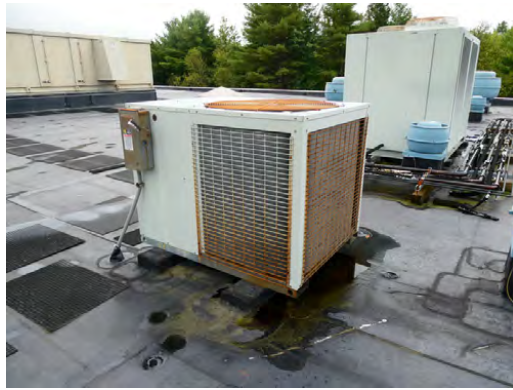
MEP - Roof mounted air recovery unit

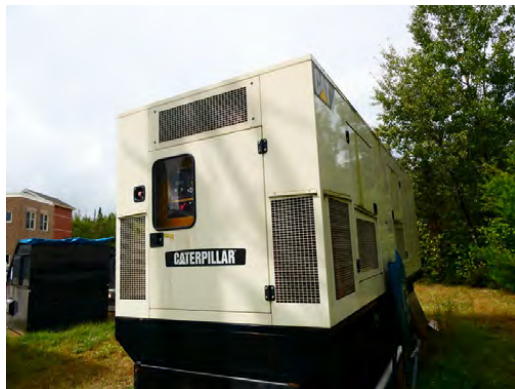
The Subject is provided with a 600kW emergency generator manufactured by Caterpillar. The generator is reportedly 15 years old. The system is provided with a 1,118 gallon day tank and diesel fueled. When in use the generator operates the fire life safety systems and emergency lighting. The system is run tested weekly, and full load tested quarterly. The generator transfer switch is located in the main electrical room. Based on the age of the unit and EUL for generators of this type, AEI does not anticipate replacement during the term. Continued servicing and component replacement are recommended at this time.

MEP - Emergency electrical generator

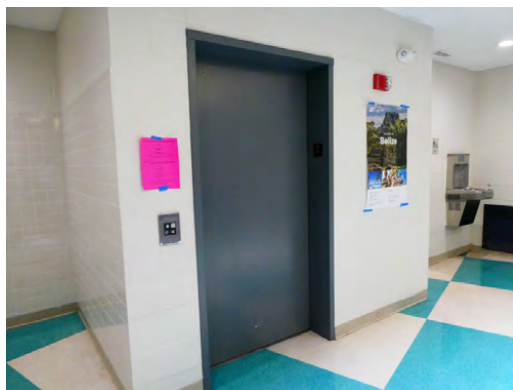
The Subject is provided with one hydraulic passenger elevator that serves the high school area only. The age of the elevator is approximately 24 years. The elevator inspection information was observed to be current.

Based on the observed condition and age of the equipment, it is expected that modernization of the elevators will be necessary during the evaluation term. An opinion of cost for this work is included in the Tables.

Vertical Transportation - Elevator for the high school area

Cost Recommendation	EUL	EFF AGE	RUL	Year	Cost
Hydraulic Elevator, Modernize machinery, controllers, and finishes	30	24	6	6	\$40,000
Total					\$40,000

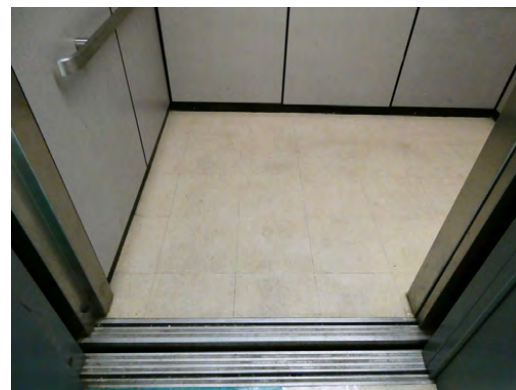
The cab finishes were observed to be in generally good condition. Refurbishment of the cab interior finishes is recommended. An opinion of cost for this work is included in the Tables.

Vertical Transportation - Elevator finishes

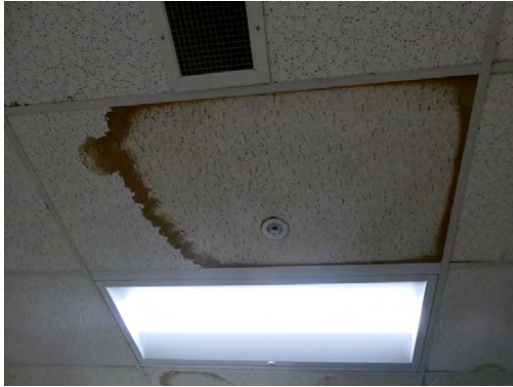
Interiors - Moisture damaged ceiling panel from prior leak

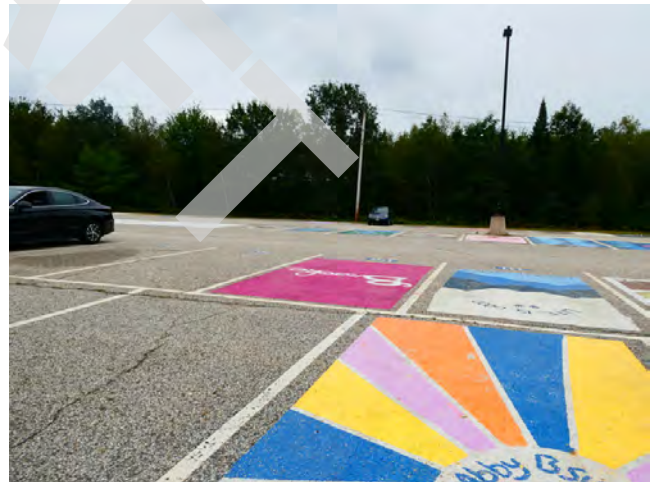
4. Site - North parking surface condition

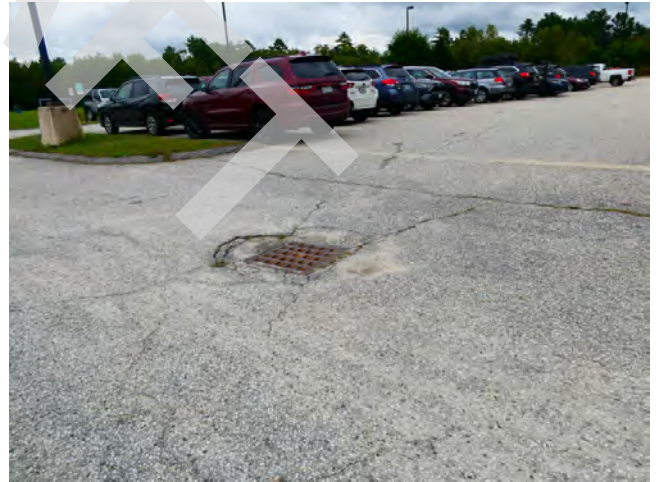
9. Site - Asphalt pavement condition at north parking area

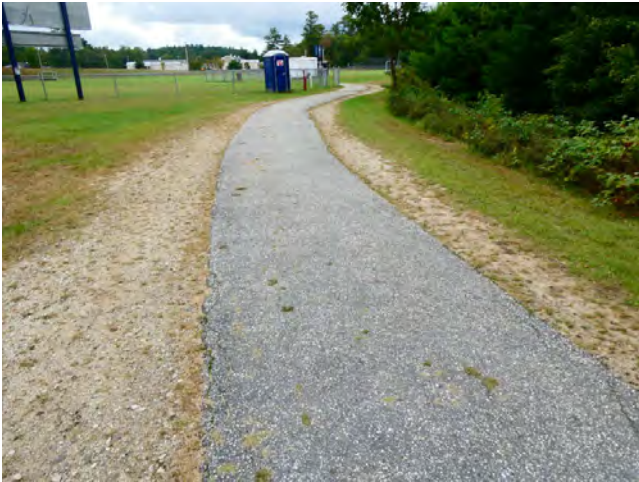
11. Site - Asphalt paved walkways to sports fields

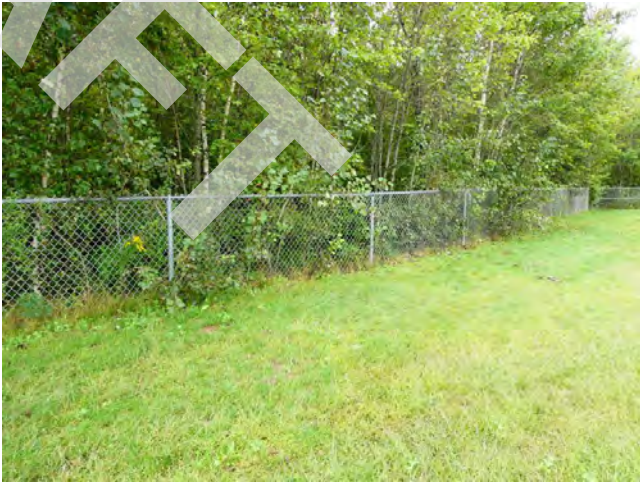
12. Site - Chain link fencing at south perimeter

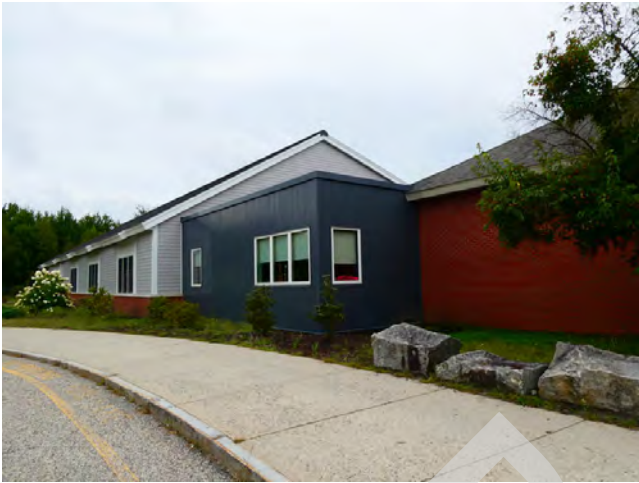
40. Exterior - Deteriorated stain finish at wood siding

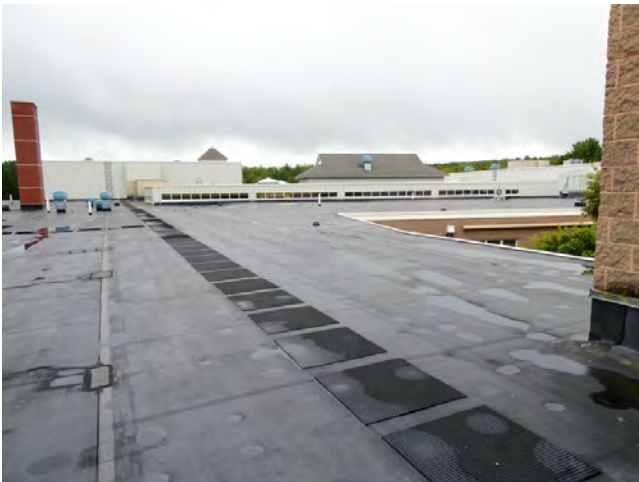
58. Roof - Deteriorated sealants at parapet flashing (south portion)

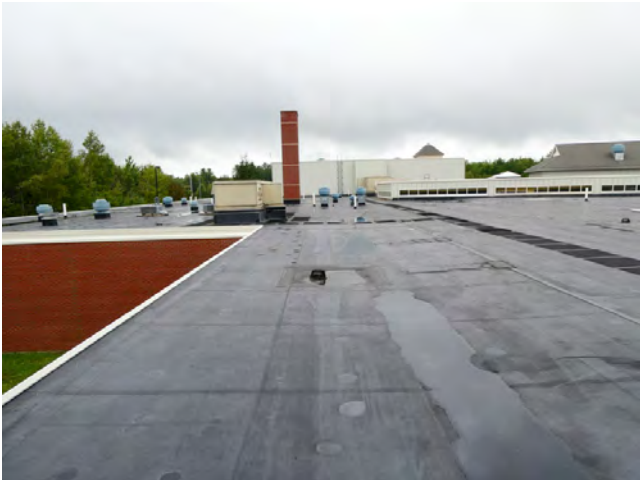
62. Roof - Isolated ponding water along southwest roof section

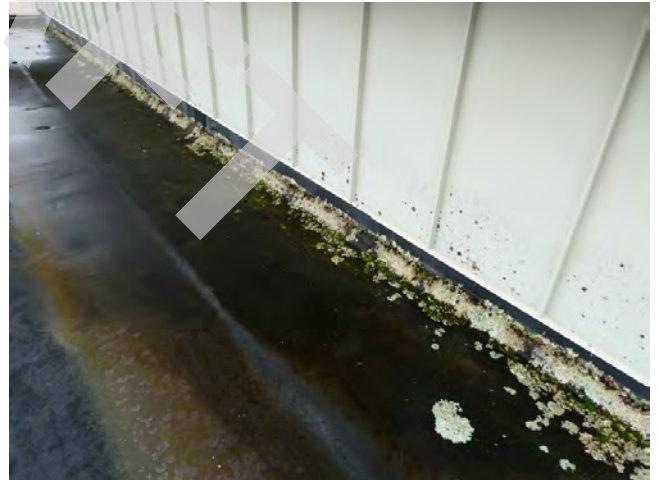
63. Roof - Mechanically fastened EPDM membrane

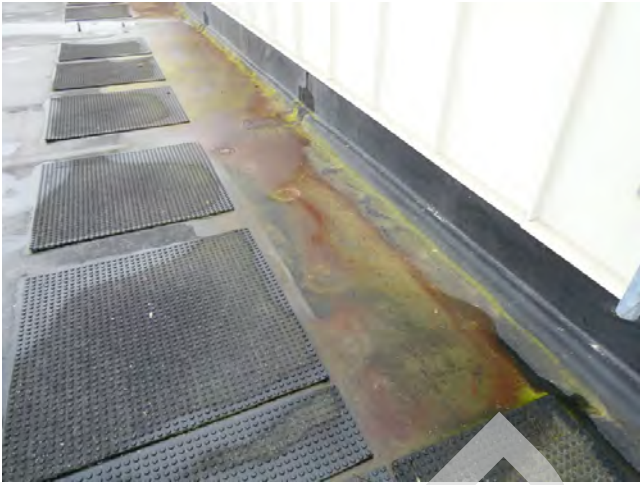
64. Roof - Organic growth along central roof section

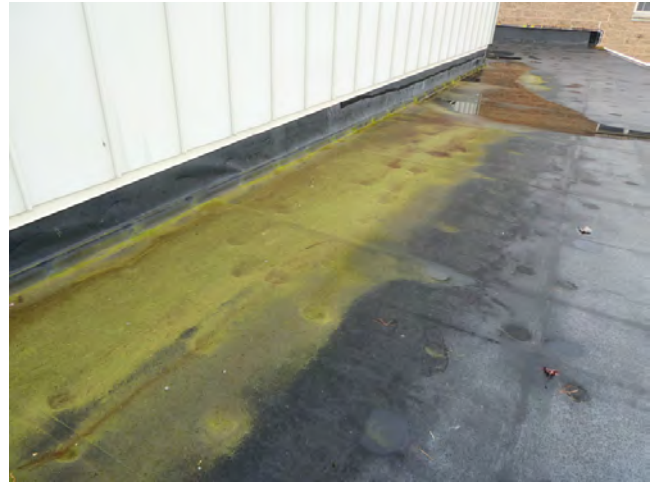
65. Roof - Organic growth along central roof section

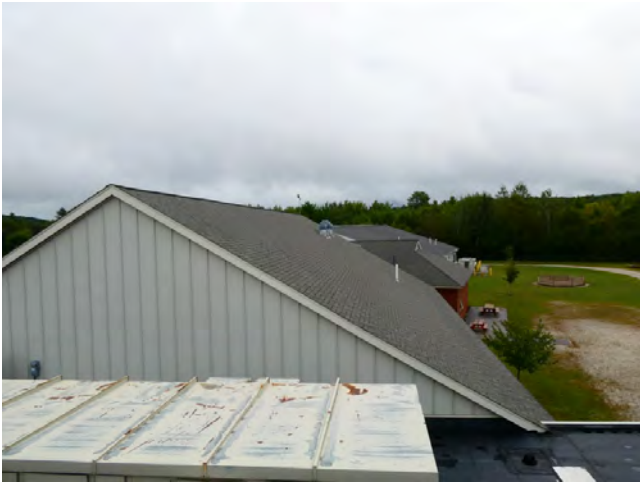
66. Roof - Organic growth along southwest roof section

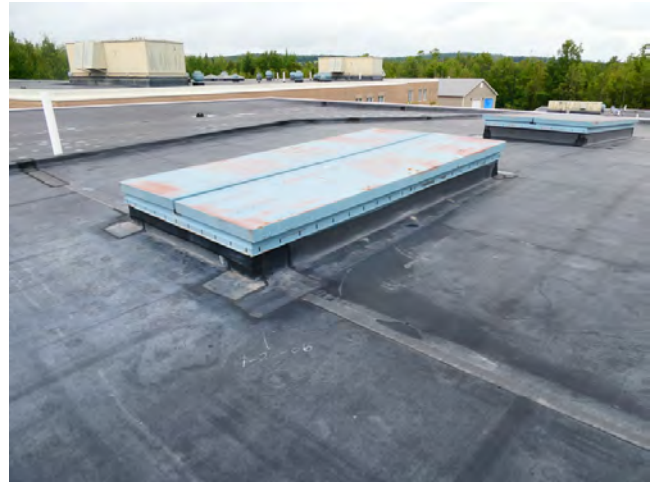
72. Roof - Skylights at central roof area with sealant replacement

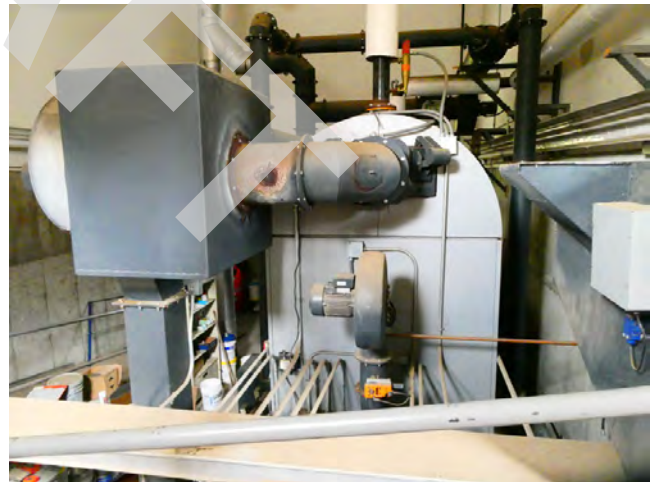
111. MEP - One of two low pressure boilers for heating

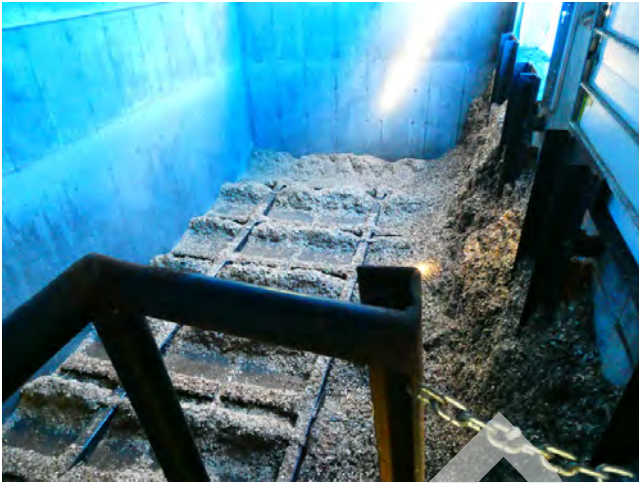
112. MEP - Biomass heating system

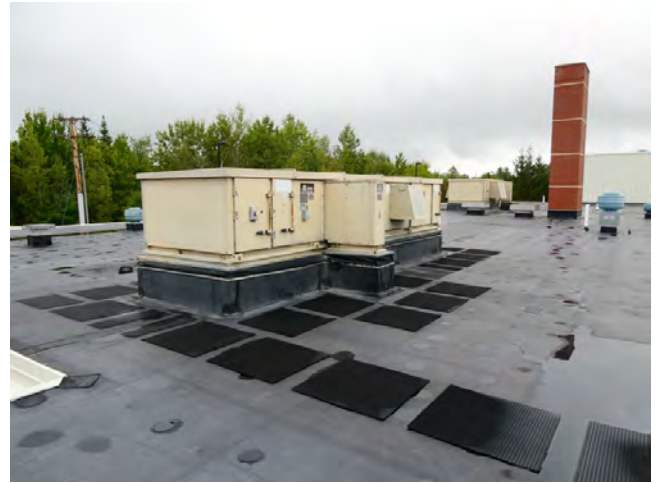
117. MEP - Kitchen refrigeration condensers

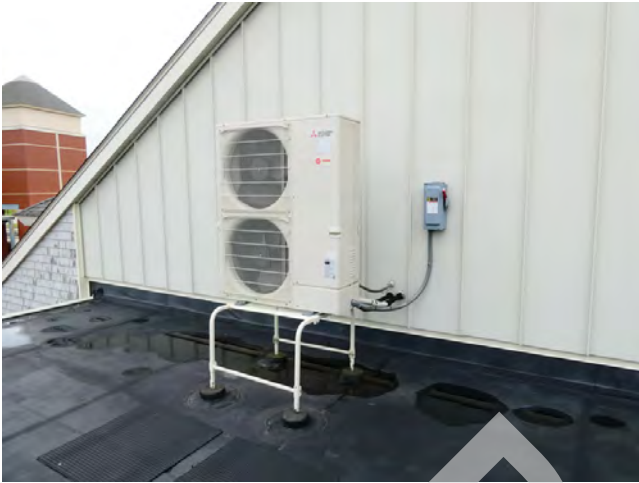
120. MEP - Older roof mounted heat pump for ductless system

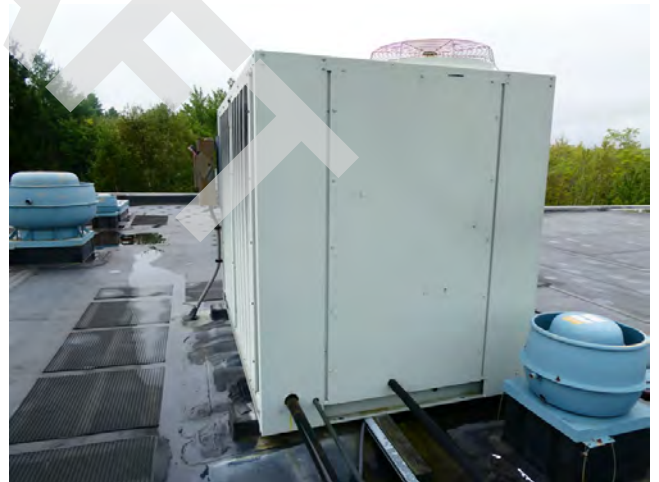
123. MEP - Older roof mounted air cooled condenser

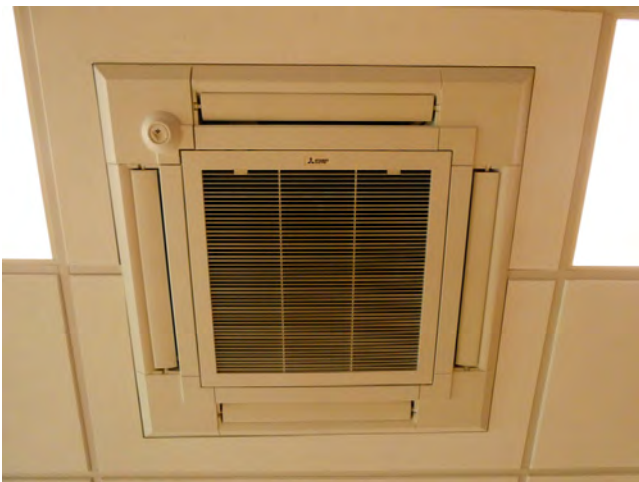
126. MEP - VRF heat pumps for the middle school

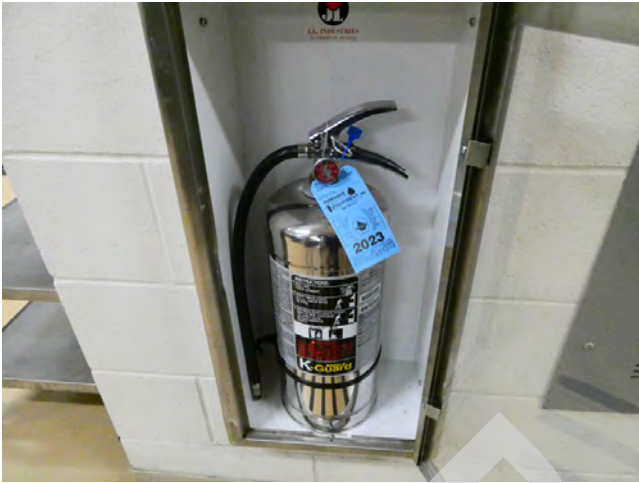
144. FLS - Cabinet mounted fire extinguishers in common areas

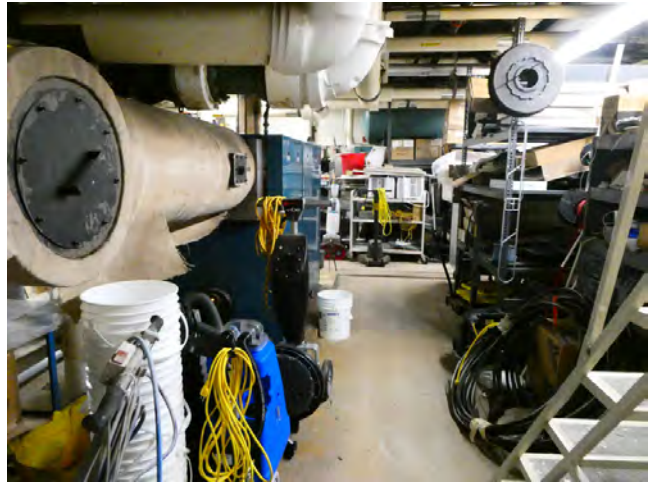
150. Interiors - Main boiler room and equipment

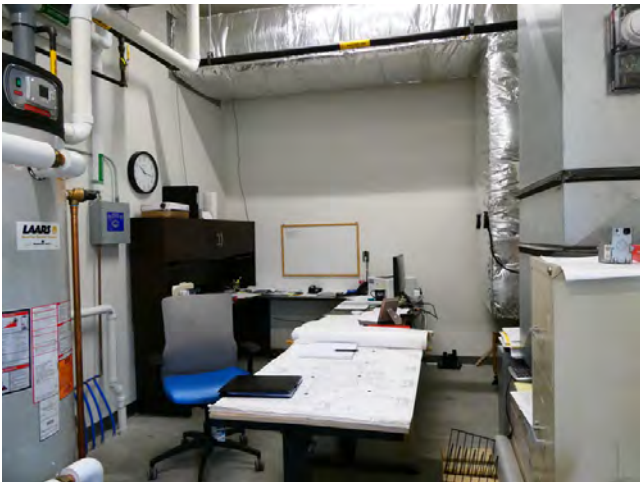
151. Interiors - Maintenance office finishes
