Facility Condition Assessment

Poland Community School
1250 Maine Street
Poland, Androscoggin County, Maine 04274

AEI Project No. 482353
Site Assessment Date: September 13, 2023

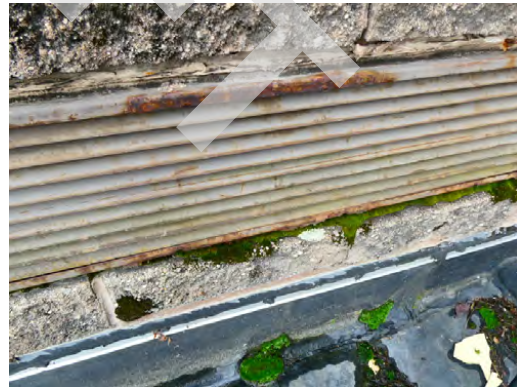
Roof - Isolated sections with organic growth present

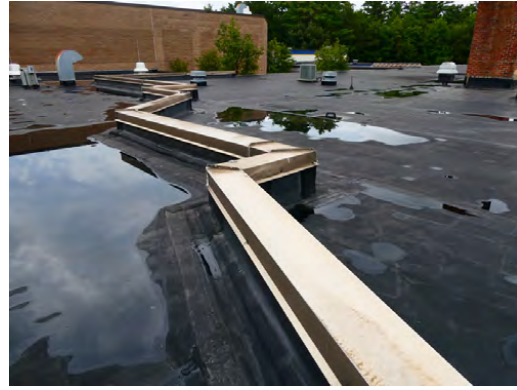
Roof - Parapet wall flashing type

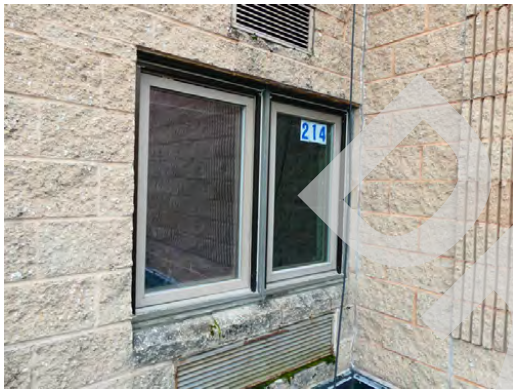
The age of the casement windows was not reported, but they appear to be original to 1982 renovation. Windows of this type have a useful life of 30 to 40 years depending on quality of material and manufacture, installation, weathering, usage, and maintenance practices. Based on the age of the casement windows, AEI recommends budgeting for replacement over the term. An opinion of cost for this work is included in the Tables.

Exterior - Aluminum framed casement window type

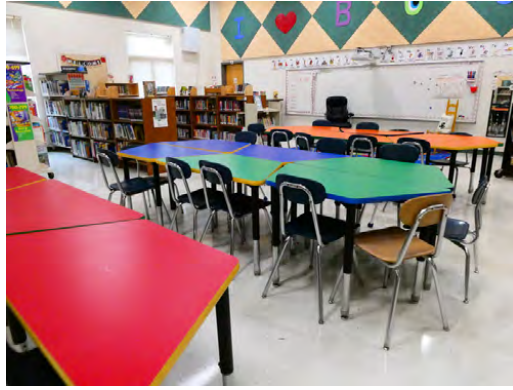
The library is provided with VCT flooring and various fixed and non-fixed FF&E. Based on the EUL of VCT flooring, replacement during the evaluation period is anticipated. An opinion of cost is included in the Tables. See *Section 3.2.8 Common Area Finishes* for cost reference.

Interiors - Library area finishes and fixtures

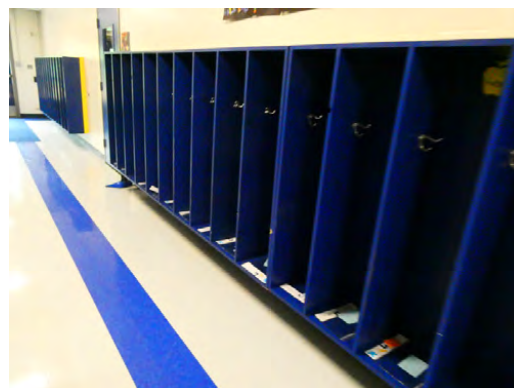
Interiors - Open locker type in common corridors

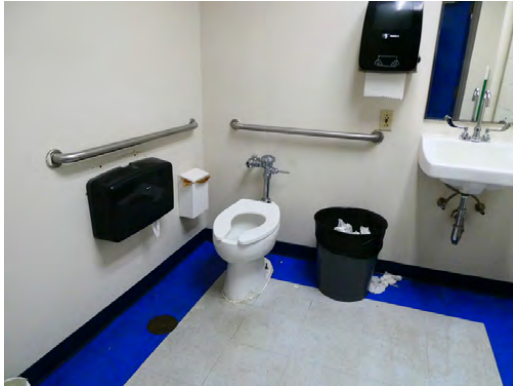
Interiors - Single use toilet room finishes and fixtures

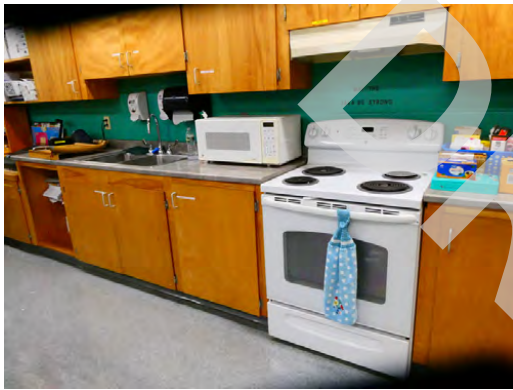
The breakroom cabinetry and countertops are likely older, but are generally in good condition, though dated. The cabinetry is stained solid wood, and durable in nature. With routine maintenance and component replacements, significant replacement is not anticipated during the term. AEI recommends budgeting for replacement of the appliances over the term and an allowance is included in the Tables.

Interiors - Teacher breakroom area finishes and appliances

Interiors - Teacher breakroom area finishes and furnishings

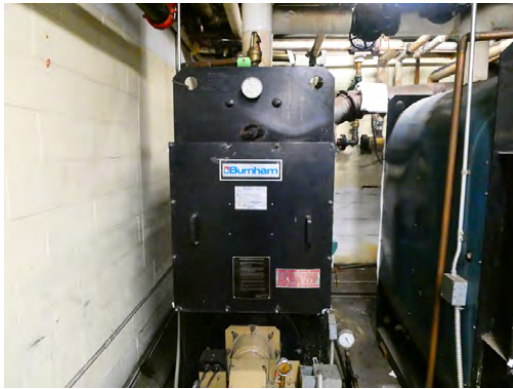
MEP - One of two low pressure boilers for heating

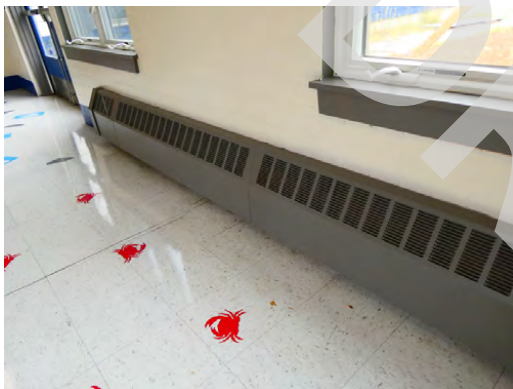
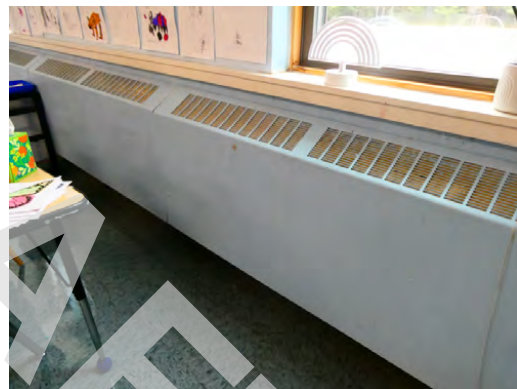
MEP - Wall mounted forced air cabinet unit type

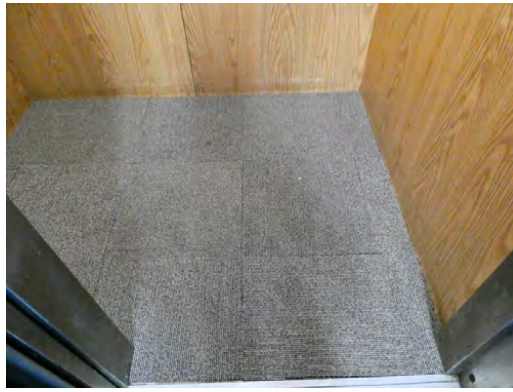
The cab finishes were observed to be in good to fair condition. Refurbishment of the cab interior finishes is recommended in the short-term. An opinion of cost for this work is included in the Tables.

Vertical Transportation - Elevator interior finishes

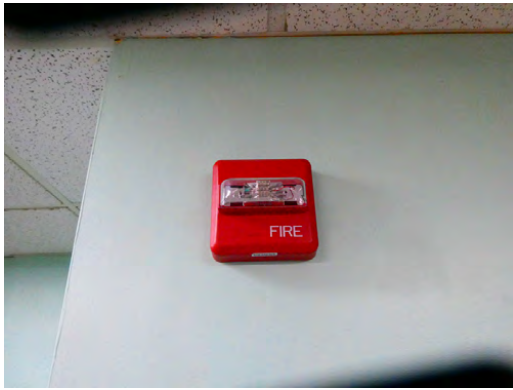
FLS - Emergency strobe light fixture

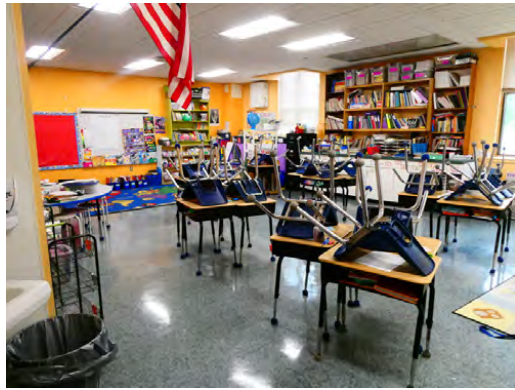
Interiors - Classroom interior finishes and furnishings (south section)

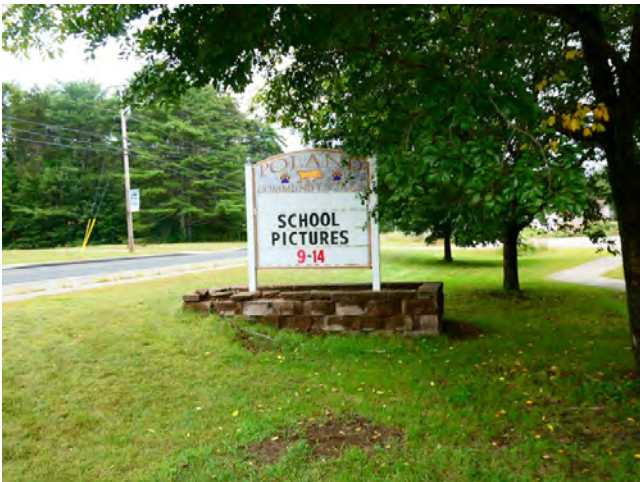
15. Site - Property signage at south perimeter

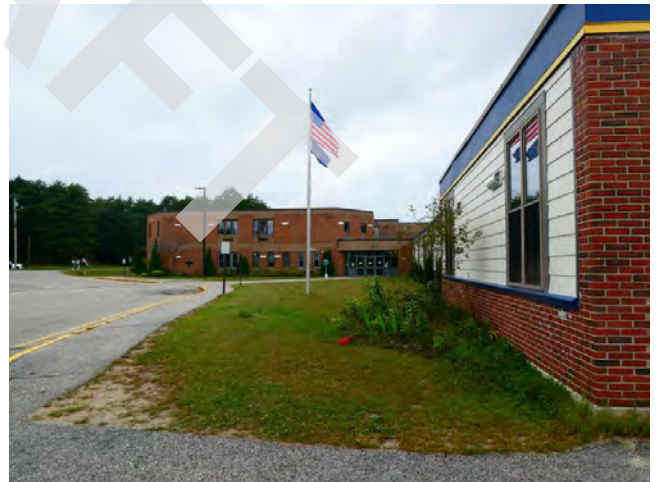
16. Site - Perimeter landscaping

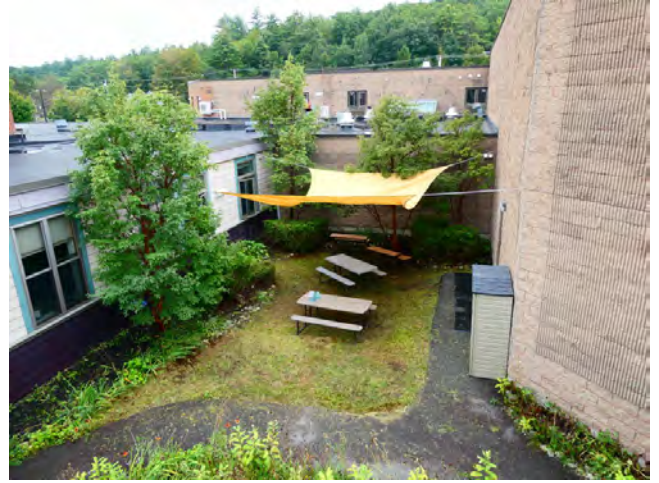
18. Site - Central courtyard area

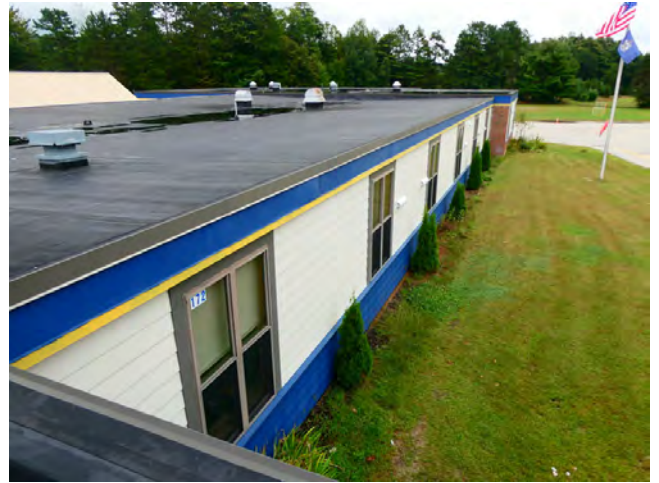
26. Elevations - Southeast facing elevation

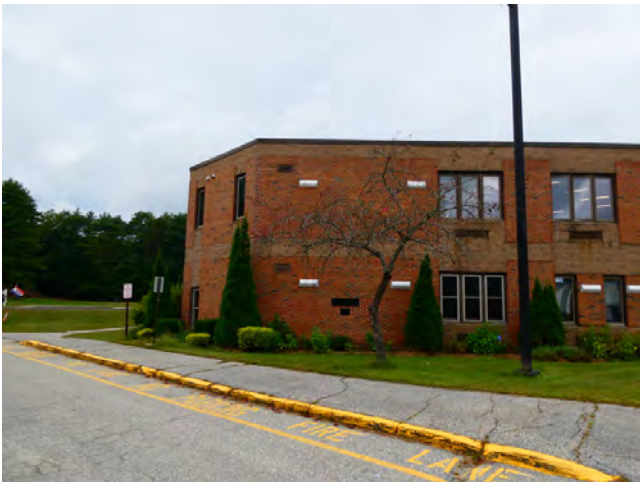
27. Elevations - Southeast facing elevation

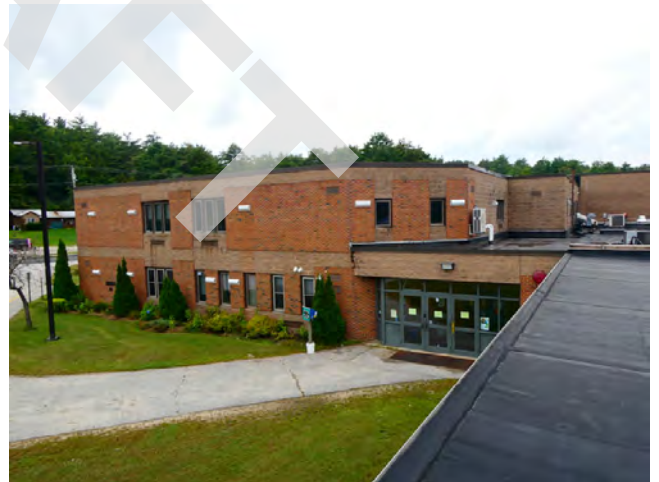
28. Elevations - Southwest facing elevation

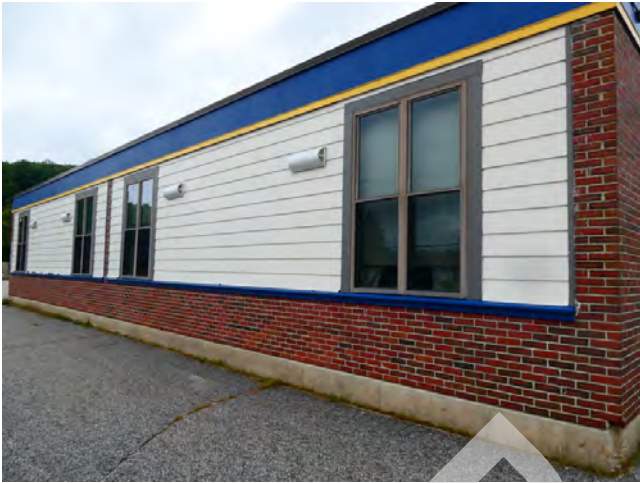
29. Elevations - West facing elevation

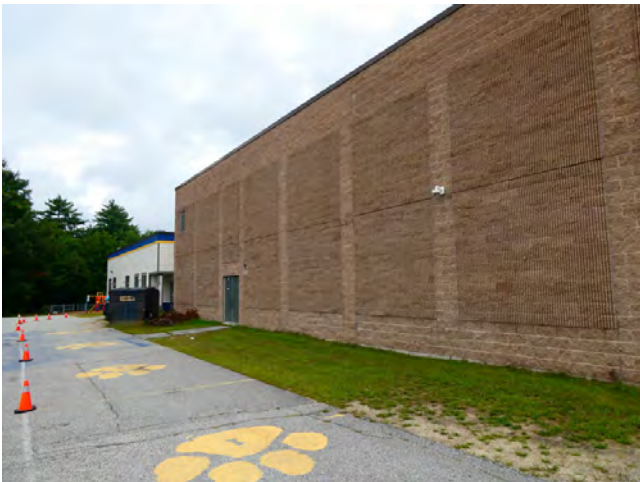
31. Elevations - West facing elevation with split face CMU

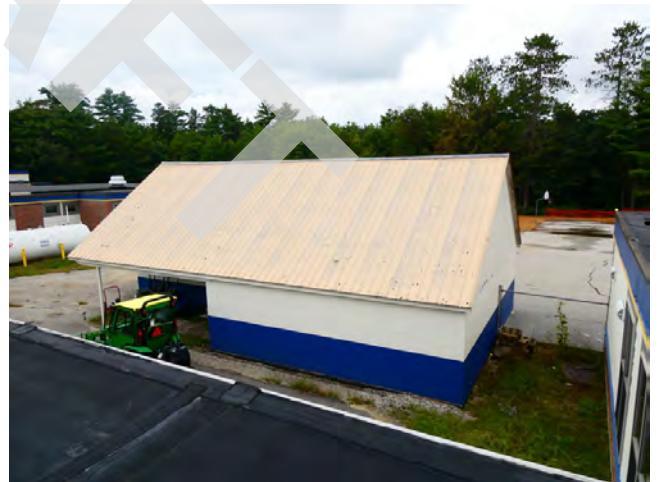
47. Roof - EPDM roof membrane (east facing)

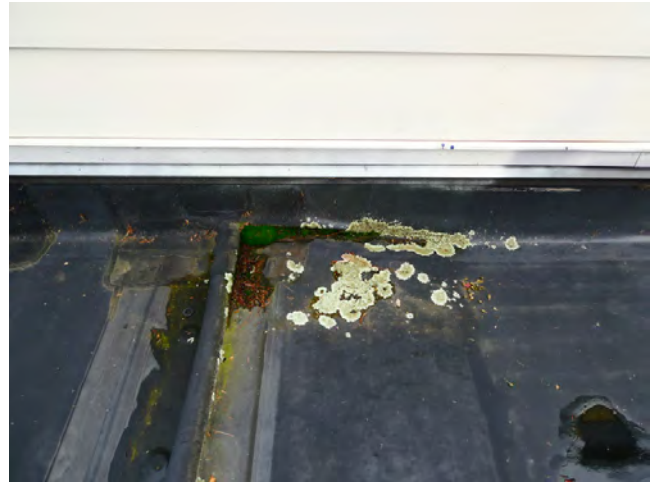
53. Roof - Standing water at northeast roof surface

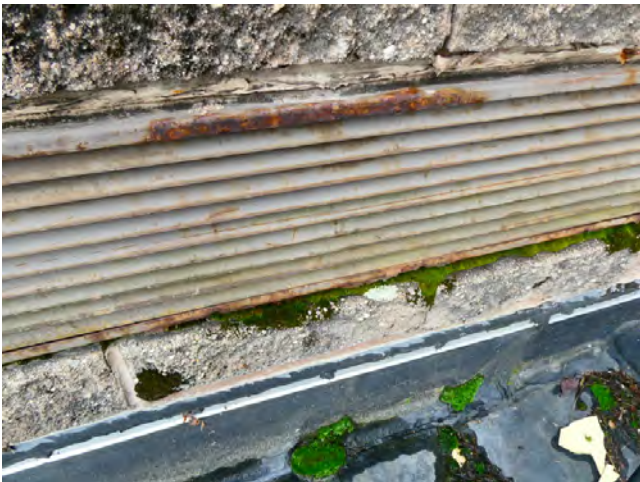
54. Roof - Isolated sections with organic growth present

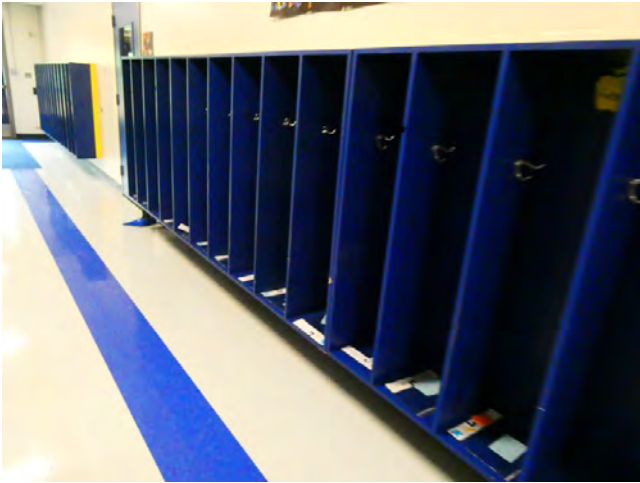
73. Interiors - Newer VCT flooring in common corridor

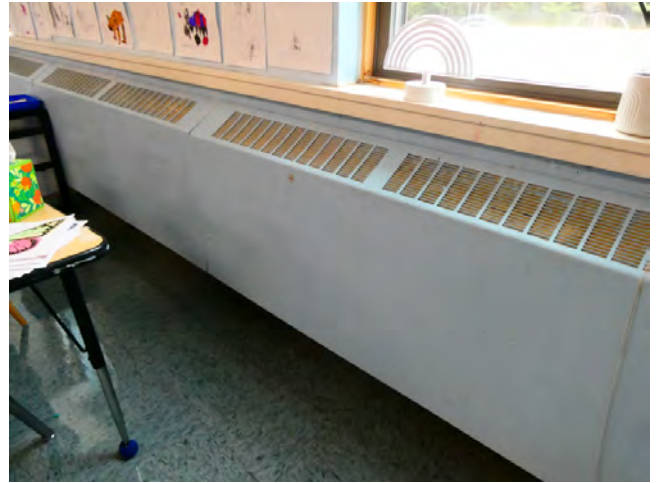
81. MEP - Wall mounted forced air cabinet unit type
