Facility Condition Assessment

Poland Regional High School/Whittier Middle School
1457 Maine Street
Poland, Androscoggin County, Maine 04274

AEI Project No. 482355
Site Assessment Date: September 13, 2023

Subject: Facility Condition Assessment
Poland Regional High School/Whittier Middle School
1457 Maine Street
Poland, Maine 04274
AEI Project No. 482355

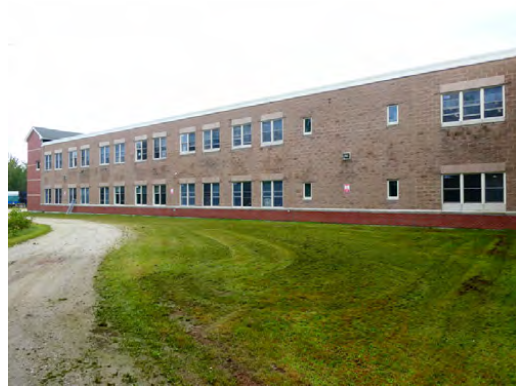
Elevations - South facing elevation of the high school

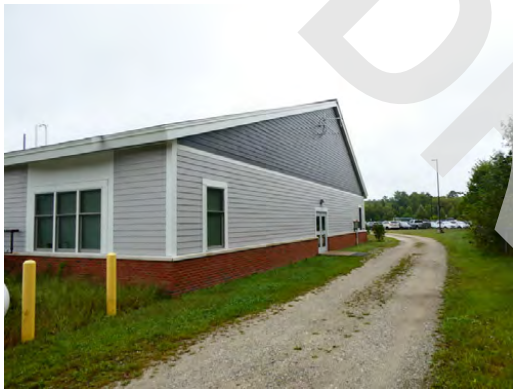
Elevations - East facing elevation of the middle school

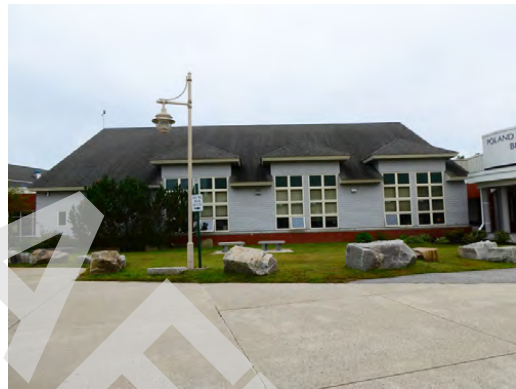
Elevations - North facing elevation of the middle school

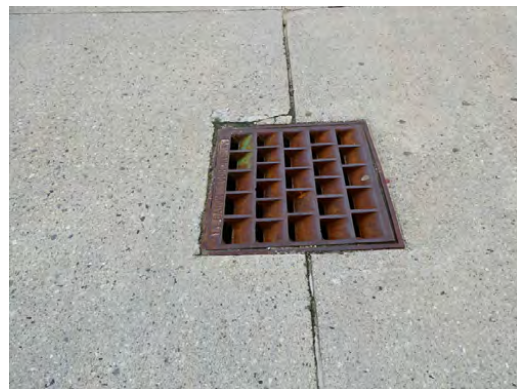
Site - Stormwater surface drain type

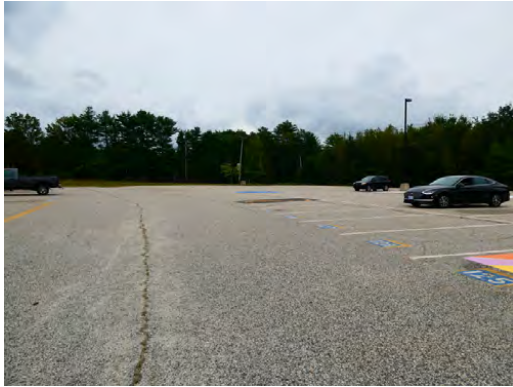
Site - Overview of the north parking area

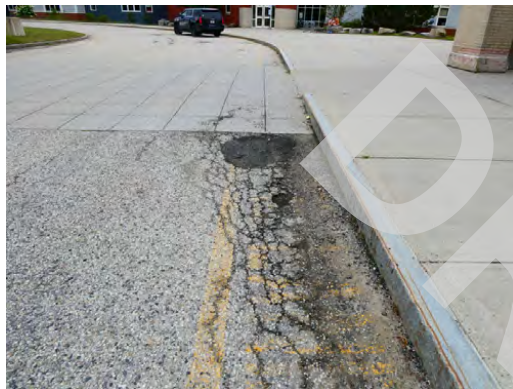
The granite curbing along the parking areas and drives was observed to be in generally good condition. The RULs of these features are expected to exceed the evaluation period.

Site - Granite curbing at drives

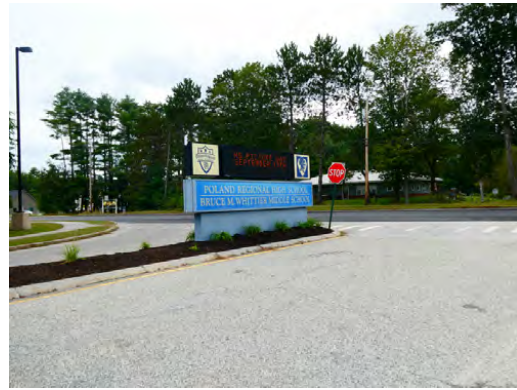
Site - Property signage at main entrance

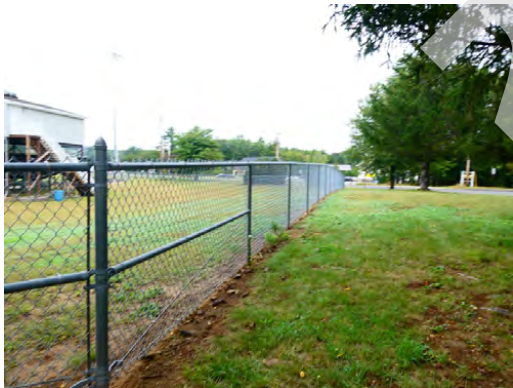
Site - Chain link perimeter fencing along track and football field

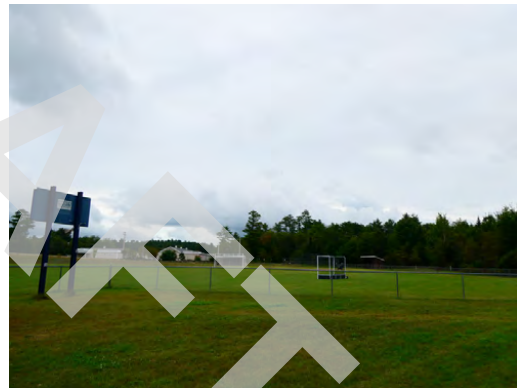
Site - Baseball fields at east perimeter

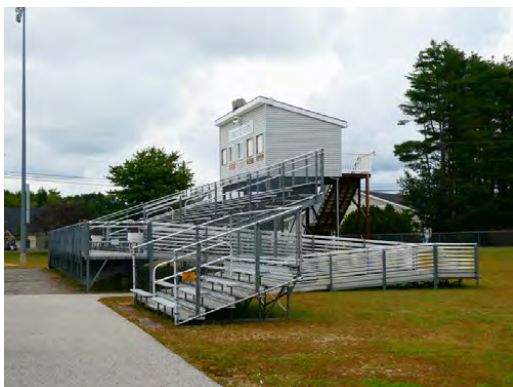
Site - Football stand seating

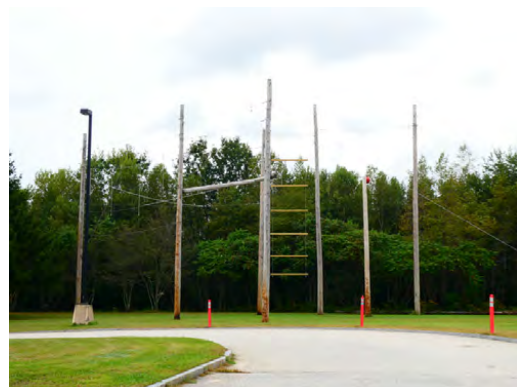
Site - Obstacle course at north perimeter

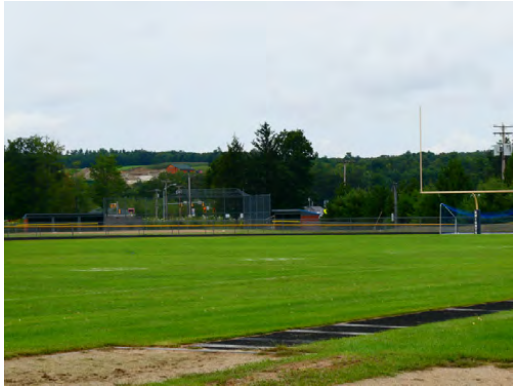
Site - Overview of the football field

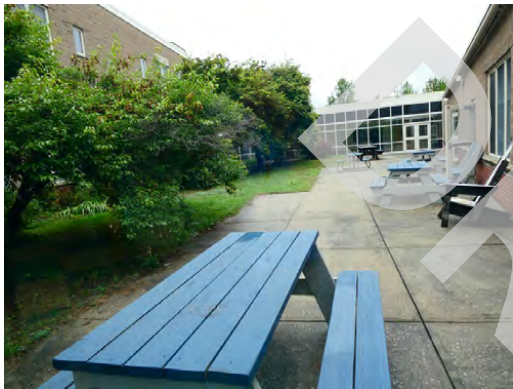
Site - Courtyard area with outdoor seating

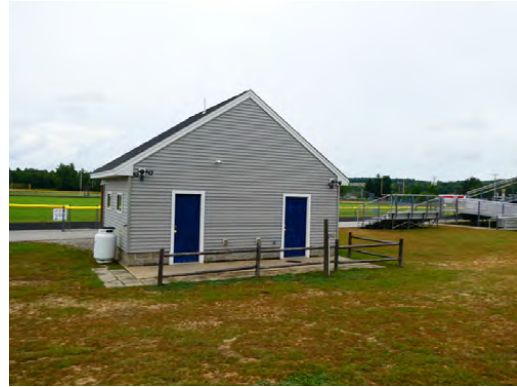
Exterior - Concessions stand at track and football field

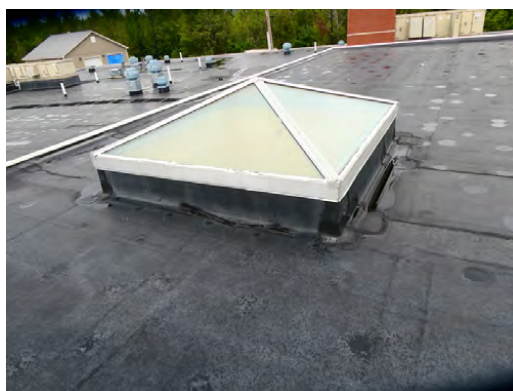
The main roof is provided skylights consisting curb-mounted and metal framed assemblies. There are approximately 13 curb-mounted skylights assumed to be original to construction. The metal framed skylights assemblies at the north portion of the main roof were observed to have recently replaced sealants. Based on the observed conditions, AEI recommends monitoring the sealants at all skylight systems to prevent moisture intrusion. However, based on the EUL for skylights, AEI anticipates that the systems will exceed the evaluation term.

Roof - Curb mounted skylight type

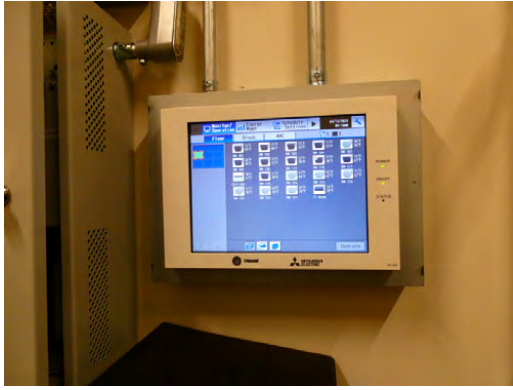
MEP - Energy management system for the middle school

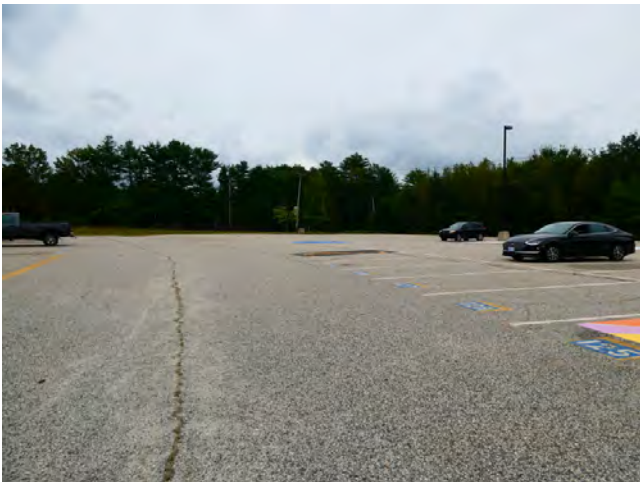
3. Site - Overview of the north parking area

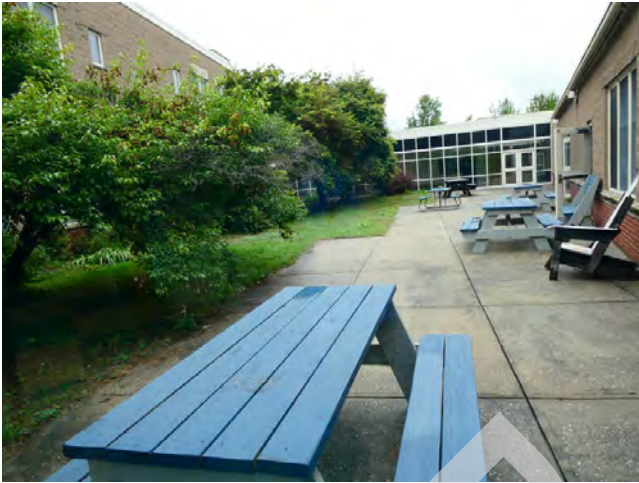
21. Site - Courtyard area with outdoor seating

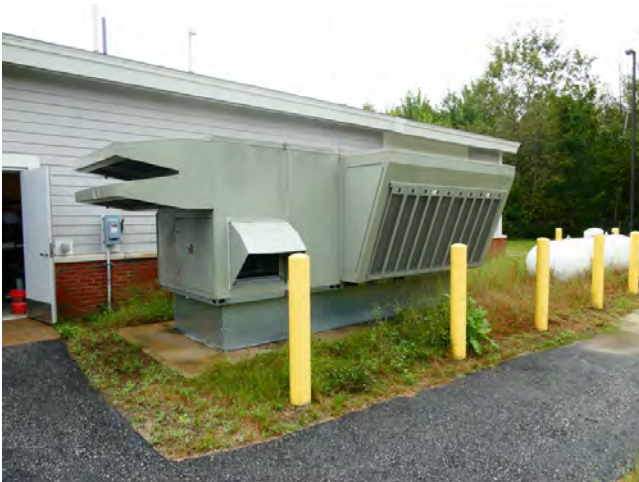
118. MEP - Packaged roof top unit

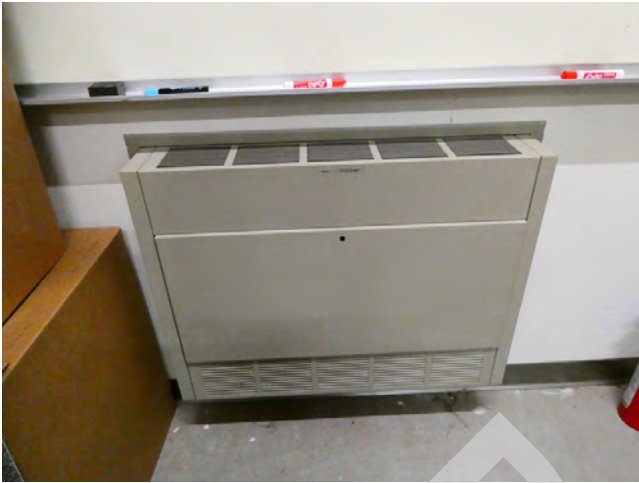
128. MEP - Wall mounted cabinet forced air units

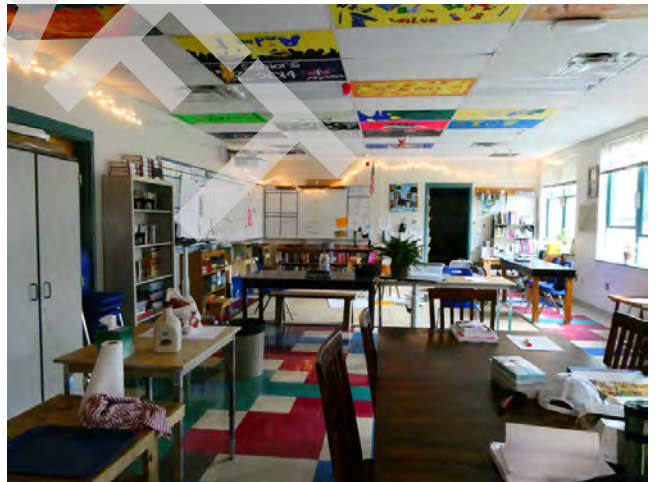
152. Interiors - High school classroom interior finishes

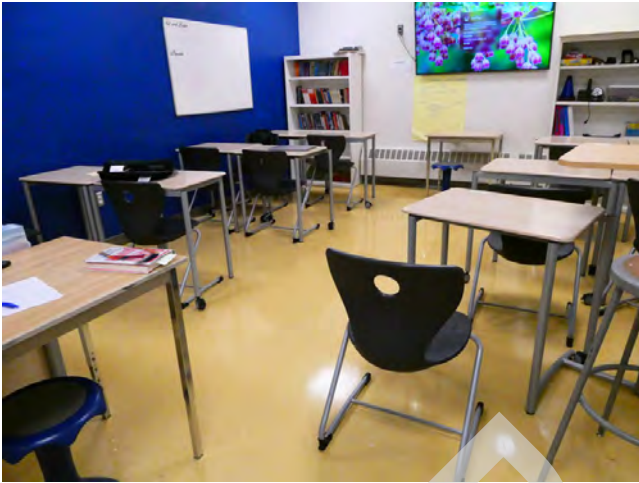
153. Interiors - Middle school class room interiors

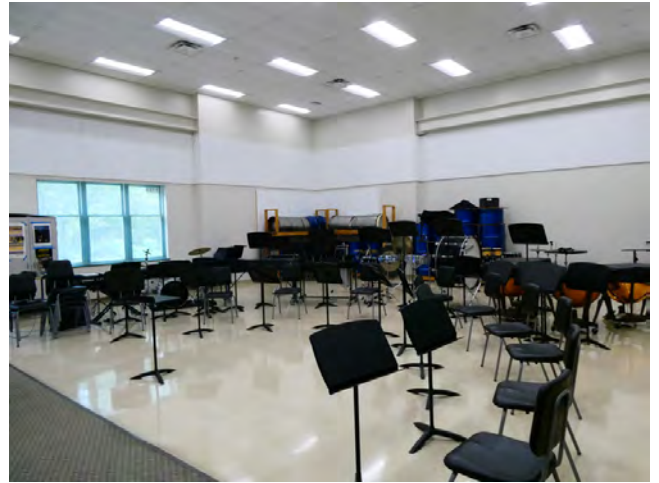
154. Interiors - Music room finishes

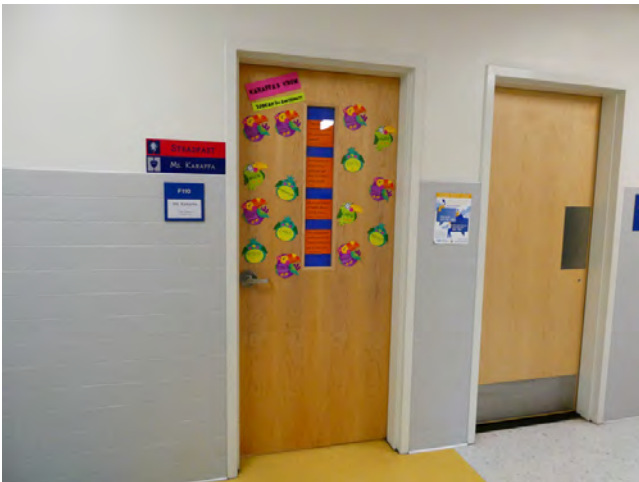
155. Interiors - Typical classroom door in middle school
